Bribie Gardens Long Term Maintenance Plan - 2016

Reference: R-J15034-4_Rev0.docx

Date: August 2016

BRIBIE GARDENS LOCK & WEIR

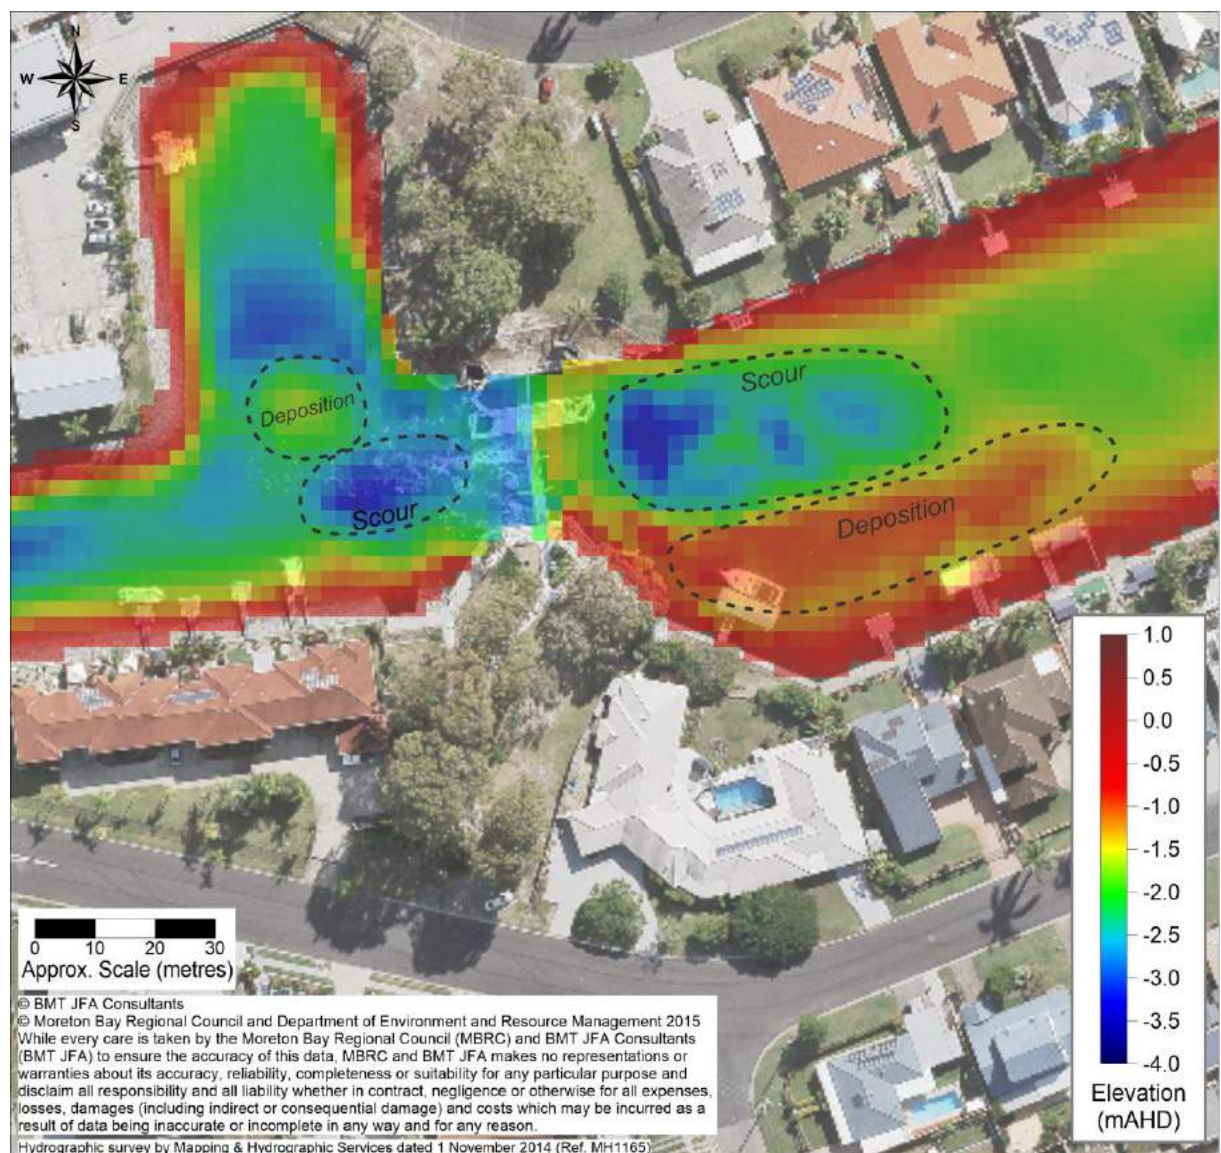
A review of erosion and deposition patterns in areas adjacent the lock and weir indicates that material may have been eroded from the bed, due to the increased velocity of tidal flows over the weir, and subsequently deposited in areas adjacent the eroded areas. The potential scour and deposition areas are broadly illustrated in Figure 4-2. In general, the potential scour appears quite limited on the downstream (i.e. western) side of the lock and weir in comparison to the upstream side.

While the original design of the channel and lake beds incorporated rock scour protection in the areas immediately upstream and downstream of the lock and weir, the scour 'holes' should be monitored via hydrographic surveys to ensure that the scour protection is not compromised or the overall structure undermined.

Figure 4-2 Possible scour and deposition areas inferred from hydrographic surveys

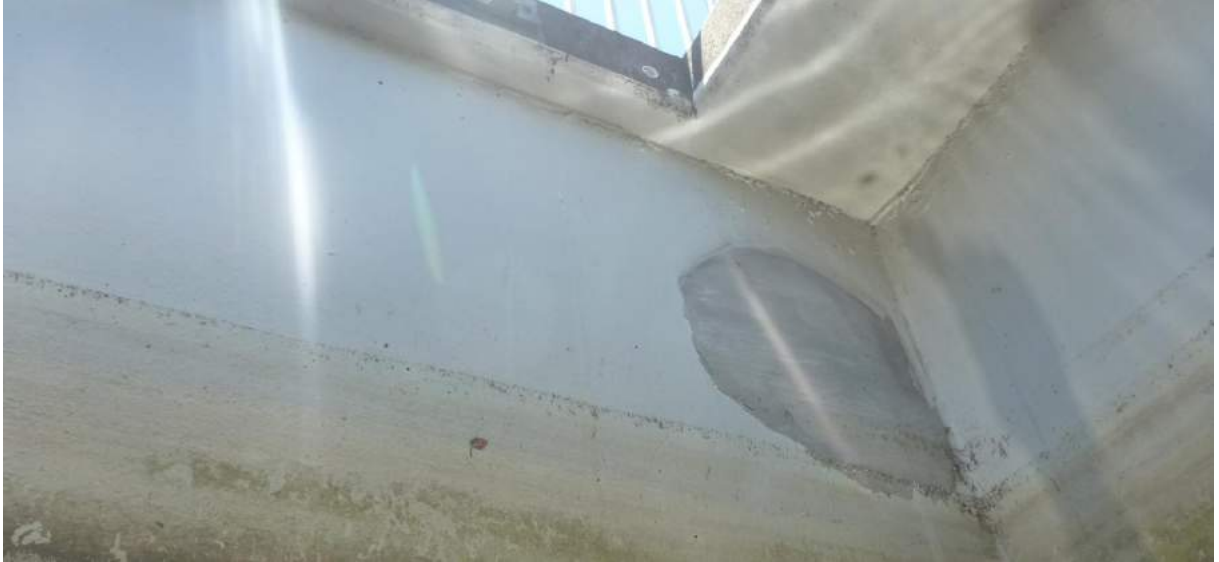
The concrete is 31 years through an assumed 50 year design life (WSCAM Table C1.4 – Expected Life). While the drawings specify 65mm cover, the covermeter tests undertaken identified that, this is consistently lower than specified. In several areas cover was found to be 40mm or less. Corrosion has occurred at a number of locations in the splash zone including one location in the south-eastern gate recess where spalling has resulted (Figure 4-1).

Figure 4-1: Lock SE Gate Recess 20/01/16 – Spall repair starting to fail at west end inner south wall of SE Recess

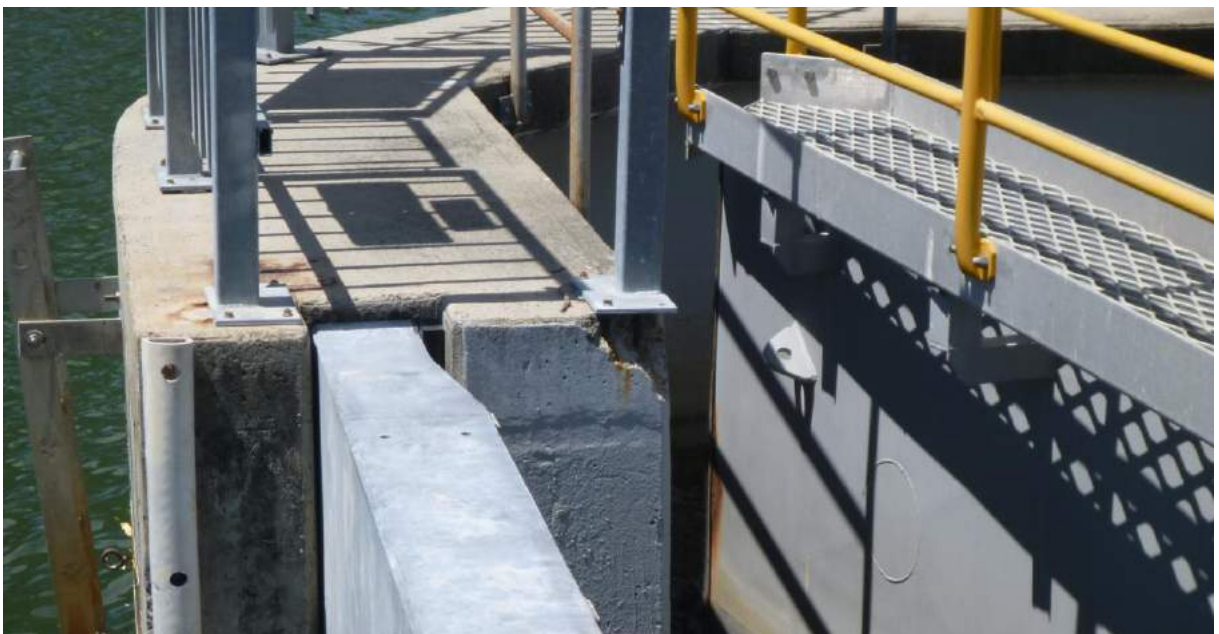
Figure 4-2: Lock Island Walkway SE Gate Recess 20/01/16 – Spall beneath handrail stanchion

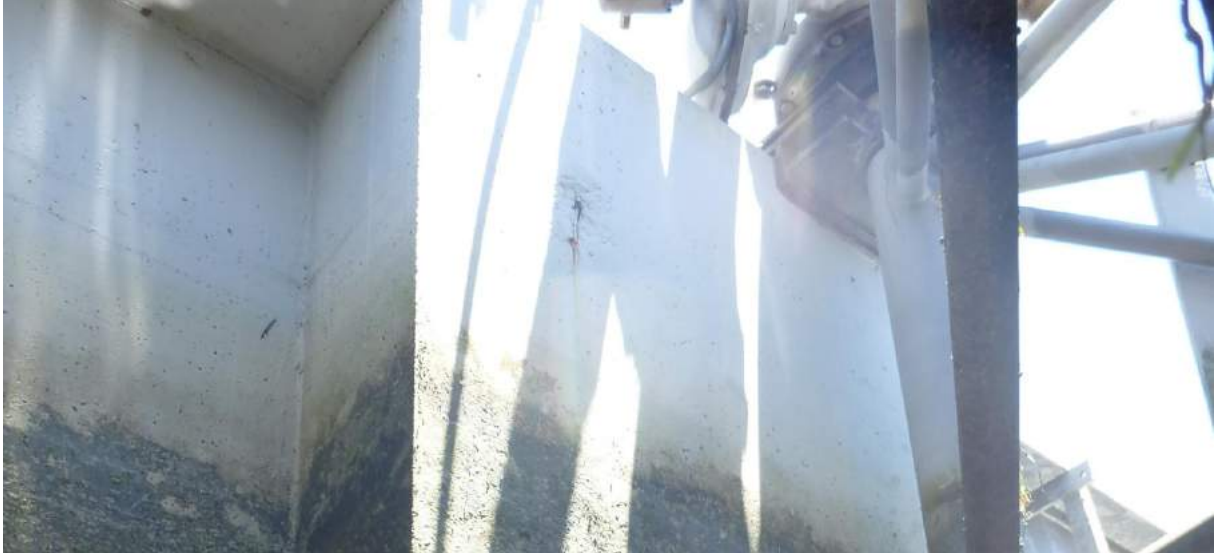
In other areas where cover is almost zero (the majority of cases were in the gate recesses in areas near to the gate pintle in the splash zone– see Figure 4-3) only minor corrosion has occurred to exposed bars. The limited corrosion is potentially due to the good maintenance practice of painting the face of the concrete in the splash/spray zone (from 1m below LAT up to 1m above HAT).

Figure 4-3: Lock Island SW Gate Recess 20/01/16 – Poor compaction and very low/zero cover on gate attachment wall, corrosion staining visible

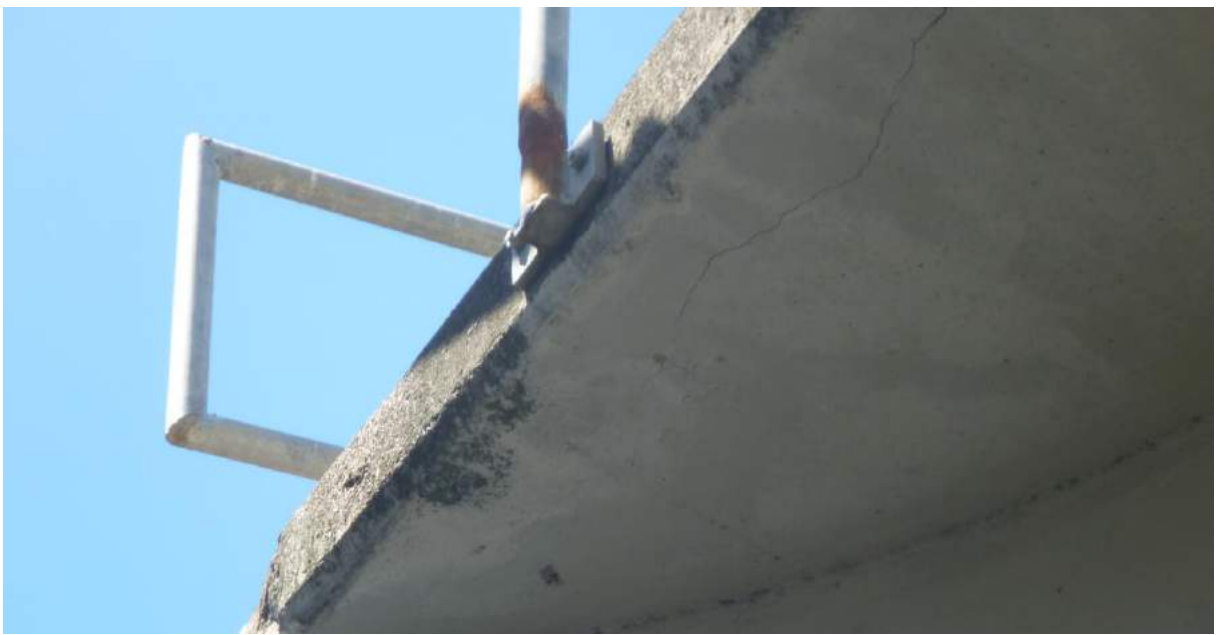
Cracking has been identified at two locations on the concrete in the southwestern gate recess. On the soffit of the cantilevered slab there is a long crack which could be an indication of a single long spall (Figure 4-4). The hand rail is connected at this outer edge, therefore, if the crack was to deteriorate it could compromise the safety of the hand rail. The crack, of greater concern, is located adjacent to the upper SW gate hinge (pintle) connection (Figure 4-5). This is a fine crack at present but there is the potential for it to cause structural problems.

Figure 4-4: Lock SW Gate Recess 20/01/16 – Crack on walkway cantilever slab section

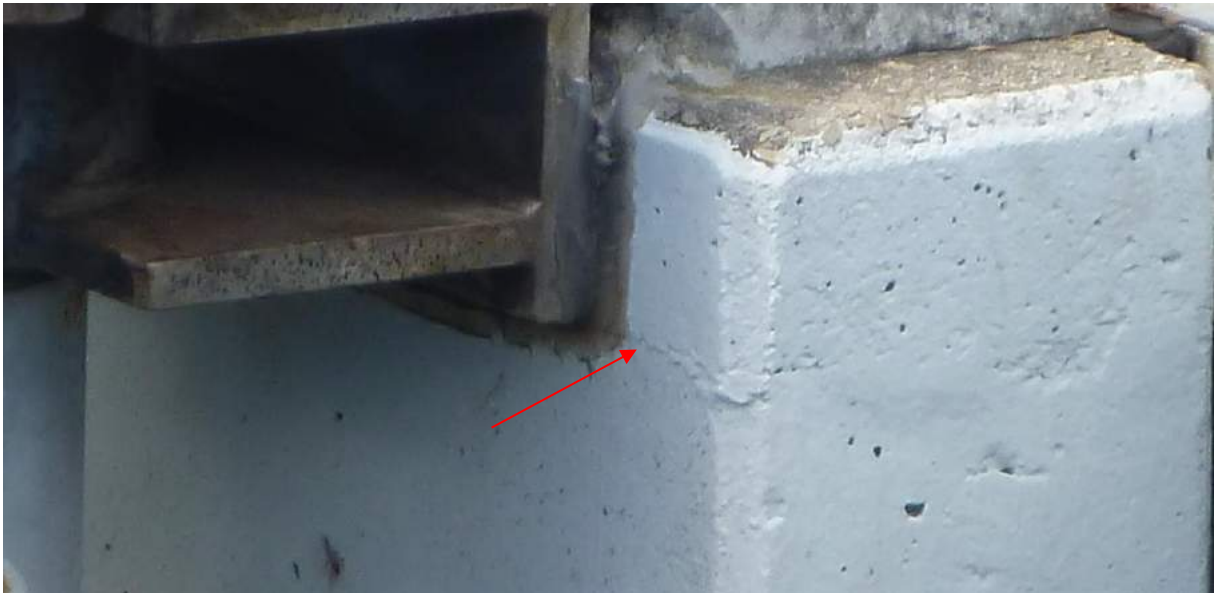
At the south-eastern gate recess on the top face of the slab there is a transverse crack south of the gate hinge (pintle) connection that has been repaired. This crack should be monitored especially for propagation into the adjacent vertical wall of the recess.

Figure 4-5: Lock SW Gate Recess 20/01/16 – Crack at top to the north of gate hinge connection (identified by red arrow)

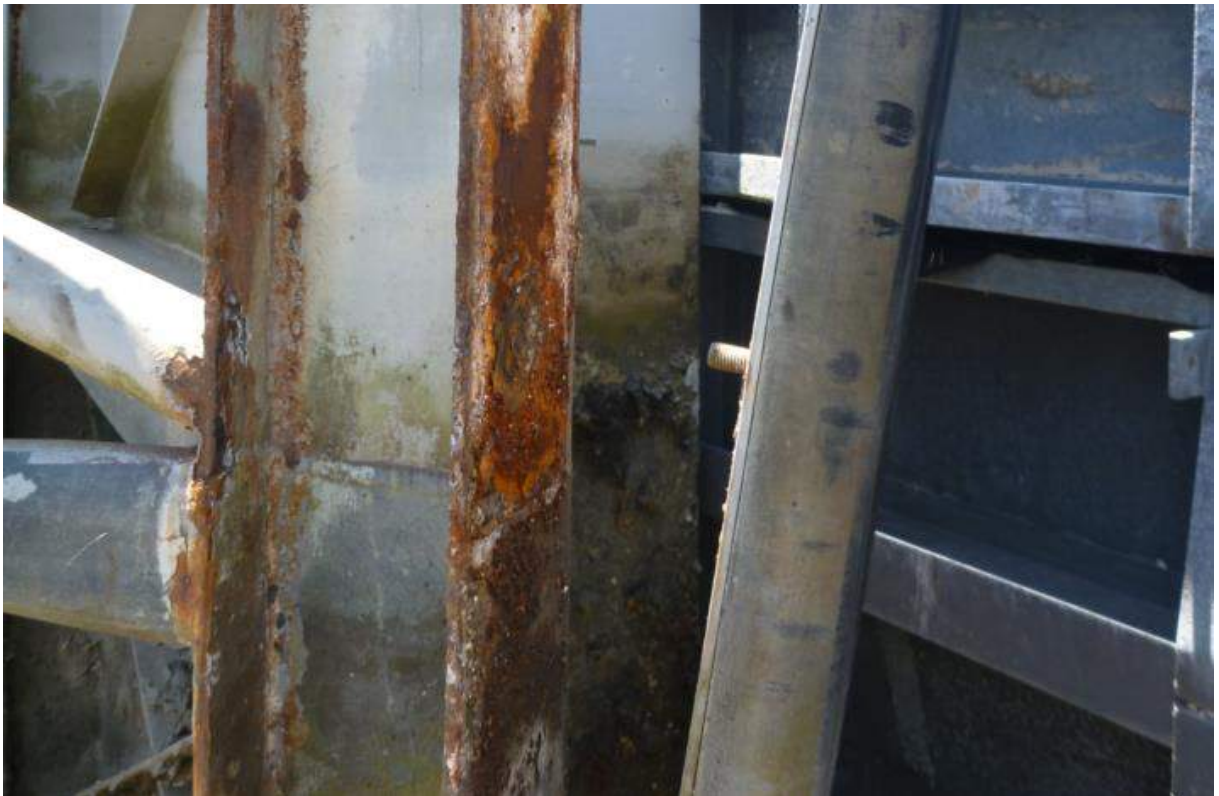
The steel gates have only shown coating deterioration and corrosion within the splash zone. The paint system has deteriorated allowing oxygenated seawater to corrode the steel. The findings of the ultrasonic thickness (UT) testing showed that while corrosion is visible no noticeable section loss had occurred to plate steel, open or hollow sections when a sample of locations were tested (Figure 4-6). The paint system has failed in the most active corrosion area, the tidal zone, where wetting and drying results in accelerated corrosion rates. This area is also not protected by the cathodic protection in place because it is not submerged. The maintenance crew present during the inspection were grinding out corrosion product, with the intention to apply a maintenance coat to the affected sections of the gates.

BMT JFA understand the most recent complete paint system recoating was 12 years ago. This complete recoating is due in the next 2-4 years as deterioration has commenced. Steel coating systems have a maximum life of 10-15 years in the marine environment (as detailed in AS2312 Table 6.3). Regular maintenance touch up coating is a labour intensive method of minimising steel section loss until a new coating system can be applied following full blasting preparation of the substrate metal.

Figure 4-6: Lock NE Gate 20/01/16 – Gate to Gate seal pulled back to reveal extent of corrosion on vertical parallel flange channel member – ultrasonic thickness measurements identified negligible section loss to steel members

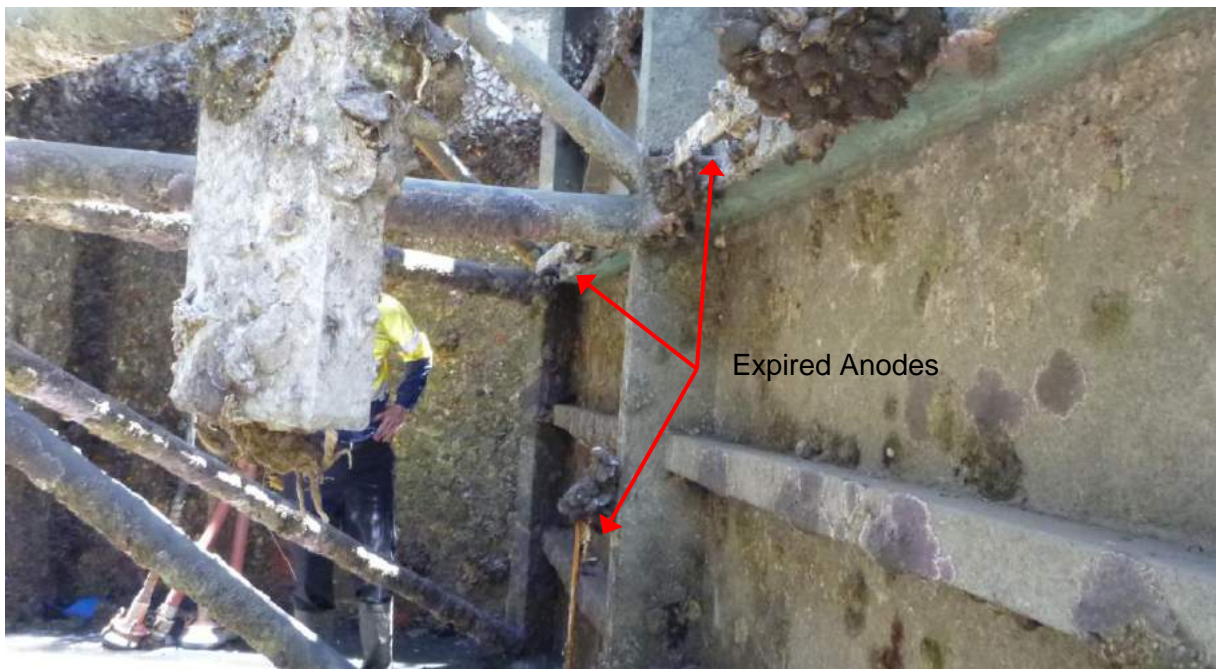
All anodes were found to have expired completely or be utilised beyond 90%. The deeper western gates had complete utilisation of all anodes (Figure 4-7). It is understood that all anodes were replaced following the inspection.

Figure 4-7: Lock NW Gate 20/01/16 – Inside face, 3 anodes (2 vertical, 1 horizontal – identified with red arrows) completely expired

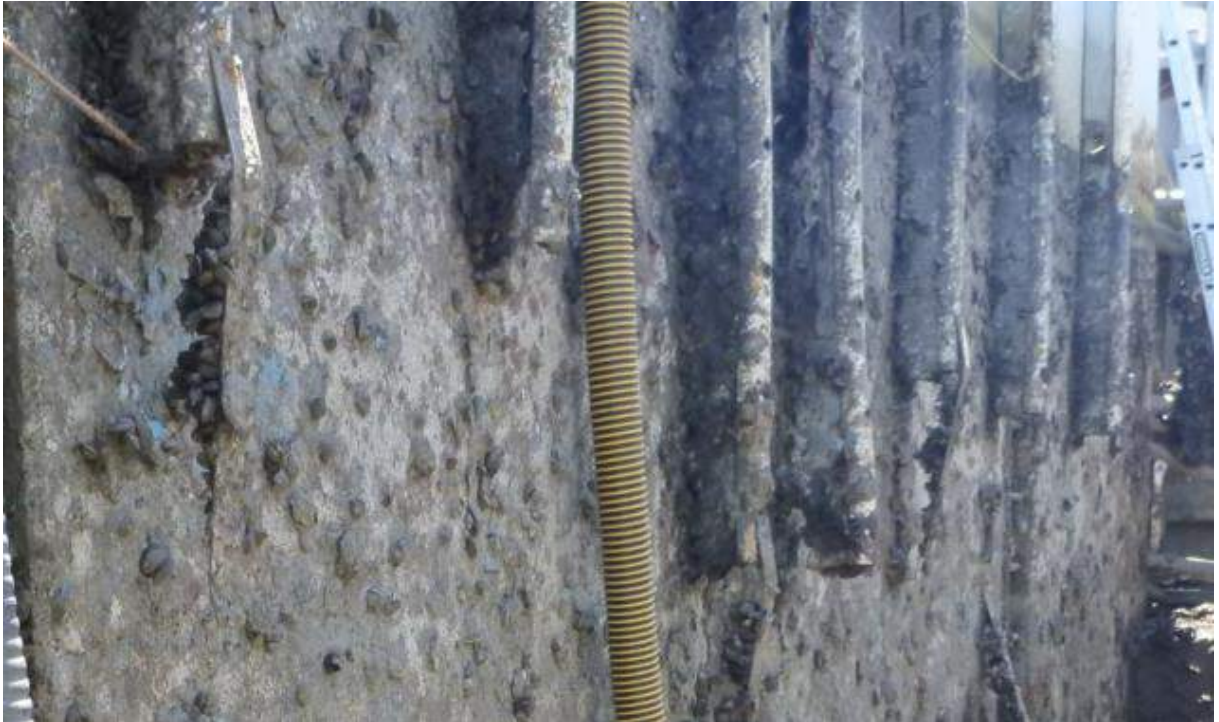
The north and south lock wall rubber faced timber fenders were found to have missing or severely deteriorated connections (Figure 4-8). The lock gates' timber fenders were in good condition.

Figure 4-8: Lock N Wall Fenders 20/01/16 – Lower fender connections missing and failed

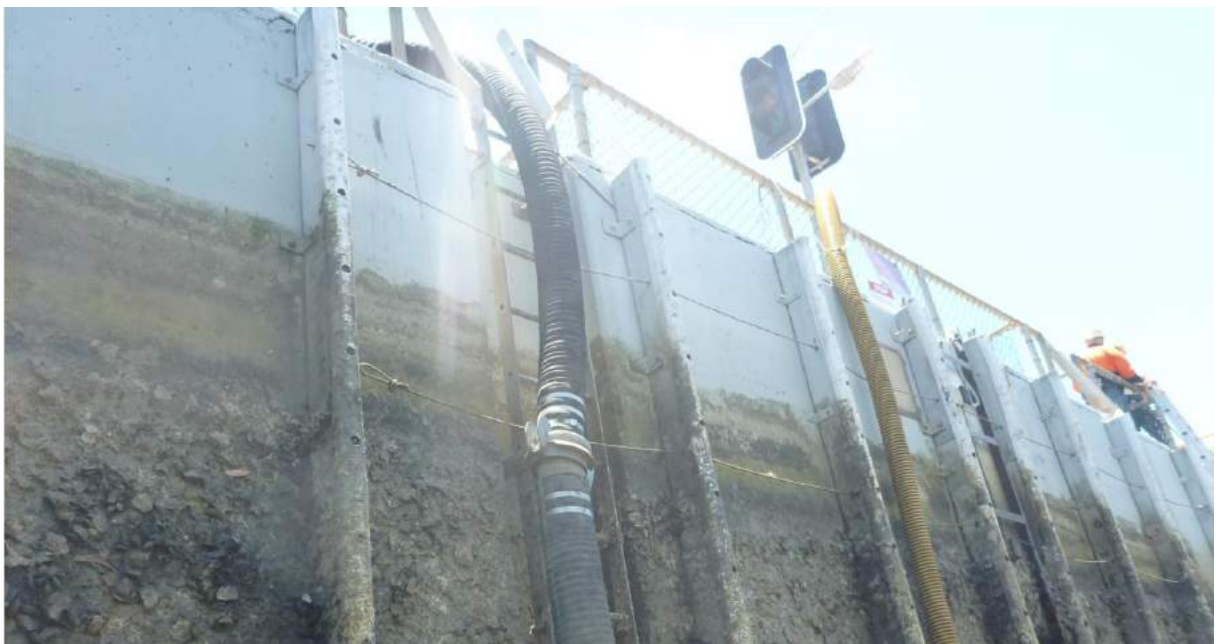
The north lock wall ladders are fouled by stainless steel wire rope running between the fenders (Figure 4-9). The stainless steel wires should be stop-ended at the ladders as they are considered a safety hazard to anyone entering or exiting the water by ladder.

Figure 4-9: Lock N Wall Ladders 20/01/16 – Ladders fouled by stainless steel wire rope between fenders

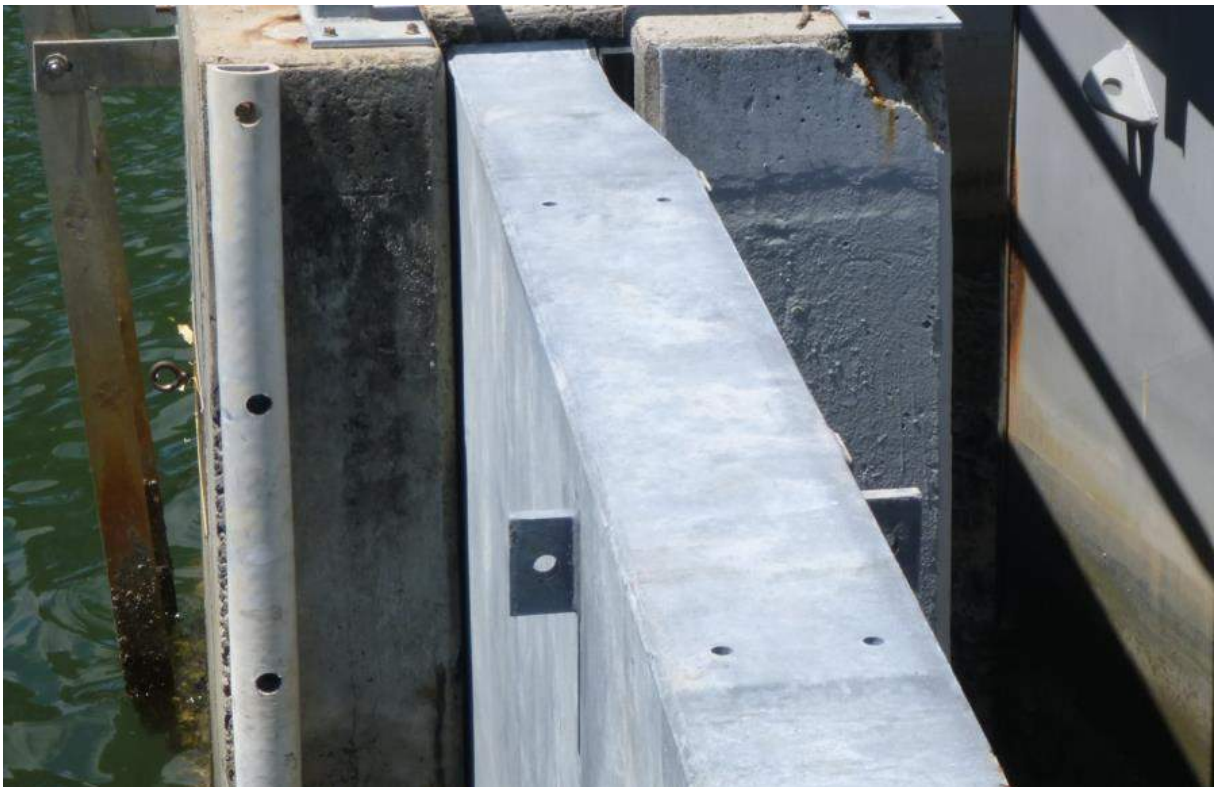
The SE gate recess outer ladder, on inspection of the photographs should be checked as the lower connection appears missing (Figure 4-10).

Figure 4-10: Lock SE Gate Recess 20/01/16 – Outer ladder lower connection appears missing

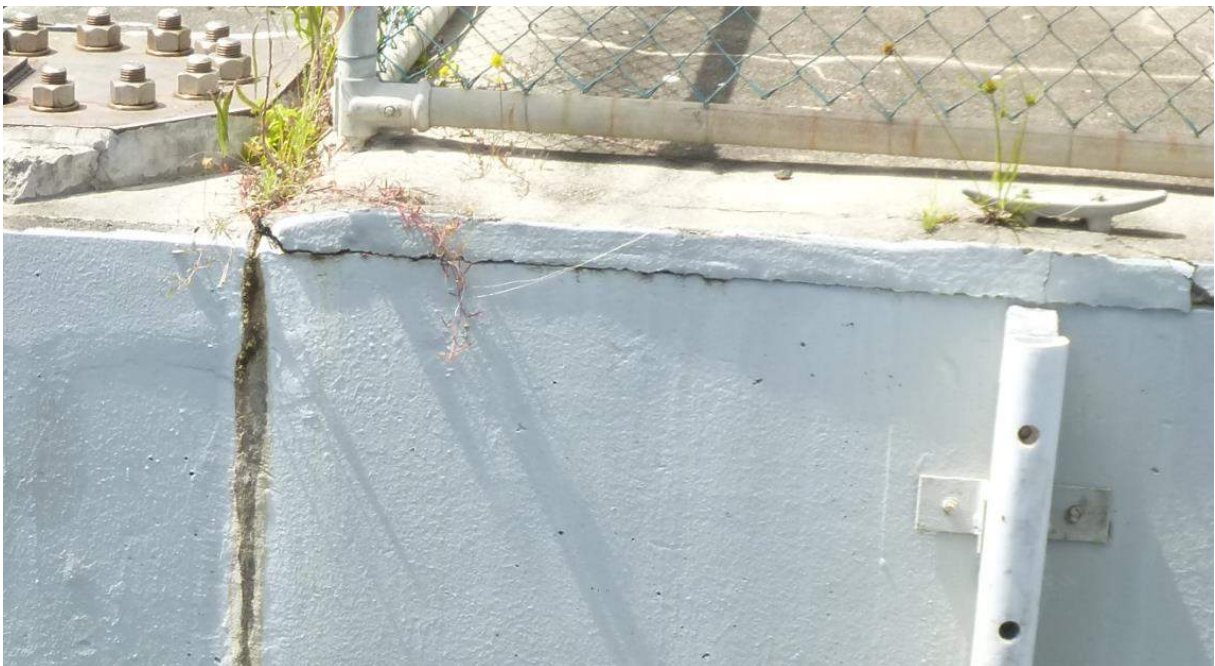
- Cracking to concrete adjacent to cleats, fencing and hand rail fixings (Figure 4-11 and Figure 4-12)
- Corrosion to galvanized steel hand railing
- Deterioration of fencing infill mesh.

Figure 4-11: Lock S Wall (Lock Island) 20/01/16 – Cracking and growth on lock island topping adjacent to cleats and other fixings

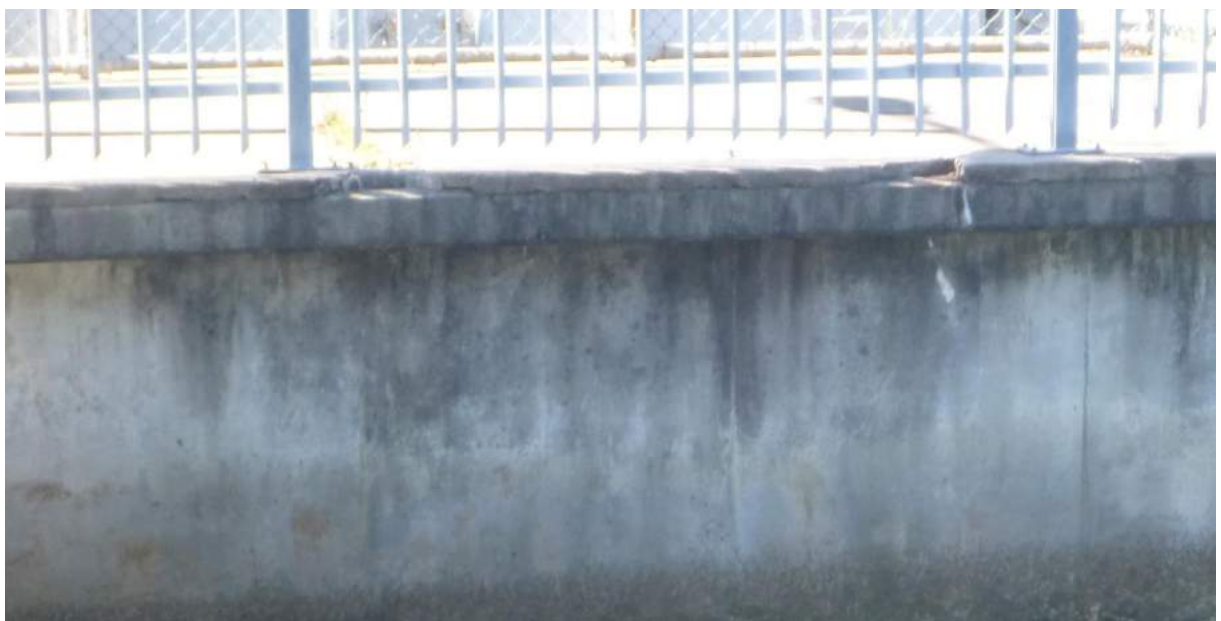
Figure 4-12: Lock Island (view from weir) 20/01/16 – cracking and spalling to edge of lock island topping slab adjacent to fencing fixings

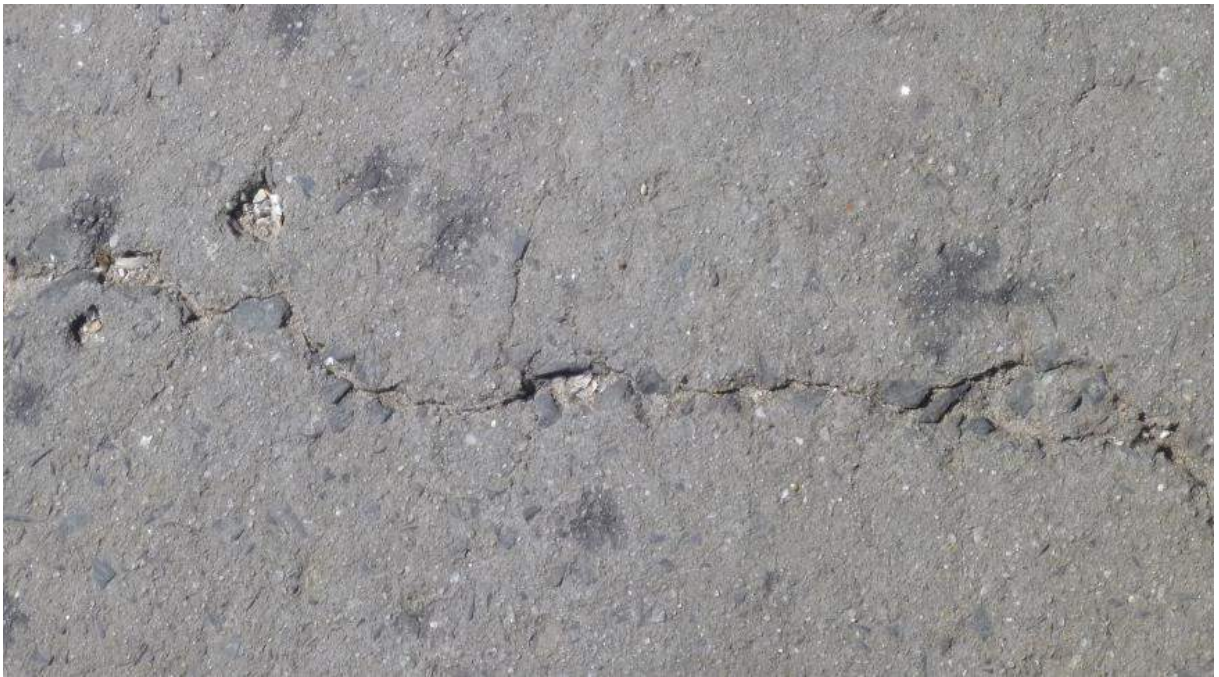
The walkway deck slab cracking (Figure 5-1) appears to be concentrated around the weir walls and could be a combination of flexure and long term drying shrinkage or thermal effects from the integral connections. The cracking is locally between 0.3 and 0.5mm in width. As this walkway is used by the public for fishing, seawater is likely to be splashed on the deck. This is likely to result in wicking, due to repetitive wetting and drying, which could allow dissolved chlorides and oxygen to ingress into the concrete. With the low cover identified on the deck concrete (as low as 45mm) and the identified cracking, the reinforcement is considered to be at risk of corrosion.

Figure 5-1: Weir Walkway 20/01/16 – Cracking of top of walkway deck at weir wall support

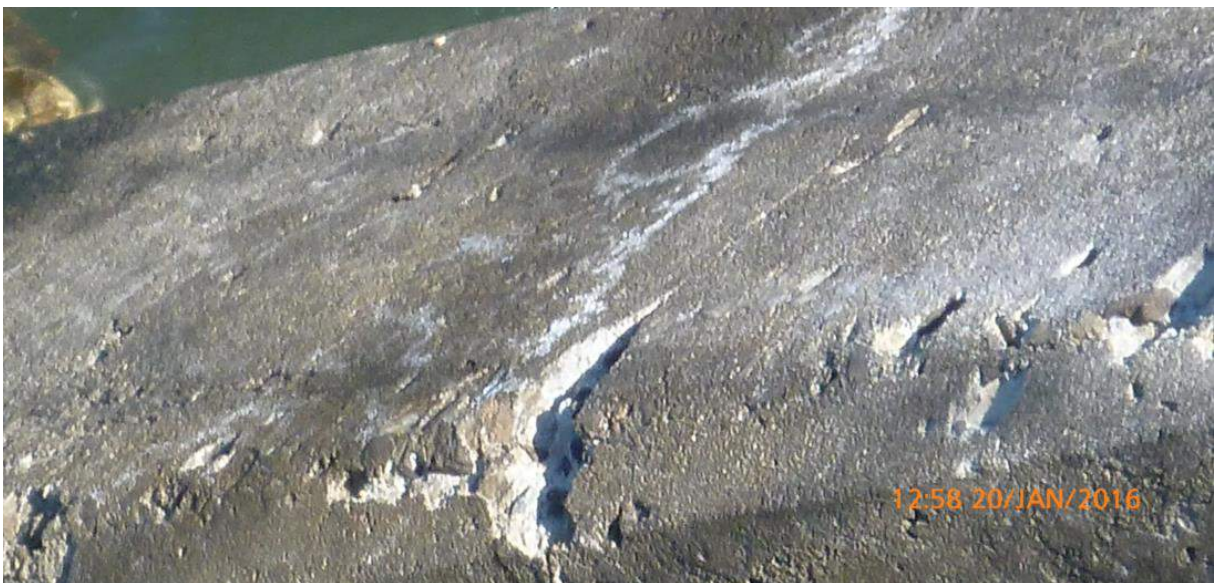
Impact damage has been identified on the upstream side of both flow separating weir walls. This damage, particularly on the south weir wall (Figure 5-2), has reduced the effective cover substantially. This loss of cover could allow corrosion to be initiated resulting in further damage from spalling.

Figure 5-2: South Weir Wall 20/01/16 – Impact damage to upstream side
