## 2 Deception Bay

### 2.1 Council Controlled Areas and Current Condition

Title: <b>Deception Bay Beach Unit - Council Controlled Shoreline Areas and Current Condition</b>	Figure: <b>2-1</b>	Rev: <b>A</b>
--	-----------------------	------------------

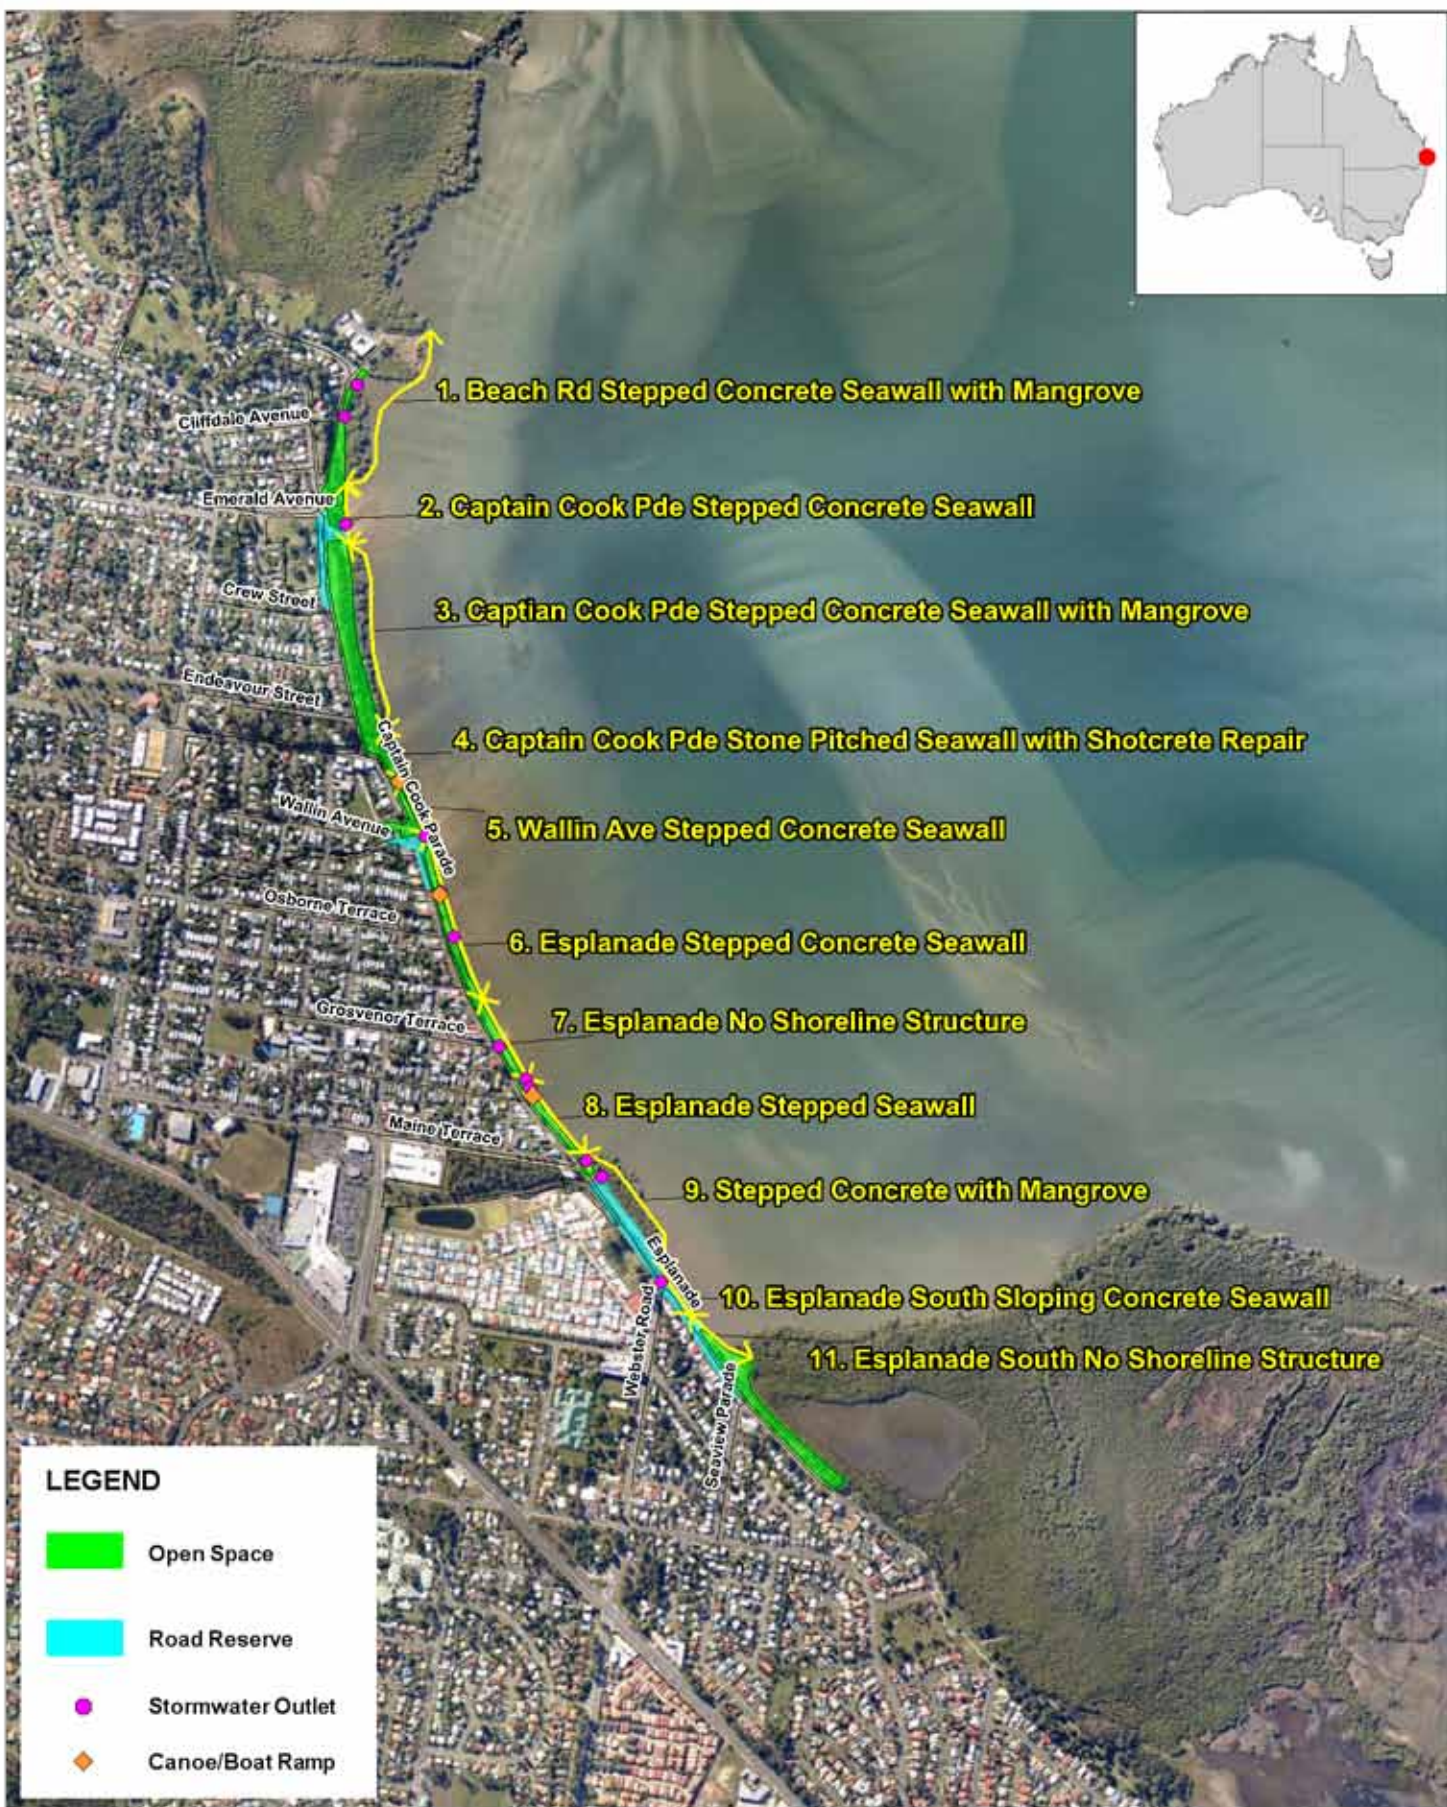
- 1. Beach Rd Stepped Concrete Seawall with Mangrove
- 2. Captain Cook Pde Stepped Concrete Seawall
- 3. Captian Cook Pde Stepped Concrete Seawall with Mangrove
- 4. Captain Cook Pde Stone Pitched Seawall with Shotcrete Repair
- 5. Wallin Ave Stepped Concrete Seawall
- 6. Esplanade Stepped Concrete Seawall
- 7. Esplanade No Shoreline Structure
- 8. Esplanade Stepped Seawall
- 9. Stepped Concrete with Mangrove
- 10. Esplanade South Sloping Concrete Seawall
- 11. Esplanade South No Shoreline Structure

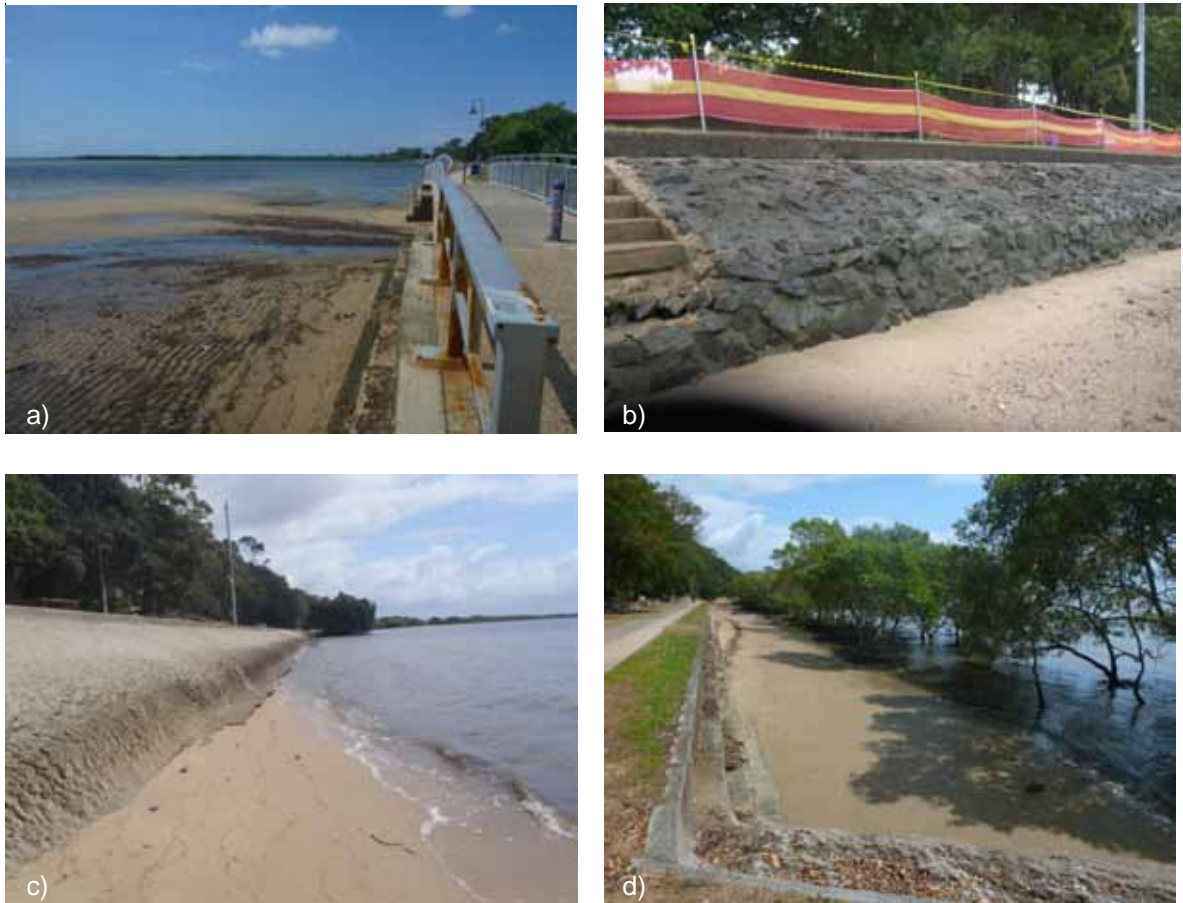
The concrete stepped seawalls common throughout the study area are generally in a good condition. Stormwater outfalls or drains are incorporated with shoreline structures at many locations. While ponding during periods of low stormwater flow is evident, the essential infrastructure does not appear to be contributing to significant shoreline erosion. Small mangrove communities are common throughout Deception Bay and act to protect sections of seawall from direct exposure to coastal processes (discussed further in Section 2.1.1).

The extent of these mangrove patches has expanded notably in recent decades, since prior clearing (refer historical aerial photographs in Stage 1 report). However, the potential for further expansion along the remaining foreshore (i.e. where intertidal vegetation is absent) seems somewhat limited. This is likely associated with the existing shoreline protection infrastructure, and the resultant changes to shoreline morphology, profile, and the resultant hydrological and sedimentary characteristics of existing intertidal shores. Hard shoreline structures will typically reflect wave energy during storm events, often leading to a lowering of the shoreline. There is evidence of these processes impacting mangrove colonisation in front of the shotcrete repaired seawall at Captain Cook Parade (Figure 2-2c).

**Figure 2-2 Example Shoreline Condition throughout Deception Bay Study Area: a) Stepped Concrete; b) Stone Pitched; c) Stone Pitched with Shotcrete Repair; d) Stepped Concrete with Mangrove Buffer**

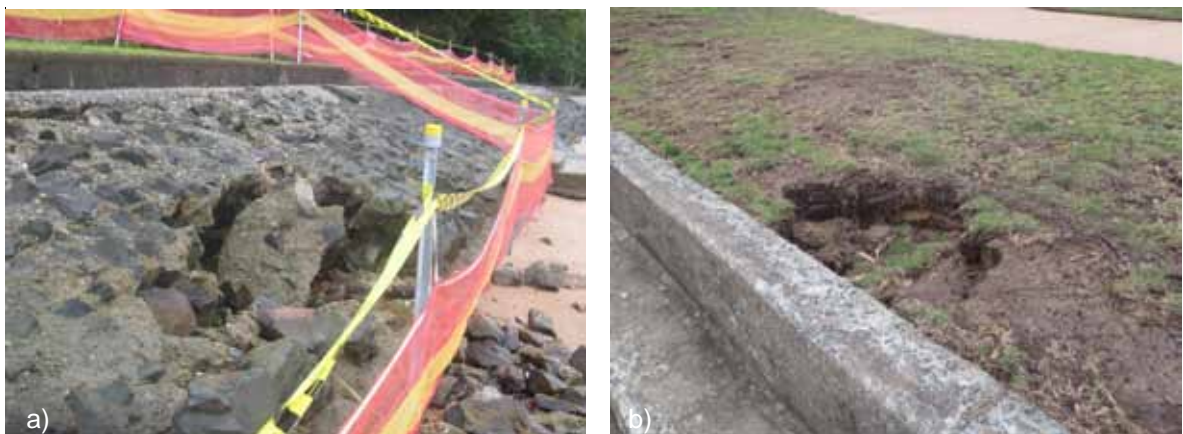
The need for enhanced shoreline management is most evident at the exposed seawall section north of the Captain Cook Parade boat ramp. Examples of storm damaged shoreline structures that represent temporary public safety and maintenance issues for Council are shown in Figure 2-3 (following ex-TC Oswald, January 2013). The modes of failure are typically associated with a combination of processes, including:

- Wave impact: waves breaking at or near the structure generate high impact pressures of short duration and may cause brittle failure of rigid seawalls or revetments. Wave overtopping can also cause damage or erosion at the crest of a structure.

- Scour: the presence of a hard, non-erodible structure may increase the current velocity in its immediate vicinity. This in turn increases the sediment transport potential at the toe of the seawall, leading to lowering of the beach due to scour and ultimately the undermining of the structure and the onset of sliding failure.
- Geotechnical failure: at Deception Bay, appears to be associated with the fluidisation of the underlying material due to excess pore water pressures and/or the loss of underlying material through internal channels due to steep hydraulic gradients (referred to as “piping”).

**Figure 2-3 Seawall Damage January 2013: a) Stone Pitched Seawall Failure (prior to Shotcrete Repair); b) Sink Hole behind Stepped Seawall**

The potential for seawall failure due to the modes described above could be reduced with a seawall design that causes greater wave and current energy dissipation during extreme events.

The exposed section of stone pitched seawall damaged during ex-TC Oswald and subsequently repaired with shotcrete in early 2013 (Captain Cook Parade Park, Section 4 in Figure 2-1) represents the most urgent works within the Deception Bay study area. This structure and section of shoreline remains vulnerable and should be upgraded in the short term. Given the exposure of this section, a rock revetment that better dissipates wave energy during storm conditions may be more appropriate than a rigid seawall design. However, stepped seawalls are common throughout the study area and there may be a preference for design consistency. A setback and realignment will also help to reduce lowering of the beach at the toe of the structure and minimise future damage. A slightly higher bed elevation in front of the wall may also allow mangroves to establish in the area. This could be encouraged through a revegetation program or may simply occur naturally if favourable physical conditions prevail (considered further in Section 2.3.1).

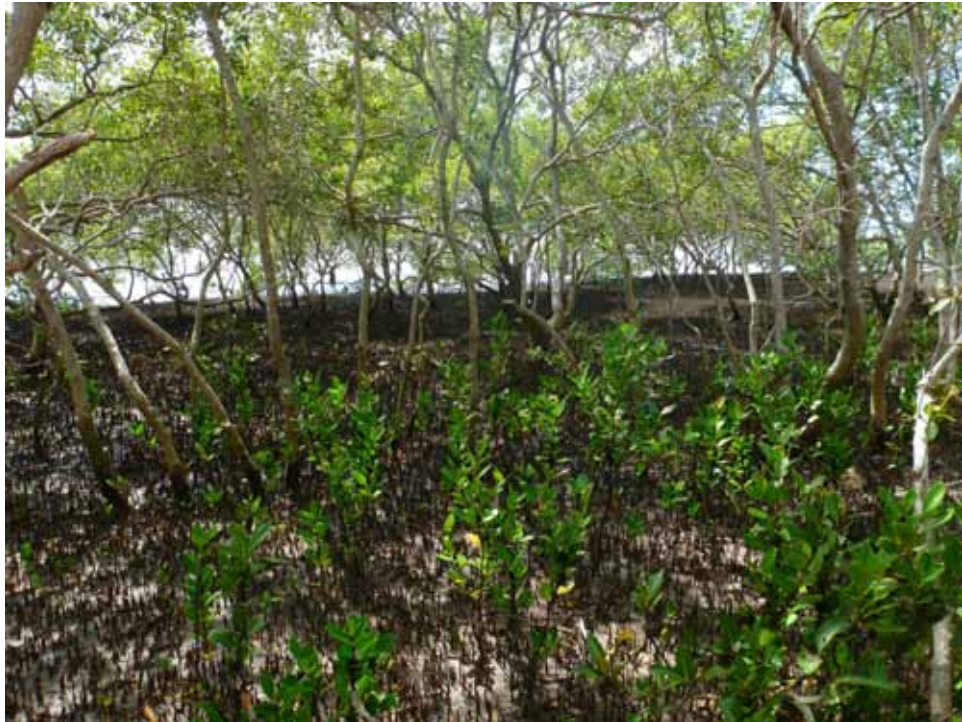
Figure 2-4 Healthy Mature (background) and Juvenile (foreground) Mangrove Vegetation Adjacent to Captain Cook Parade

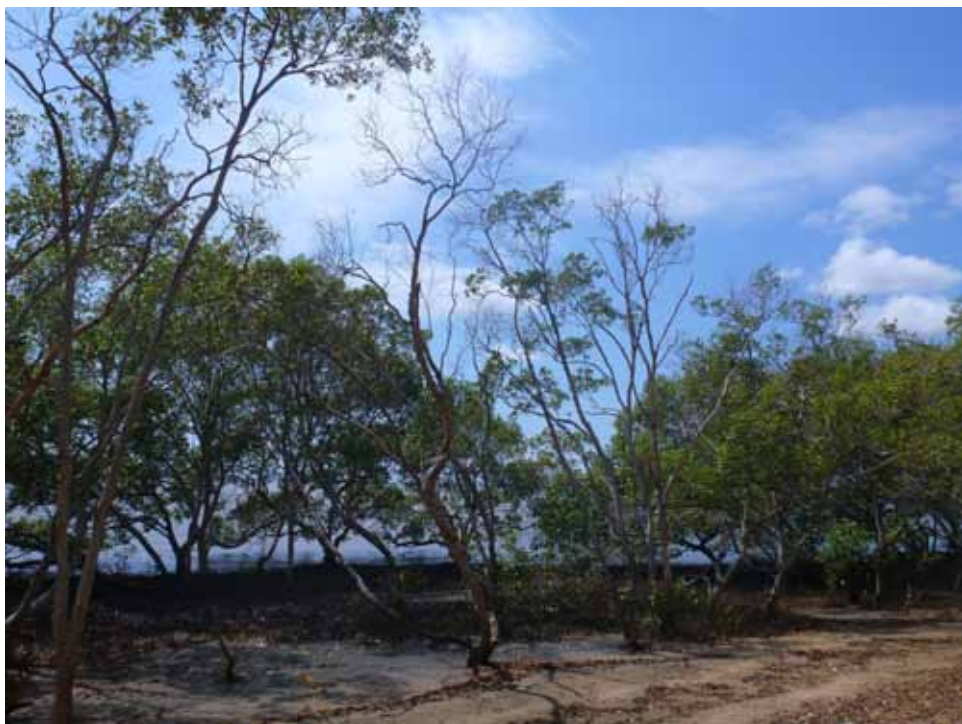
While most of the mangroves observed in this section were in good condition (Figure 2-4), a small area of mangrove dieback was evident adjacent to Captain Cook Parade (Figure 2-5). In this area, there are a few mature trees displaying visible symptoms of stress, such as leaf abscission, and few juvenile mangroves (i.e. seedlings and saplings) were observed to be present. Mangrove dieback here is likely associated with factors such as sediment accumulation, unfavourable sediment or water chemistry, or biological infection (e.g. leaf galls).

Figure 2-5 Mangrove Dieback Adjacent to Captain Cook Parade

Shoreline management actions that seek to maintain or enhance the existing mangrove communities are likely to have the combined benefit of preserving ecological values and minimising shoreline erosion. Maintenance would typically require minimal effort, and may be limited to regular (e.g. opportunistic or annual) inspection of tree health and management of obvious potential stressors such as weeds and accumulated litter. More involved inspection and management may be required from time to time to target problems areas where dieback is observed.

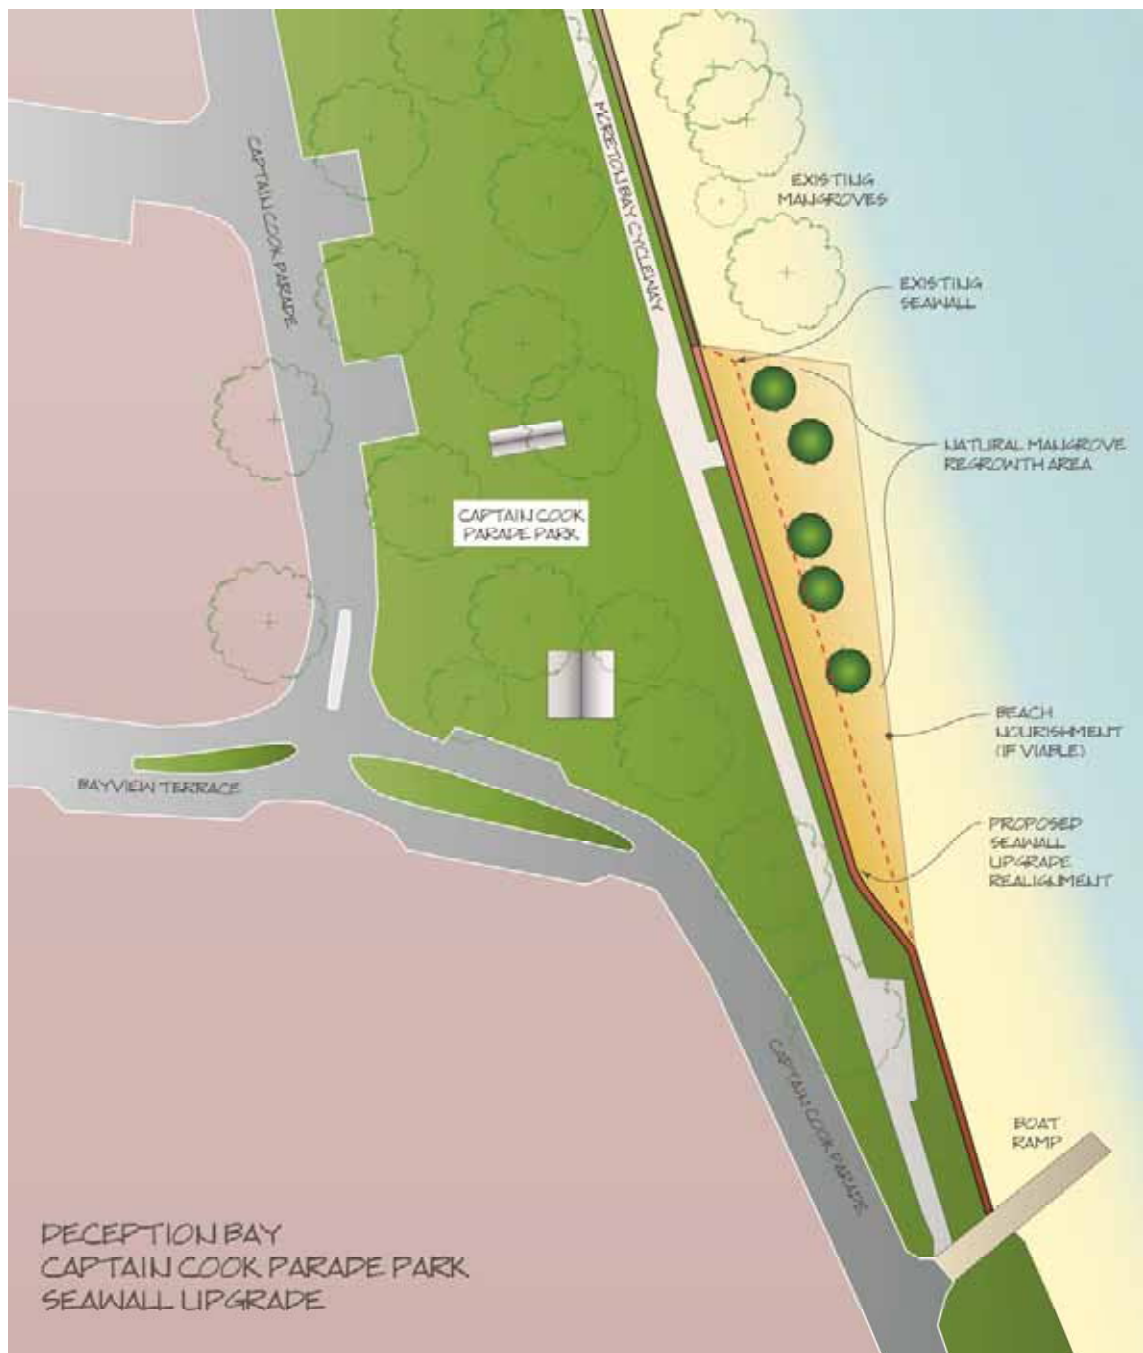
Figure 2-6 Captain Cook Parade Park Seawall Upgrade and Realignment and Mangrove Rehabilitation

A conceptual layout of the proposed seawall upgrade and realignment is shown in Figure 2-6. The realignment would cause a small loss of foreshore area however this is not expected to negatively impact social or environmental values of the area. If a setback was achieved it is expected that the loss of foreshore area would be offset by the establishment of a narrow beach and the potential

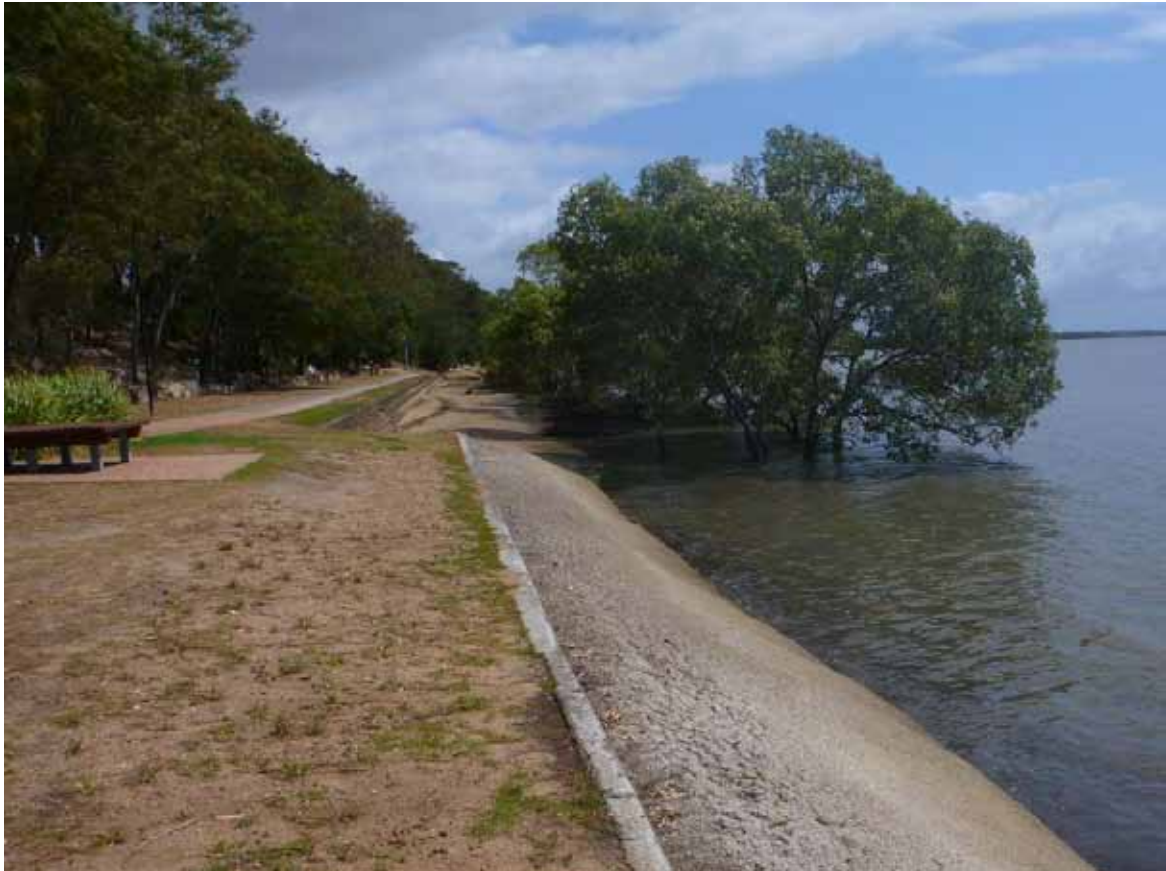
At the southern extent of the mangrove community along Captain Cook Parade Park (near Endeavour Street) there is a distinct disparity in the alignment of the seawall where the mangroves end, as shown in Figure 2-7. In contrast to the intact stepped wall fronted by mangroves, the adjoining wall where no mangroves occur is positioned approximately 5m further seaward and requires ongoing maintenance due to scour at the toe of the structure. As illustrated in Figure 2-6, realignment of this structure may improve adjacent environmental conditions that promote further mangrove colonisation and expand the longshore extent of this vegetation buffer.

**Figure 2-7 Southern Extent of Mangroves adjacent to Captain Cook Parade Park**

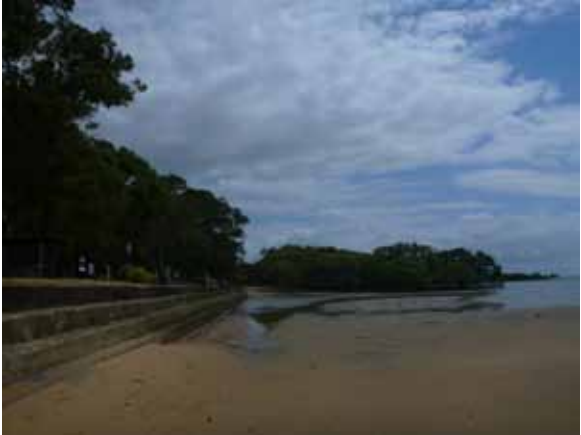
Shoreline Section Number	Existing Condition	Proposed Management Strategy
<p>1. Beach Rd – approx. 420m</p>

<ul style="list-style-type: none"> <li>• Stepped concrete seawall in good condition</li> <li>• Sandy beach and mangrove buffer</li> <li>• Beach lowering in front of seawall</li> </ul>	<ul style="list-style-type: none"> <li>• Maintain status quo including ongoing foreshore and vegetation management</li> <li>• Inspect seawall and foreshore following severe storm events</li> <li>• Perform maintenance as required</li> </ul>
<p>2. Captain Cook Pde – approx. 130m</p>

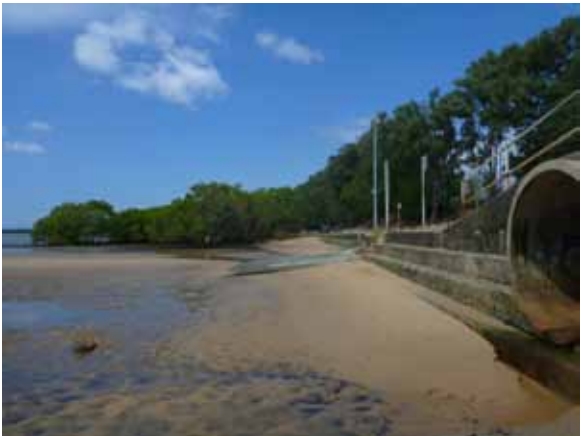
<ul style="list-style-type: none"> <li>• Stepped concrete seawall in good condition</li> <li>• Sandy beach buffer</li> <li>• Stormwater outfall</li> <li>• Public boat ramp</li> </ul>	<ul style="list-style-type: none"> <li>• Maintain status quo including ongoing foreshore and vegetation management</li> <li>• Inspect seawall and foreshore following severe storm and stormwater flow events</li> <li>• Perform maintenance as required</li> </ul>

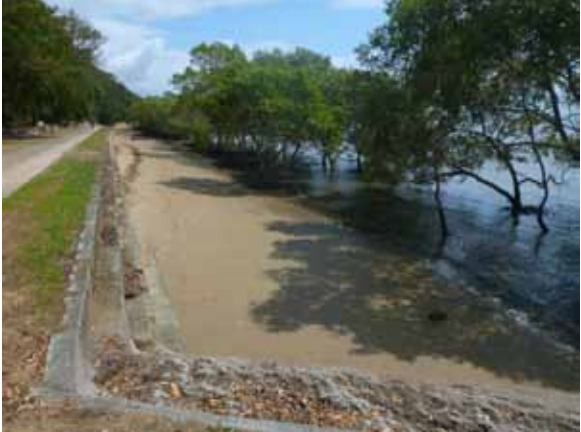
Shoreline Section Number	Existing Condition	Proposed Management Strategy
<p>3. Captain Cook Pde – approx. 420m</p>

<ul style="list-style-type: none"> <li>• Stepped concrete seawall in good condition</li> <li>• Sandy beach and mangrove buffer</li> </ul>	<ul style="list-style-type: none"> <li>• Maintain status quo including ongoing foreshore and vegetation management</li> <li>• Inspect seawall and foreshore following severe storm events</li> <li>• Perform maintenance as required</li> </ul>
<p>4. Captain Cook Pde Park – approx. 120m</p>

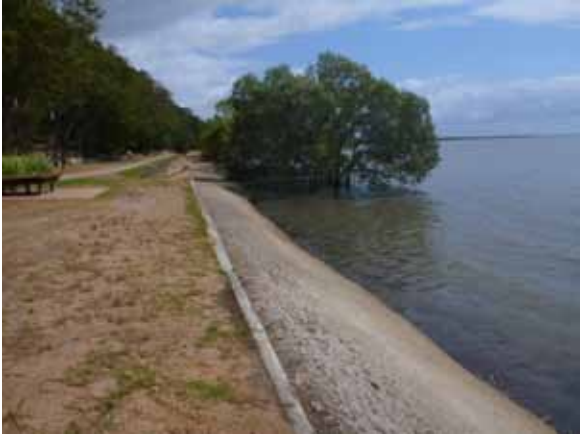
<ul style="list-style-type: none"> <li>• Stone pitched seawall with shotcrete repair completed in 2013 (following ex-TC Oswald)</li> <li>• Sinkhole damage along foreshore observed following severe storm conditions</li> </ul>	<ul style="list-style-type: none"> <li>• Upgrade seawall within 2 years</li> <li>• Realign with stepped seawall to the north</li> <li>• Minor beach nourishment in front of realigned seawall</li> </ul>

The additional capital cost associated with the proposed 120m seawall upgrade at Captain Cook Parade Park (Section 4) is approximately \$720,000 in 2014. This estimate is based on a pre-cast concrete stepped seawall design, corresponding to \$6,000/meter for detailed design, approval, construction and foreshore rehabilitation costs. Consideration to relatively minor works at the Wallin Ave drain, intended to intercept sand before it enters the drain, could be considered at this time (at an additional cost not expected to exceed \$100,000). The intercepted material could provide an ongoing source of sand for minor beach nourishment at adjacent shorelines.

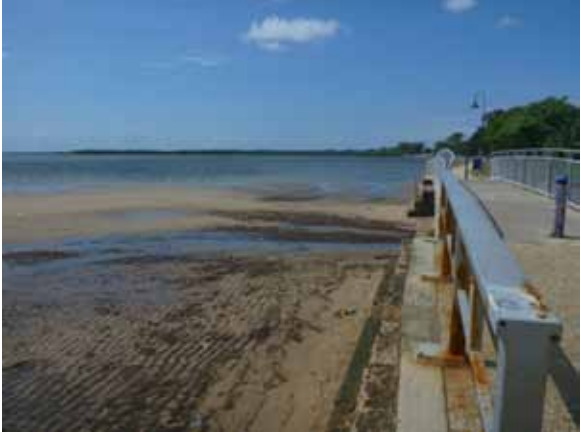
Shoreline Section Number	Existing Condition	Proposed Management Strategy
<p>5. Wallin Ave – approx. 130m</p>

<ul style="list-style-type: none"> <li>• Stepped concrete seawall in good condition</li> <li>• Open channel stormwater outlet</li> <li>• Sand accumulation in outlet</li> <li>• Accumulated sand disposed offshore during channel flow events</li> </ul>	<ul style="list-style-type: none"> <li>• Redistribute accumulated sand to adjacent areas</li> <li>• Potential sand source for minor nourishment proposed at Section 4</li> <li>• Consider minor training wall structures designed to intercept sand prior to entering the drain</li> </ul>
<p>6. Esplanade – approx. 370m</p>

The proposed use of accumulated sand from the Wallin Ave drain could be enhanced by the addition small “training wall” structures at the drain entrance (approximately 10m length either side of the drain entrance). The intention of the short structures would be to intercept and restrict sand entering the drain. The intercepted sand could be easily accessed and mechanically redistributed to the adjacent beaches to manage any emerging erosion problems (including minor erosion associated with stormwater flows across the beach). This approach would be expected to reduce drain maintenance requirements and provide the benefit of intercepting the marine sand prior to it mixing with potential stormwater contaminants.

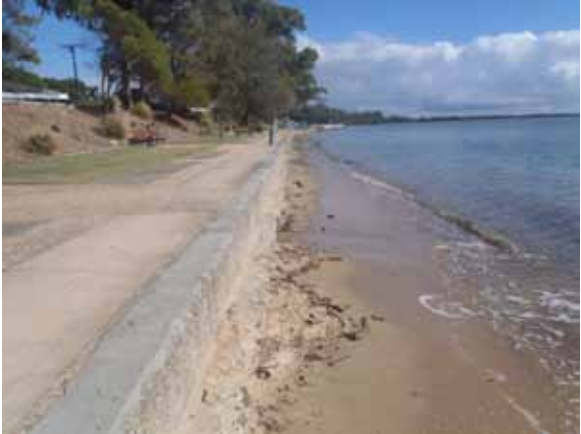
<ul style="list-style-type: none"> <li>• Stepped concrete seawall in good condition</li> <li>• Narrow sandy beach</li> </ul>	<ul style="list-style-type: none"> <li>• Maintain status quo including ongoing foreshore and vegetation management</li> <li>• Inspect seawall and foreshore following severe storm events</li> <li>• Perform maintenance as required</li> </ul>
