## 6 Toorbul

### 6.1 Council Controlled Areas and Current Condition

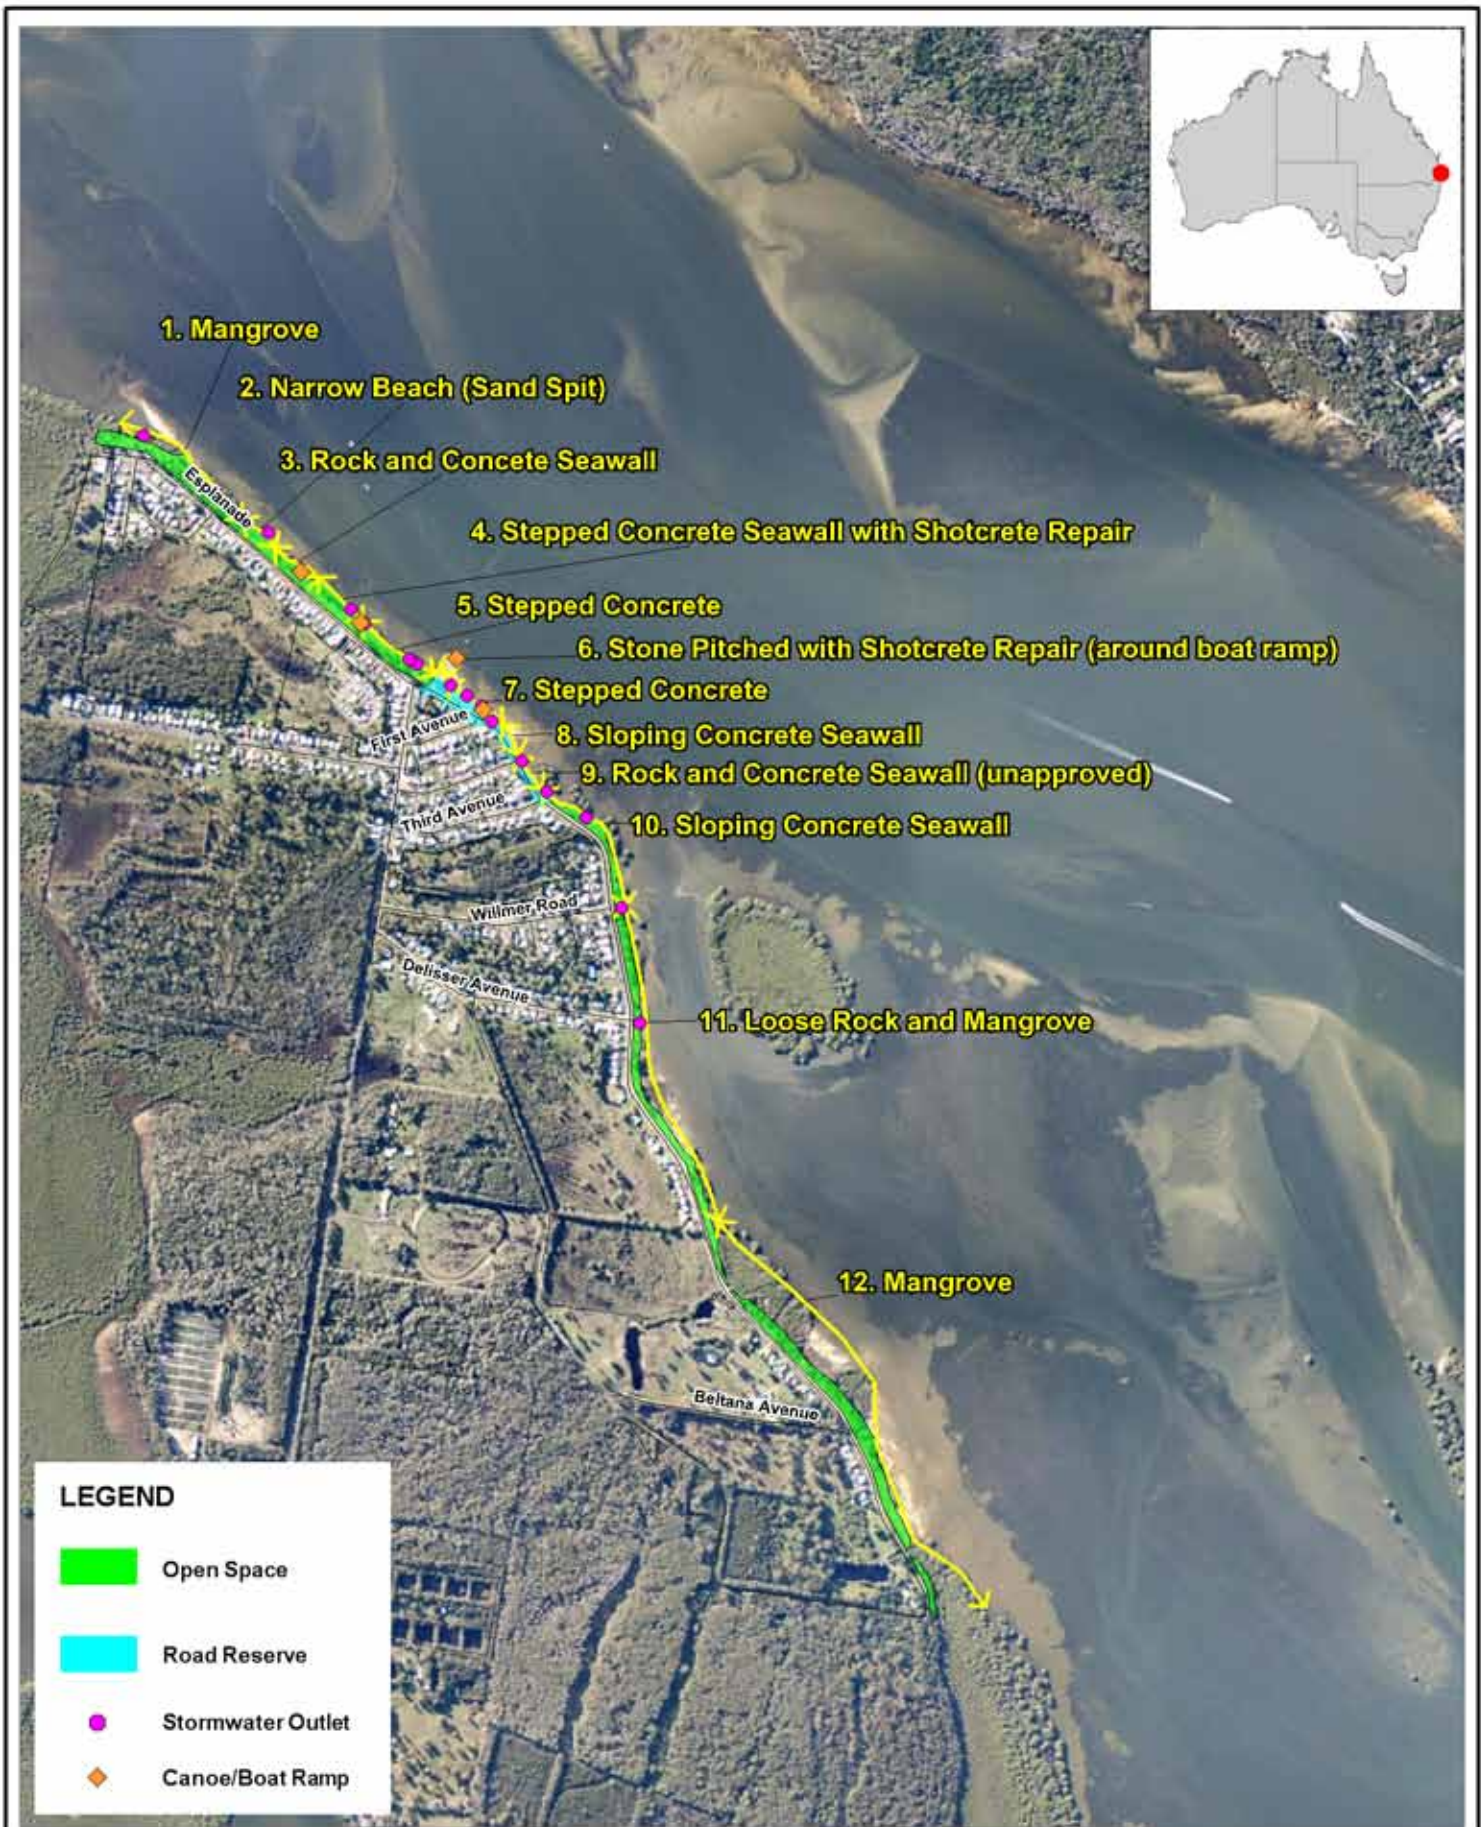
Figure:  
**6-1**

Council controlled land and shoreline types within the Toorbul study area are indicated in Figure 6-1. A range of seawalls of varying design and condition exist along The Esplanade shoreline. The majority of the foreshore is open space and includes facilities to support recreational and social values including car parking, boat ramps, public toilets, picnic facilities and pathways. A small section of road reserve (car and boat trailer parking) forms the shoreline boundary to the immediate south of the public boat ramp. The beach unit is within a declared Conservation Park Zone and Fish Habitat Area. Three distinct shorebird habitat areas have been identified within the study area; including a southern roost that is managed and maintained by Council (refer Appendix A).

Title:  
**Toorbul Beach Unit - Council Controlled Shoreline Areas and Current Condition**

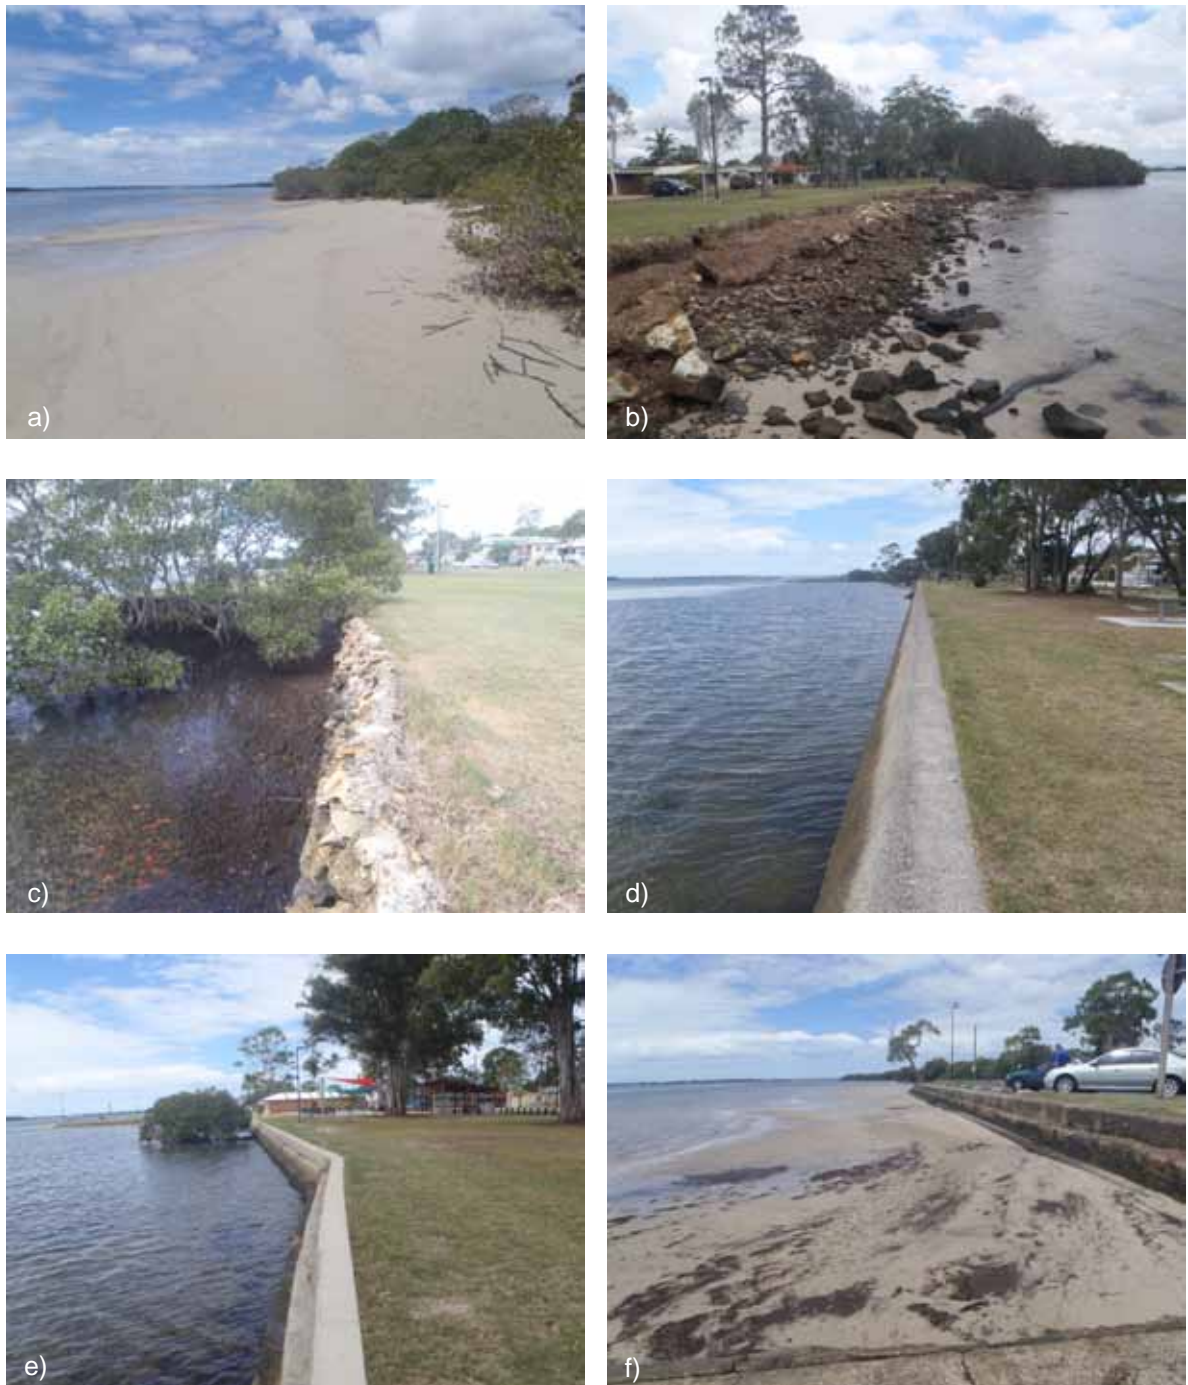
The sand spit at the northern extent of the study area (Figure 6-2a) and sand accumulation observed at the southern side of the public boat ramp (Figure 6-2f) suggest a net northerly sand transport direction. The narrow sandy beaches at these locations present relatively safe water access.

- Loosely placed rock rubble (Figure 6-2b);
- Stone and concrete seawalls (Figure 6-2c);
- Stepped seawalls (Figure 6-2e and Figure 6-2f); and
- Stepped seawall with shotcrete repair (Figure 6-2d).

**Figure 6-2 Example Shoreline Condition throughout Toorbul Study Area: a) Sandy Shore with Mangrove; b) Loose Rock and Erosion Scarp; c) Stone and Concrete Seawall; d) Stepped Seawall with Shotcrete Repair; e) Stepped Seawall; f) Stepped Seawall with Sand Accumulation at Boat Ramp**

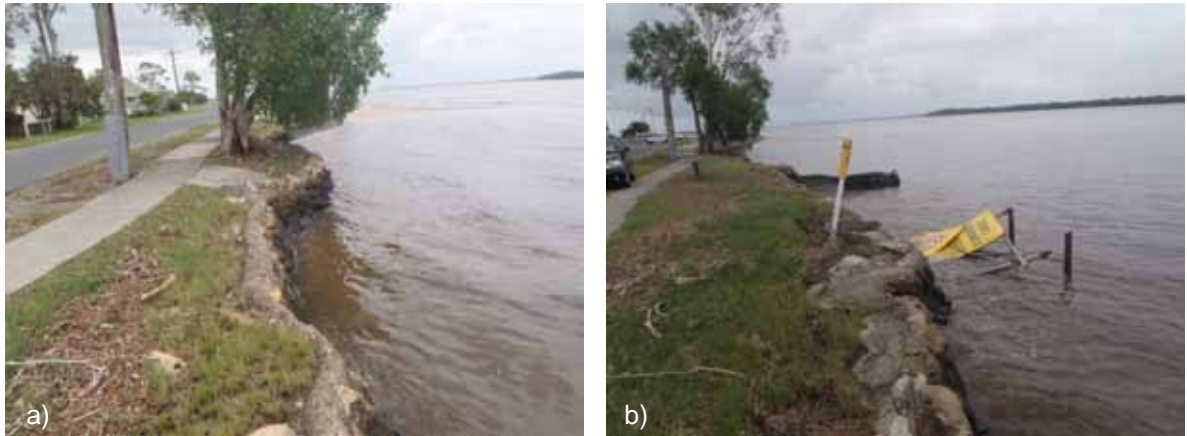
- Concept design and development application to upgrade and realign an unapproved seawall opposite Second Ave (refer Figure 6-3).

**Figure 6-3 Unapproved Seawall Opposite Second Ave: a) Narrow Section between Pathway and Seawall Crest; b) Sinking Damage following ex-TC Oswald (January 2013)**

Council has identified a need to upgrade a section of seawall (Figure 6-1, Section 9) where significant damage occurred during ex-TC Oswald, January 2013. The seawall at this location was originally built by local residents in the 1970s and is therefore an unapproved structure. The proposed upgraded structure opposite Second Avenue will follow a straight alignment and is intended to protect the adjacent footpath and road. Council submitted a development application for the proposed structure in early 2014; the conceptual layout is shown in Figure 6-5. These proposed works are supported in this study.

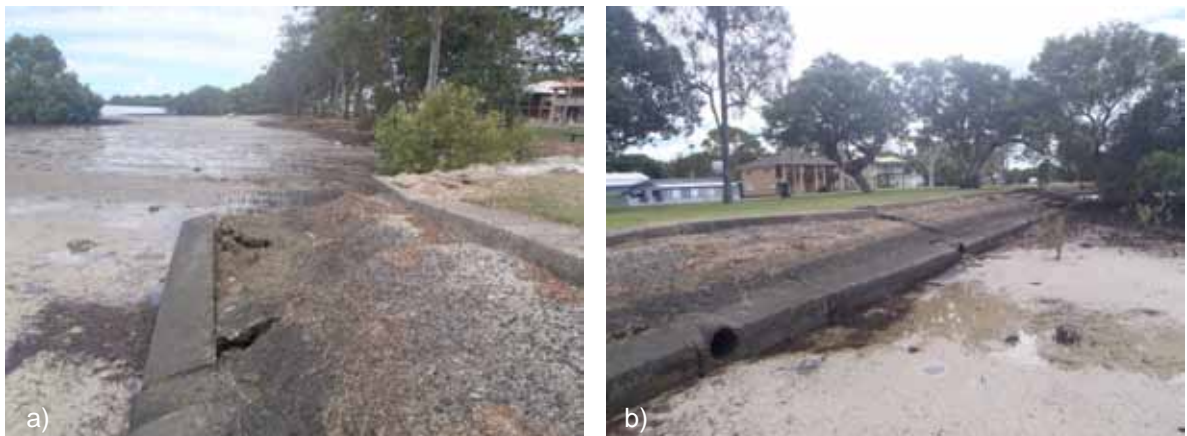
A sloping concrete seawall that extends a further 360m south of Second Avenue is also showing signs of damage related to the loss of material from behind the seawall (refer Figure 6-4). While the shoreline erosion threat at this location appears relatively low, the sections of seawall that have cracked and slumped present public safety hazards.

**Figure 6-4 Sloping Concrete Seawall Damage Opposite Willmer Road**

The sloping concrete seawall south of the Second Avenue (Figure 6-1, Section 11) is in a poor condition in some locations. Large cracks and subsequent slumping of the structure present a trip hazard and suggest significant loss of sediment from behind the rigid structure. While the immediate risk to assets appears low, planning to upgrade this structure should commence.

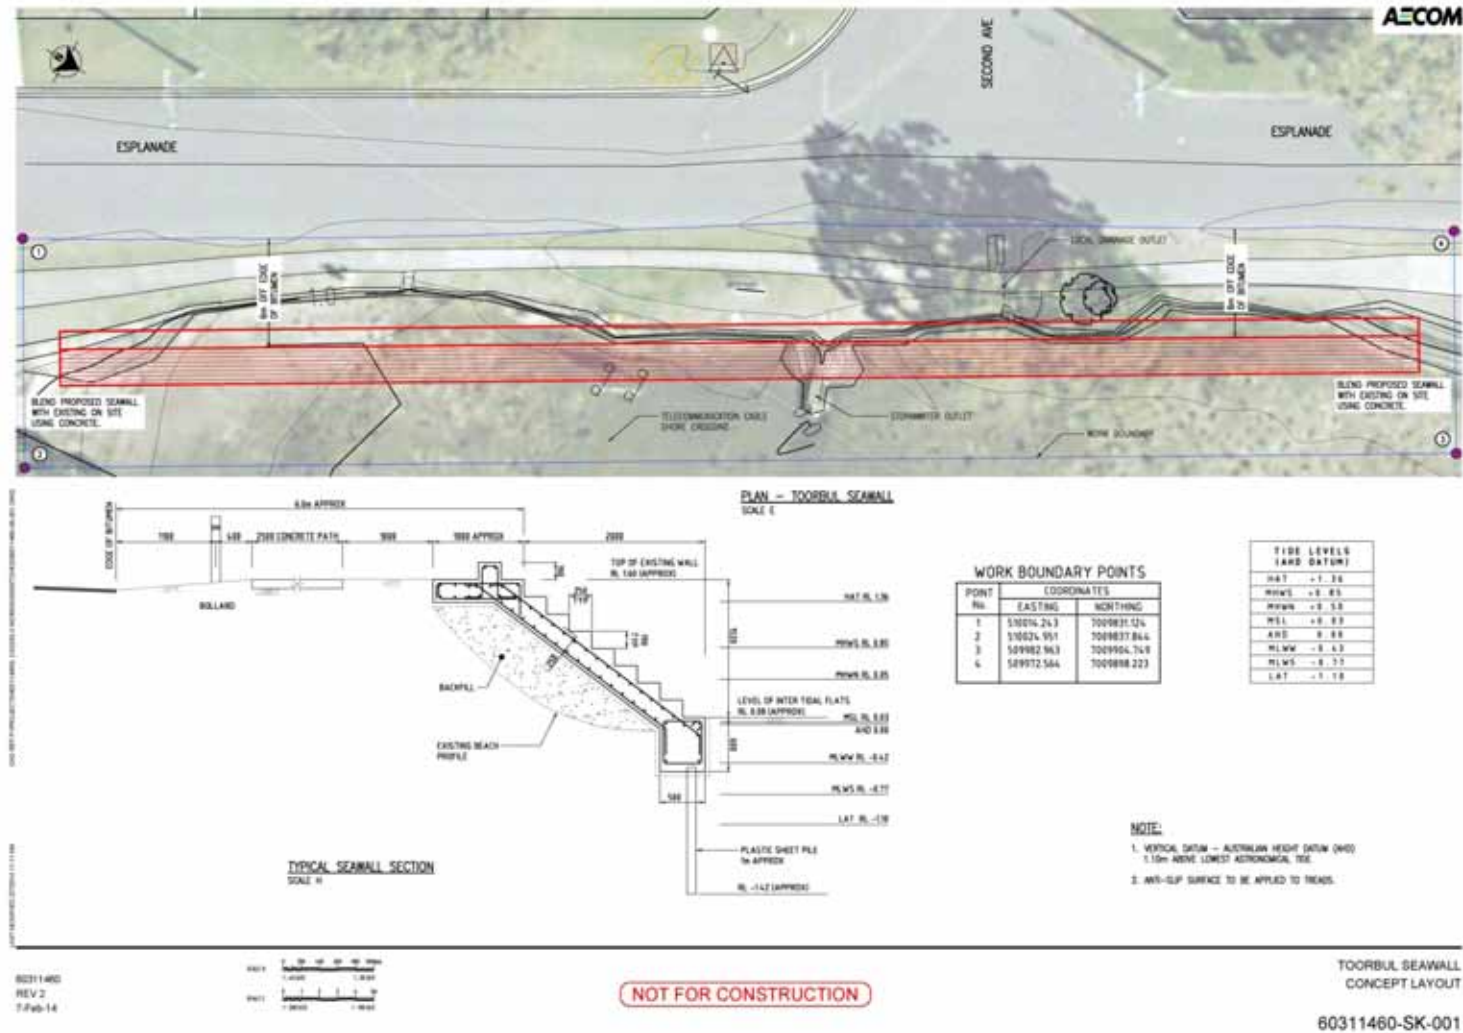
Figure 6-5 Conceptual Design of Seawall Upgrade and Realignment opposite Second Avenue

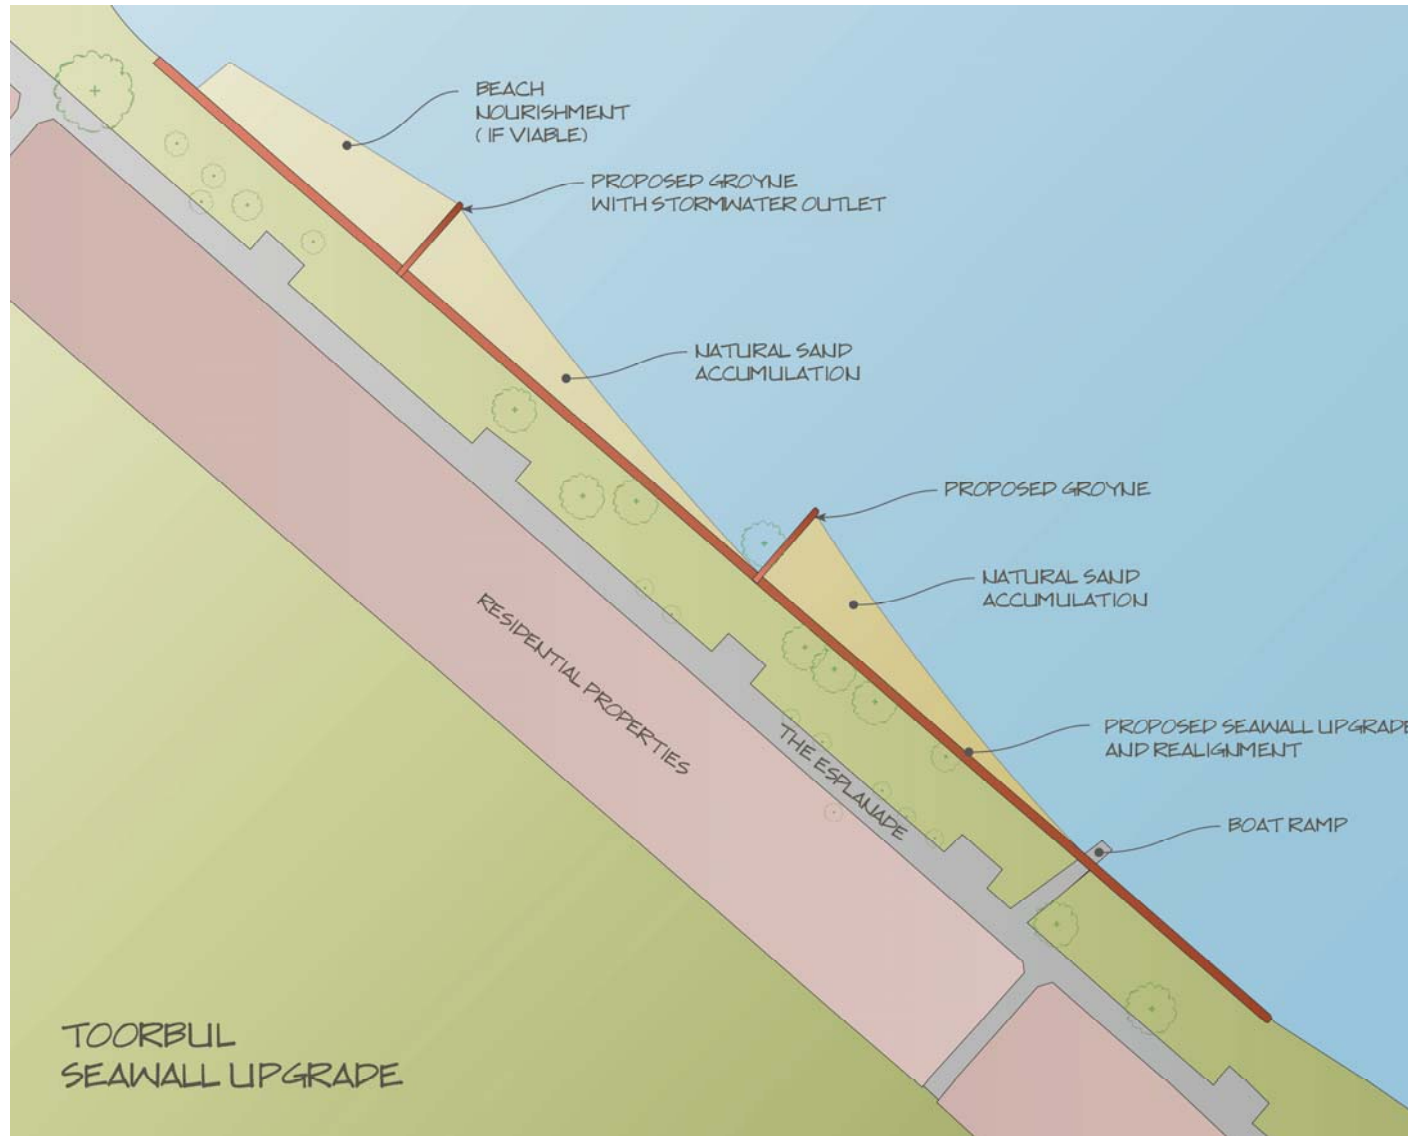
Figure 6-6 Esplanade North Seawall Upgrade and Realignment and Sandy Shoreline Development

Council should consider having the northern Esplanade structures assessed and commence planning to upgrade the seawalls along this section. A conceptual layout of the proposed seawall upgrade and realignment is shown in Figure 6-6. The conceptual layout also indicates an opportunity to stabilise the shoreline using small groynes to intercept the north-westerly directed sediment transport. Together with a setback of the seawall, it's expected that groynes could be

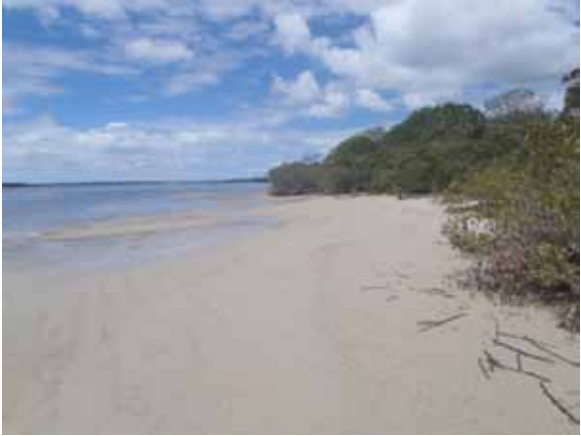
Shoreline Section Number	Existing Condition	Proposed Management Strategy
<p>1. The Esplanade 157-141 – approx. 350m</p>

<ul style="list-style-type: none"> <li>• Sandy beach part of small sand spit</li> <li>• Mangrove and grassy foreshore provide erosion buffer</li> <li>• No significant assets in erosion prone area</li> </ul>	<ul style="list-style-type: none"> <li>• Maintain status quo including ongoing foreshore and vegetation management</li> </ul>
<p>2. The Esplanade 141-135 – approx. 90m</p>

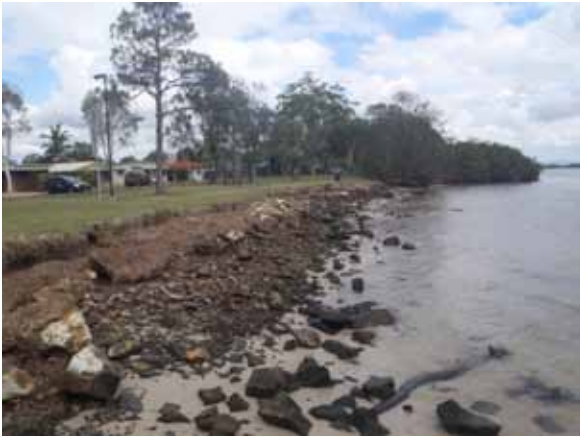
<ul style="list-style-type: none"> <li>• Erosion scarp and loosely placed rock rubble in lee of stormwater outlet</li> <li>• Small beach on updrift side of outlet due to groyne-like effect trapping northerly sand transport</li> </ul>	<ul style="list-style-type: none"> <li>• Sort loose rock at shoreline</li> <li>• Consider feasibility and likelihood of obtaining permits to implement small groyne to hold sand and create a small beach</li> <li>• Potential for vegetation rehabilitation</li> <li>• Management options potentially constrained by zoning Fish Habitat and Marine Park zoning</li> </ul>

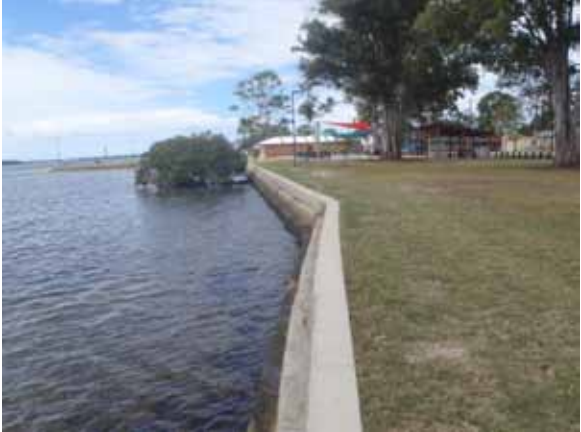
Shoreline Section Number	Existing Condition	Proposed Management Strategy
<p>5. The Esplanade 120-108 – approx. 190m</p>

<ul style="list-style-type: none"> <li>• Stepped concrete seawall with shotcrete resurfacing</li> <li>• Lowered beach completely submerged at high tide</li> <li>• Some safety concern regarding step height and potential trip hazard</li> </ul>	<ul style="list-style-type: none"> <li>• Structural assessment of structure due to uncertain design life</li> <li>• Plan to upgrade seawall within 10 years, consider seawall realignment (setback)</li> <li>• Assess and improve existing safety hazard and shoreline access</li> </ul>
<p>6. Public Boat Ramp – 130m</p>

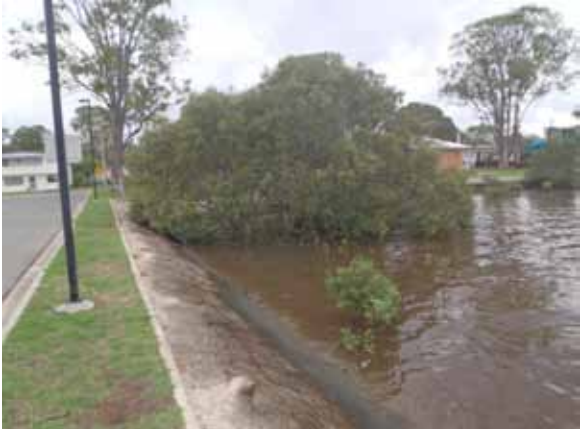
<ul style="list-style-type: none"> <li>• Stone pitched seawall with concrete repair along boat ramp access</li> <li>• Some safety concern and potential slip hazard</li> </ul>	<ul style="list-style-type: none"> <li>• Structural assessment of structure due to uncertain design life</li> <li>• Plan to upgrade seawall within 10 years</li> <li>• Assess and improve existing safety hazard</li> </ul>

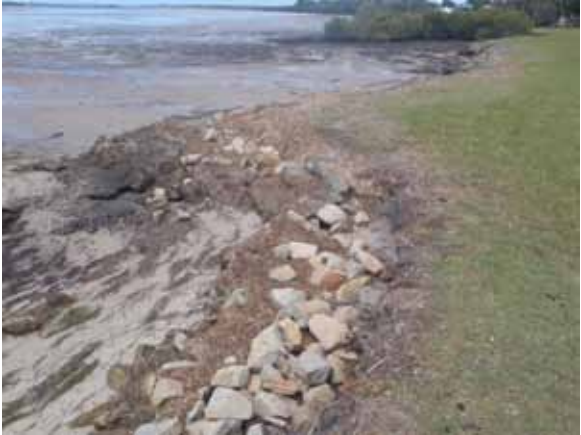
Shoreline Section Number	Existing Condition	Proposed Management Strategy
<p>11. Wilmer Rd-The Esplanade 47 – approx. 720m</p>

<ul style="list-style-type: none"> <li>• Erosion scarp and loosely placed rock rubble</li> <li>• Rock and concrete in some small sections</li> <li>• Shorebird habitat</li> </ul>	<ul style="list-style-type: none"> <li>• Sort loose rock at shoreline</li> <li>• Potential for vegetation rehabilitation</li> <li>• Maintain status quo including ongoing foreshore and vegetation management</li> <li>• Maintain shorebird habitat</li> </ul>
<p>12. The Esplanade 47-14 – approx. 1000m</p>  	<ul style="list-style-type: none"> <li>• Narrow sandy beach with grassy foreshore</li> <li>• Dense mangrove toward the south</li> <li>• Shorebird habitat</li> </ul>	<ul style="list-style-type: none"> <li>• Maintain status quo including ongoing foreshore and vegetation management</li> <li>• Potential for vegetation rehabilitation</li> <li>• Maintain shorebird habitat</li> </ul>
