5 South Pine River Geomorphic Processes

An understanding of the geomorphic processes which drive change within the tidal reaches of the South Pine River is essential for the development of an effective management strategy.

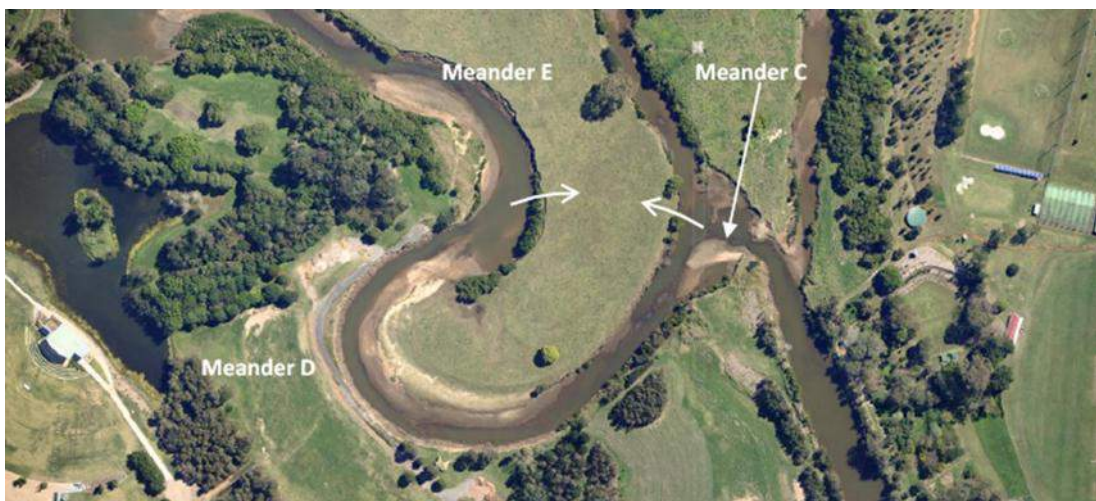
Figure 5-5 Alluvium Consulting (2011) Study Area

The Alluvium Consulting study found that Meander D eroded at a rate of between 1-1.5m/year between 2009 and 2011. This rate is consistent with the accelerated average migration rate of the river bend documented by Saxton et al (2010) for the post 2002 period.

If erosion continues along the trajectories indicated at Meanders C and E in Figure 5-5, this may lead to Meander D becoming cut-off and any erosion protection work in Meander D becoming redundant.

- Implementation of an ongoing monitoring program measure the rate of bank retreat.
- Consideration of soft engineering bank stabilisation measures to mitigate current accelerated migration of Section D, shown in Figure 5-6.
 - Armouring of the bank toe using large wood and mangrove planting within the range of tidal water level fluctuations;
 - Battering of the bank to reduce the slope to 1V:3H and erosion matting; and
 - Revegetation of the bank above the large wood toe protection bank and greater riparian zone.
- Hard engineering works aligned with the MBRC's limits of acceptable channel migration (40m setback from the 2011 top of bank location).

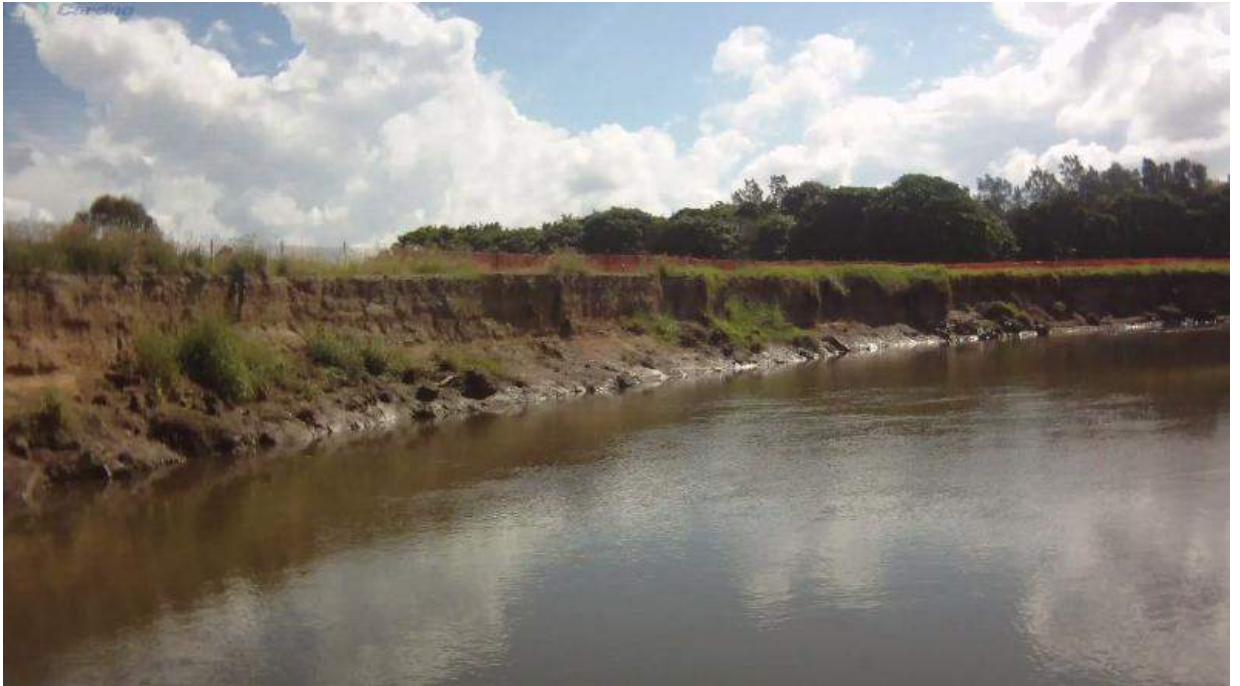
- Extreme Erosion Risk (No Erosion Protection, High Rate Eroding Bank) - Exhibiting active bank slumping, often with clean vertical scarps and recent vegetation loss. See Figure 5-7 for example.

Figure 5-7 Extreme Erosion Risk Example

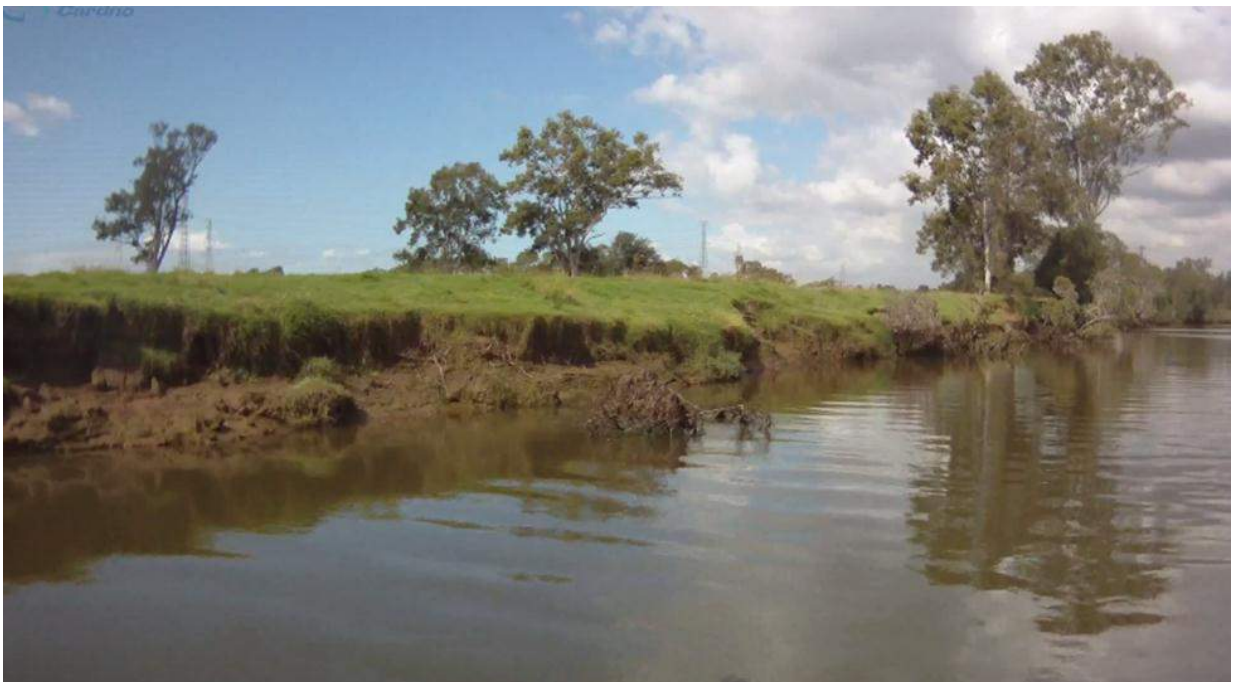
- High Erosion Risk (No Erosion Protection, Slow Rate Eroding Bank) - Showing lower rates of bank erosion, albeit with some bank slumping. See Figure 5-7 and Figure 5-8 for example.

Figure 5-8 High Erosion Risk Example

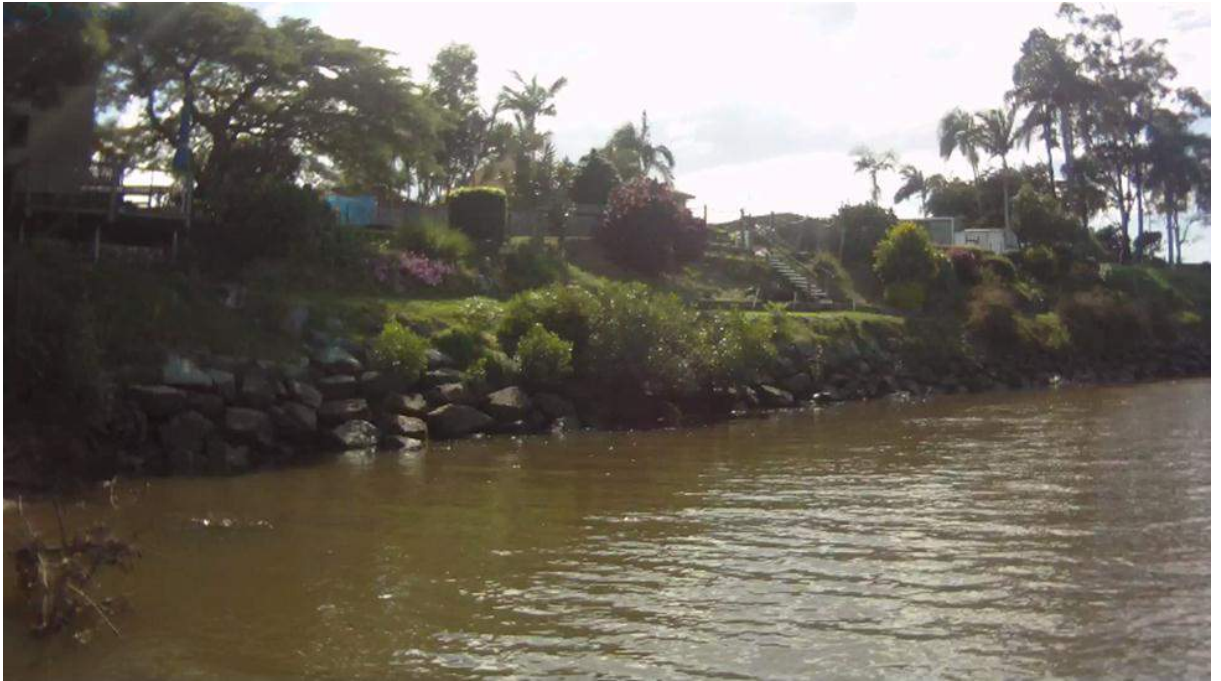
- Moderate Erosion Risk (Hard Engineering Protection, Eroding Bank) – Areas of past extreme or high erosion risk which have been mitigated using hard engineering protection (e.g. armouring). See Figure 5-9 for example.

Figure 5-9 Moderate Erosion Risk Example (Learmonth Street)

- Fronting the residential properties along Learmonth Street. A boat ramp is located immediately south of these properties at Bob Bell Park. Properties on the left bank of the river are located in the vicinity of an outside river bend, and are, therefore, exposed to a risk of bank erosion. Property owners have used erosion protection (mostly rock armouring) to mitigate this bank erosion risk (refer to Figure 5-9), which appears to be in good condition and effective.

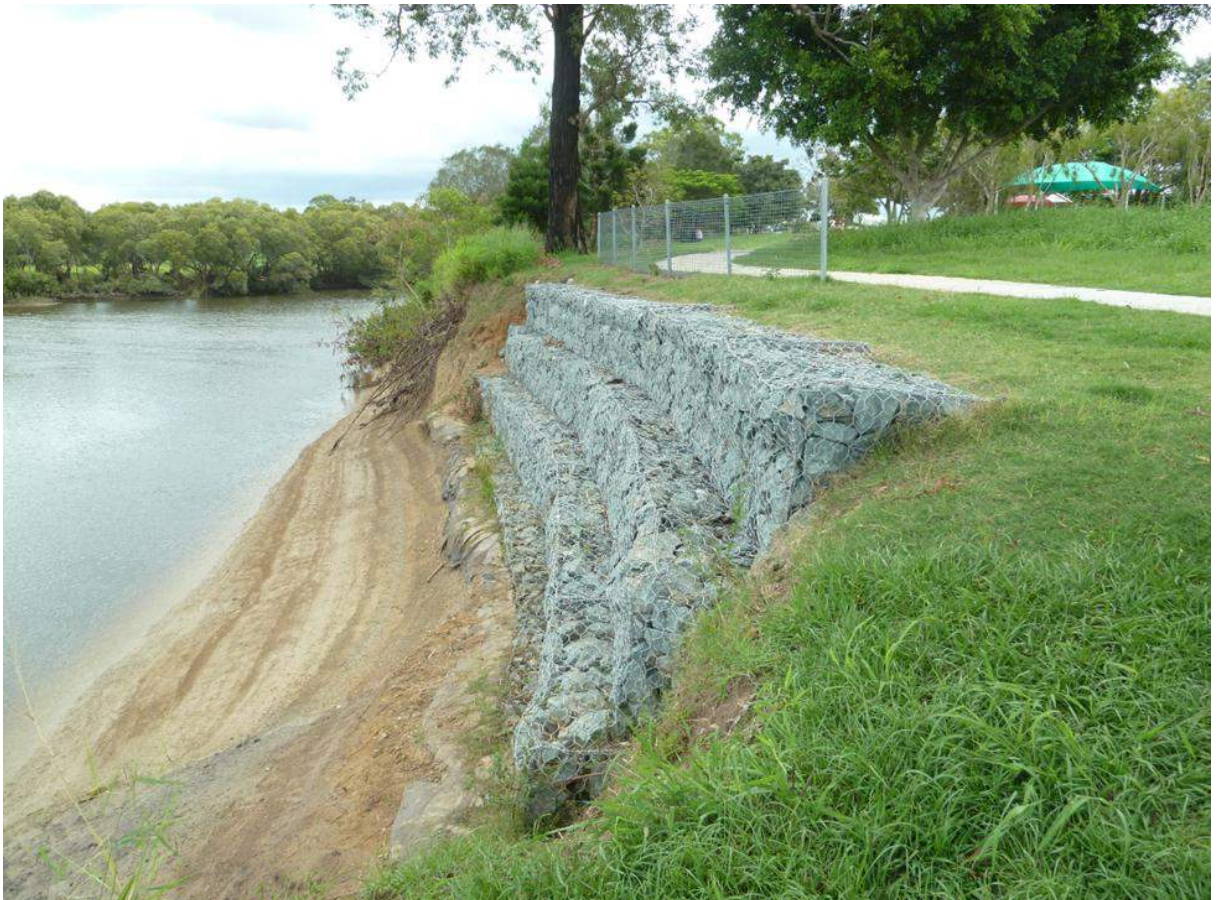
Figure 5-10 Moderate Erosion Risk Example (Pitonga Way)

- Adjacent to the Pitonga Way, downstream of the Pine River Hospital – rock filled gabion baskets above the high tide line (refer to Figure 5-10). This erosion protection structure is relatively high up the bank, and was installed in a localised pocket of bank scour. It is aimed at stabilising the steep bank and providing erosion protection during significant flood events to protect a public footpath close to the river bank. The structure is relatively new and there are no signs of bank erosion impacts upstream or downstream of the structure.

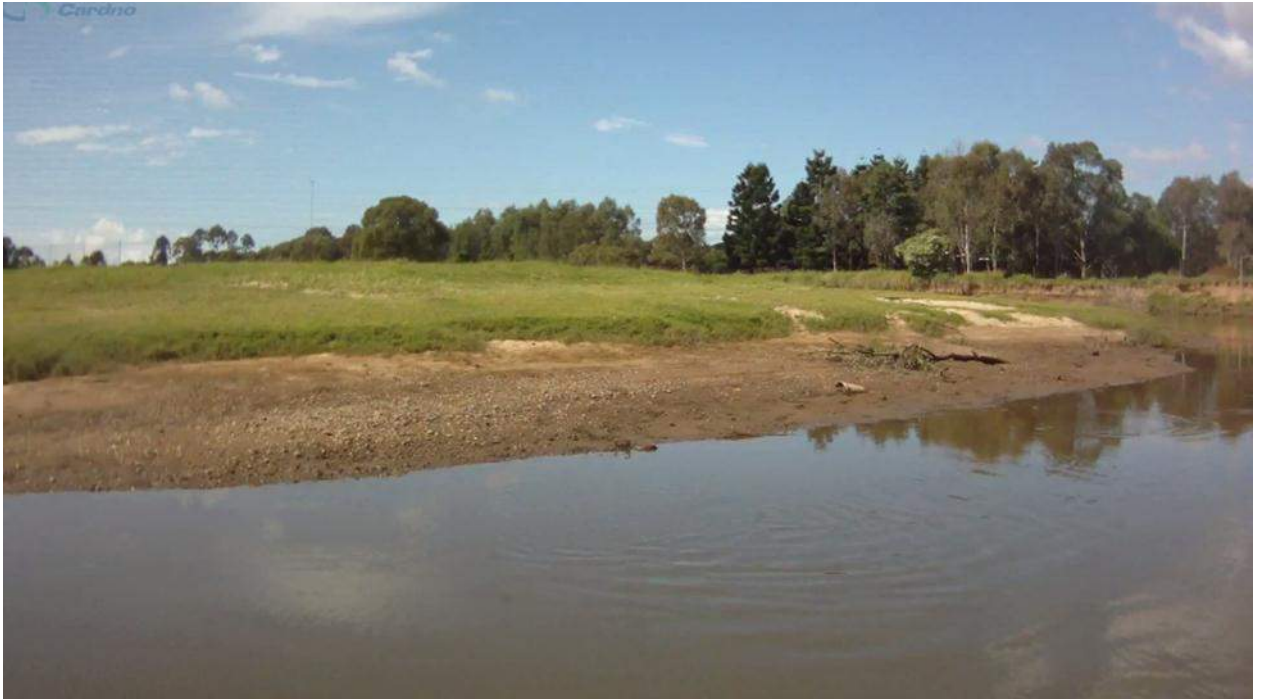
- Sediment deposition zones adjacent to Extreme or High Erosion risk areas; or
 - Along inside bends of the river.
- See Figure 5-11 for example.
- Low Erosion Risk (Riparian Vegetation, Stable Bank) - Older erosion scarps (possibly flood related) have been revegetated with grass and small trees or where mangrove roots are being slowly exposed with the general lowering of the bank level. See Figure 5-12 for example.

Figure 5-11 Low Erosion Risk (No Riparian Vegetation) Example

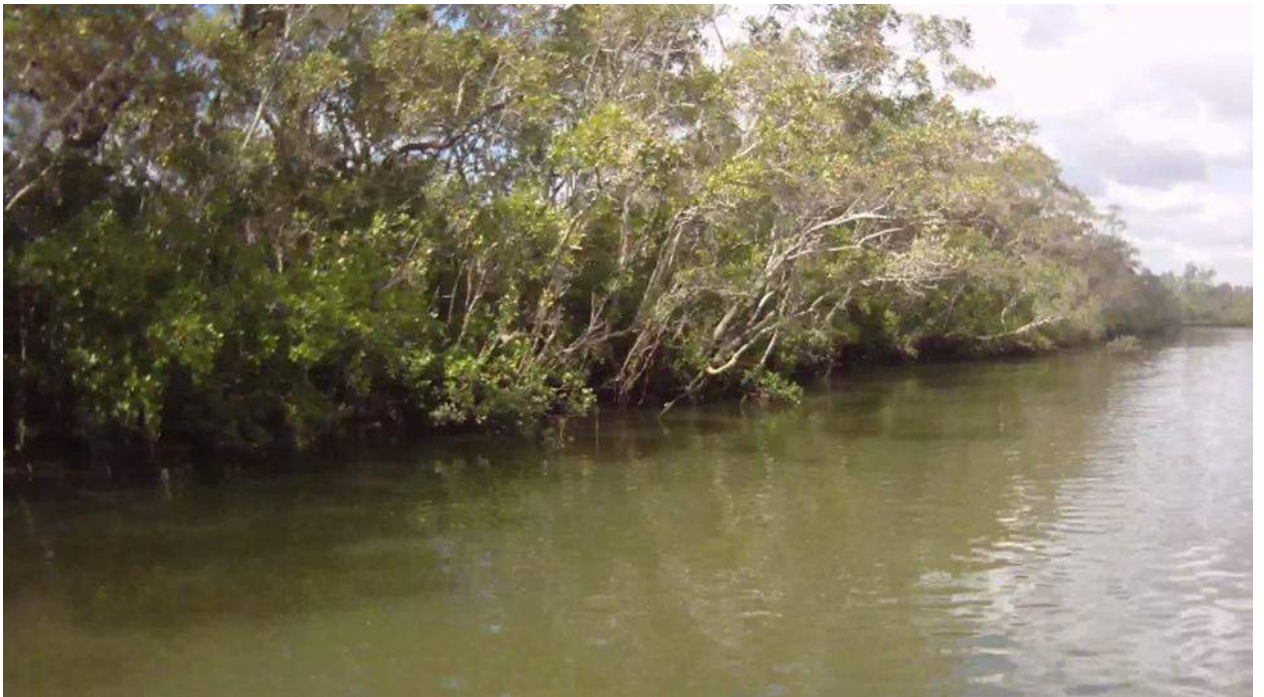
Figure 5-12 Low Erosion Risk (Riparian Vegetation) Example

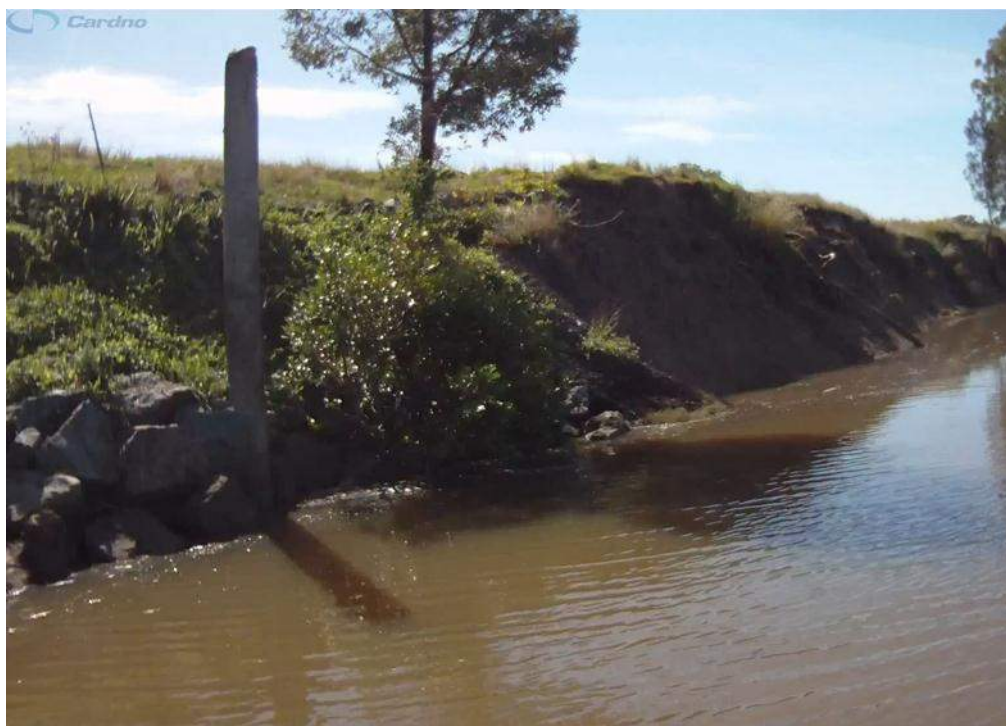
The structural protection is limited to the location of residential property river frontage, which terminates on the apex of the river bend. Immediately downstream of the structural erosion protection, erosion on the river bank is evident by the steep bank slopes (see Figure 5-13). However, there is little evidence that the structural erosion protection is impacting on the rate of erosion immediately downstream; i.e. the bank alignment remains relatively continuous (see Figure 5-13).

The structural erosion protection has altered the natural erosion processes at this location. In time, the apex of the river bank may migrate further north, away from the residential property; therefore reducing the erosion risk to the residential area. Whereas, the migration of the river bend may have been through the northern section of the residential area under natural conditions.

Figure 5-13 Learmonth Street Erosion Protection

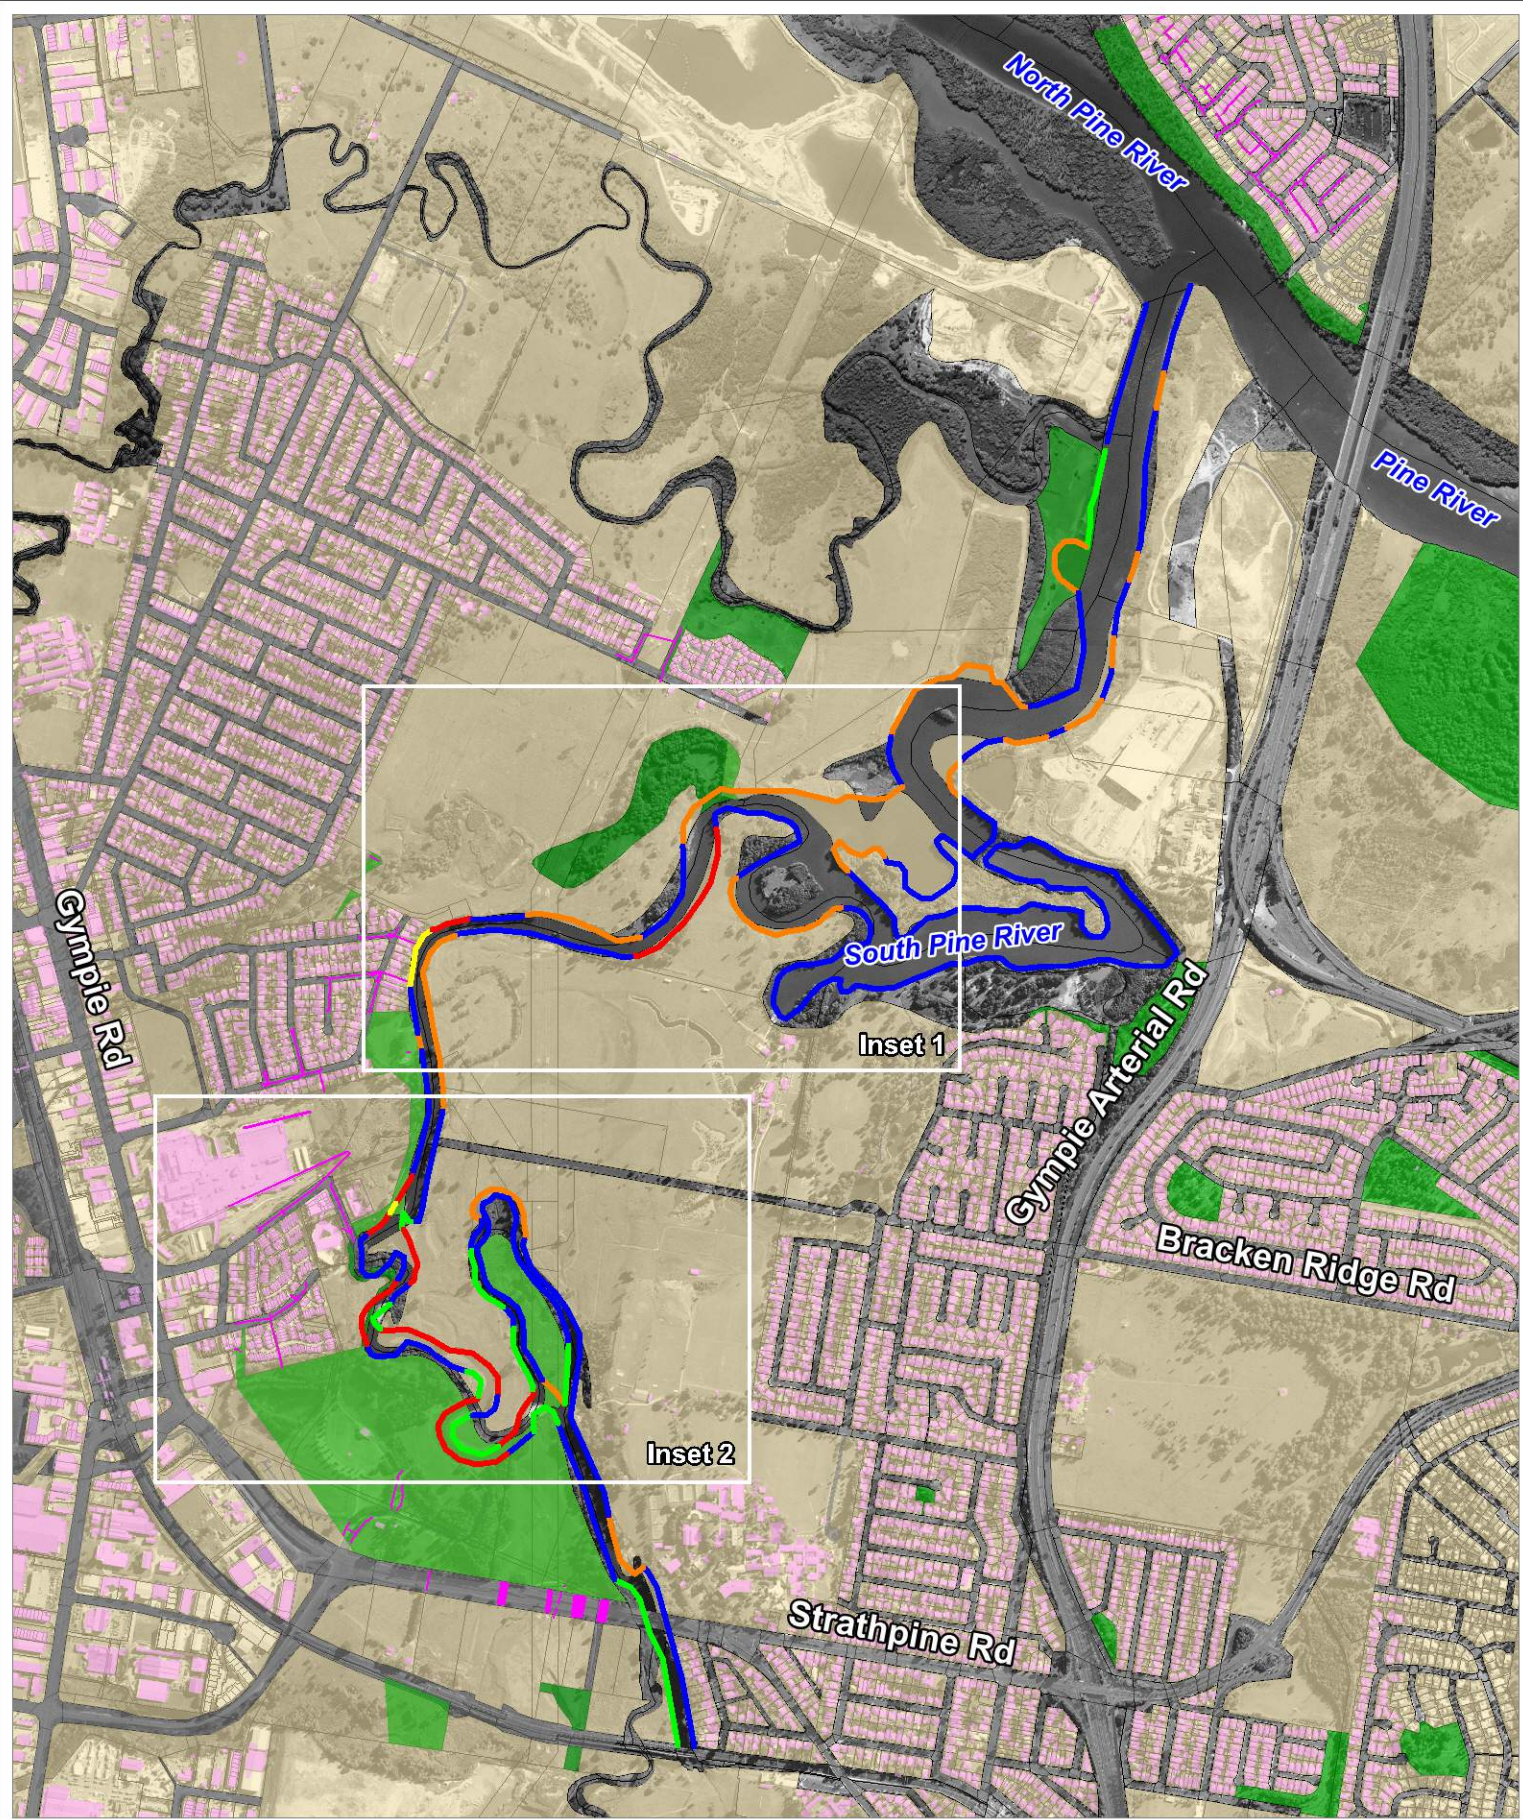
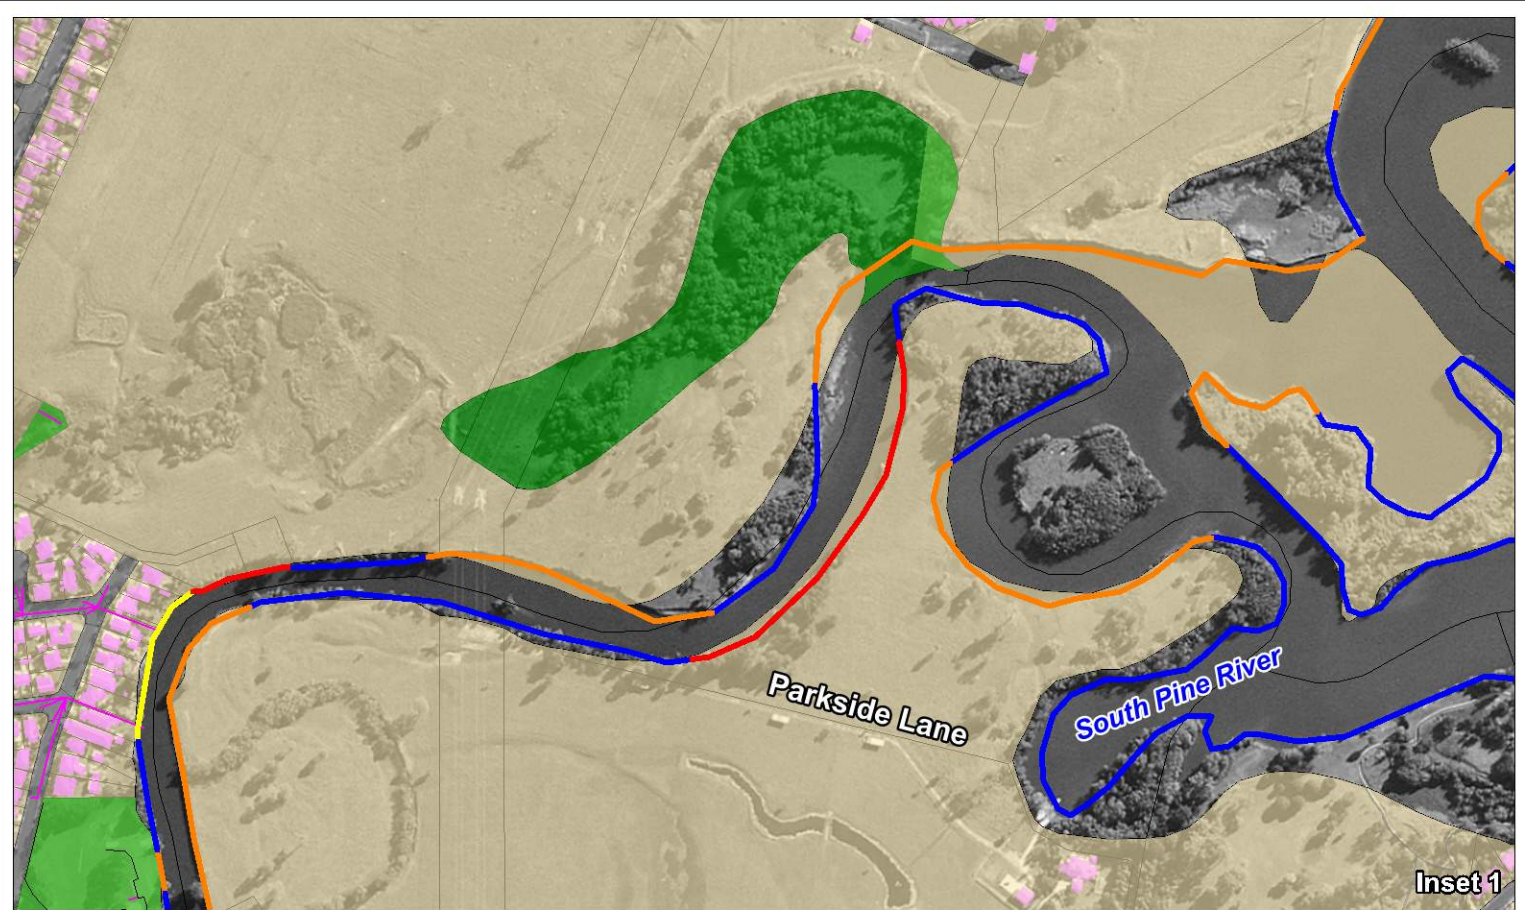
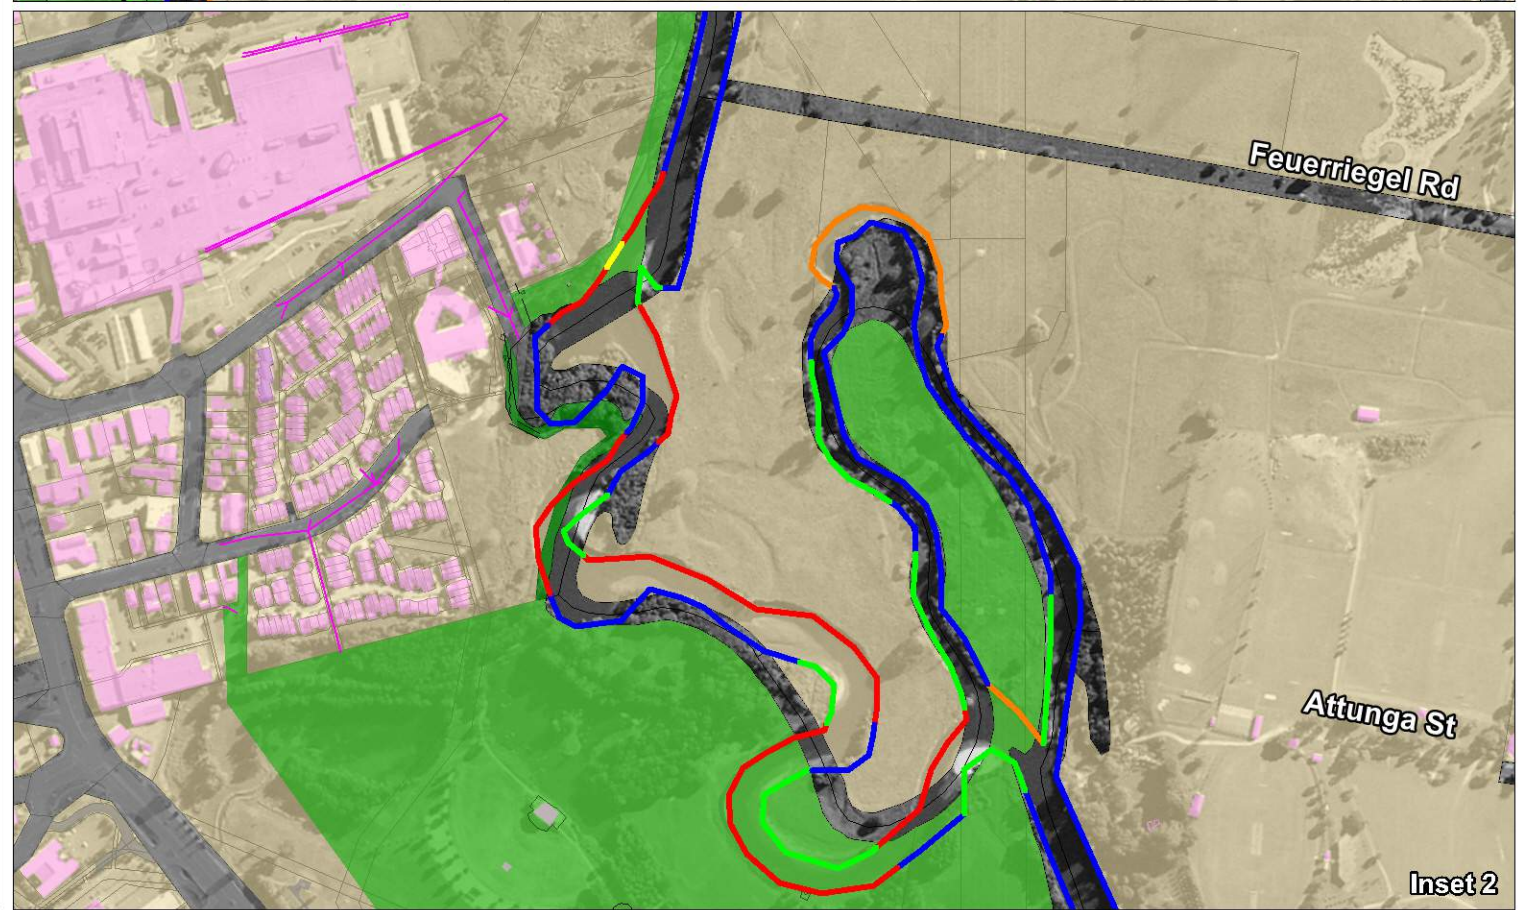
Figure: **5-14**

Recent inspections of the riverbanks within the study area have been carried out by boat to identify their present state. These inspections indicated varying levels of erosion stress. The current degree of erosion is shown in Figure 5-14, in the following qualitative terms.

The erosion appears to be greatest in the non-vegetated meandering portion of the South Pine River within the reaches between Gympie Road and Harvey Street. Of particular note was the evidence of high rate of erosion on the outside bend of the meander adjacent to Pine River Park. The erosion in this location is currently undercutting a minor road within the Park.

Title: **South Pine River Erosion Risk Mapping**

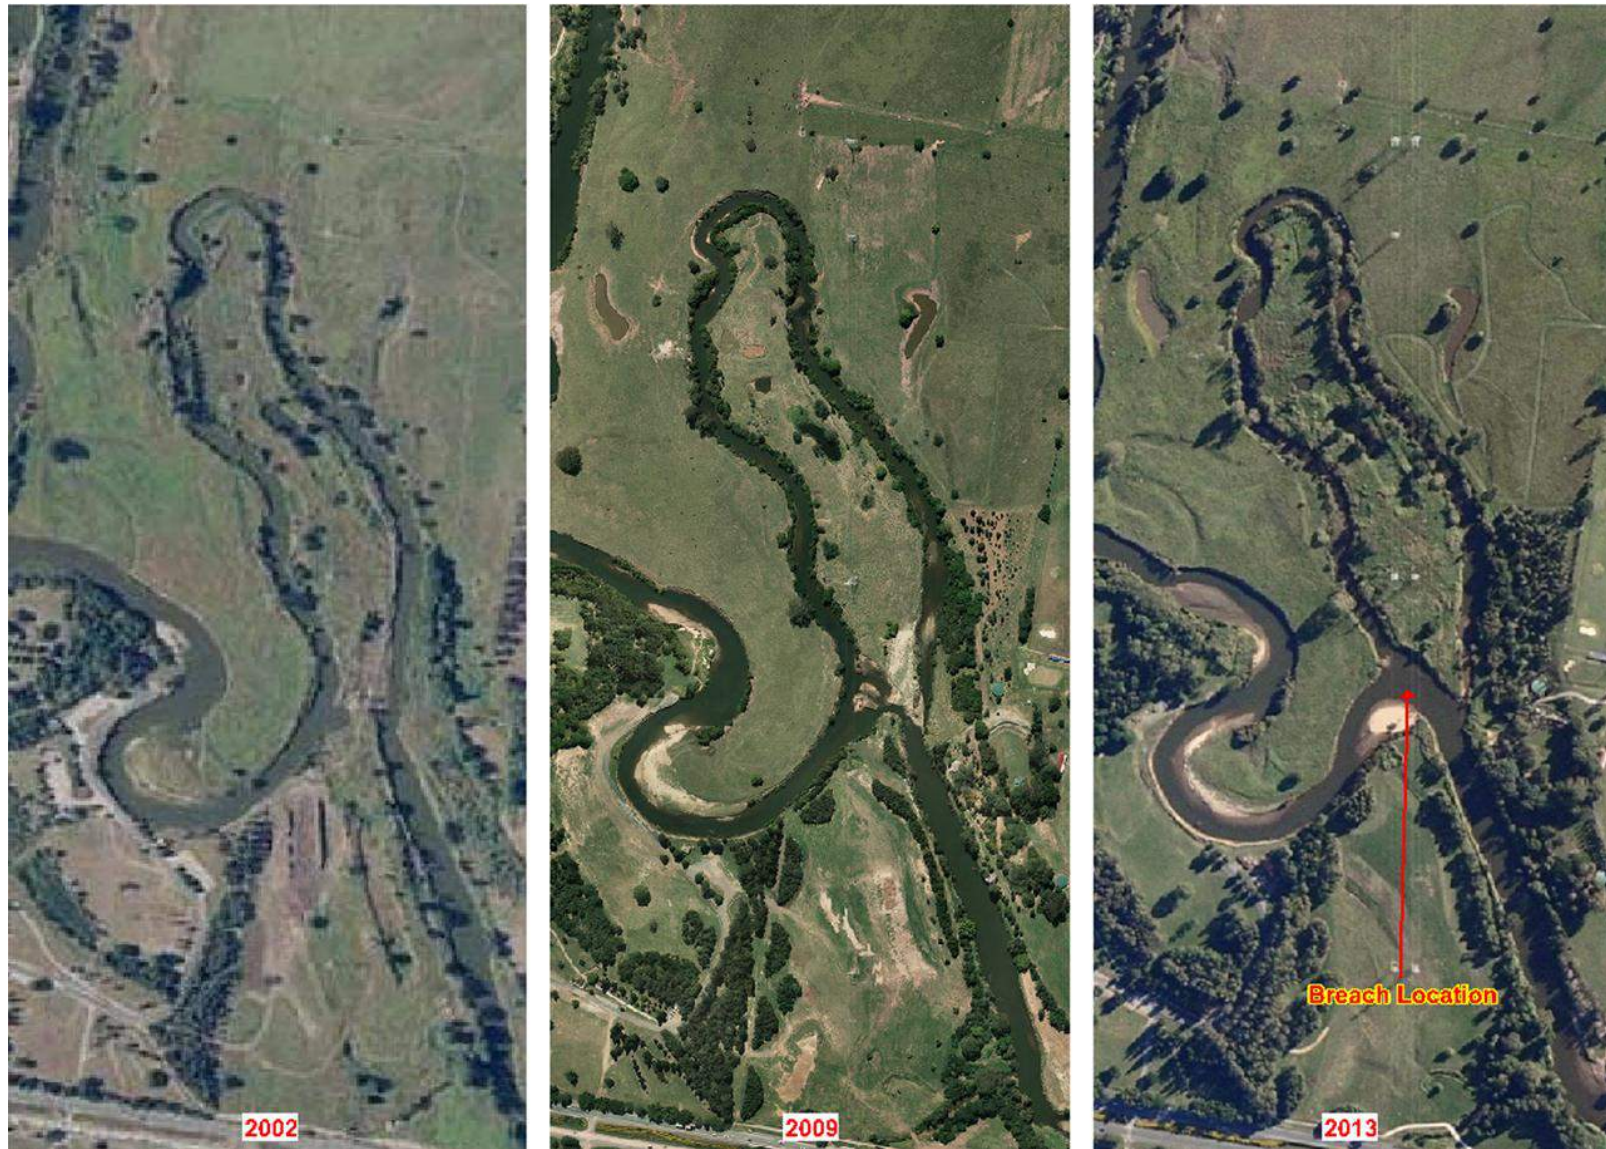
- Sometime between 2002 and 2009 the meander upstream of Reach B was breached (see Figure 5-32). This has resulted in the meander loop on which Reach A is located being bypassed. This major change in flow path is currently resulting in:

- Stabilisation of the Reach A. Significant future migration of Reach A is unlikely whilst this meander loop is cut off from the main river channel.
 - Reach B bank migration rates increasing, eroding towards Reach D.

- This erosion trend is impacting MBRC infrastructure at Reach C and F.
 - There is potential that that Reach B may breach through to Reach D in as little as 20 years if these erosion rates are sustained. If this occurs, this major river alignment change will result in Reach C no longer being part of the main river channel, significantly reducing the erosion rates in this location.

Figure 5-32 Breach at Pine Rivers Park
