4. Bongaree Jetty to Bribie Gardens Estate

Moreton Bay Regional Council
Shoreline Erosion Management Plan

Job Number | 41-22291
Revision | 0
Date | FEB 2011

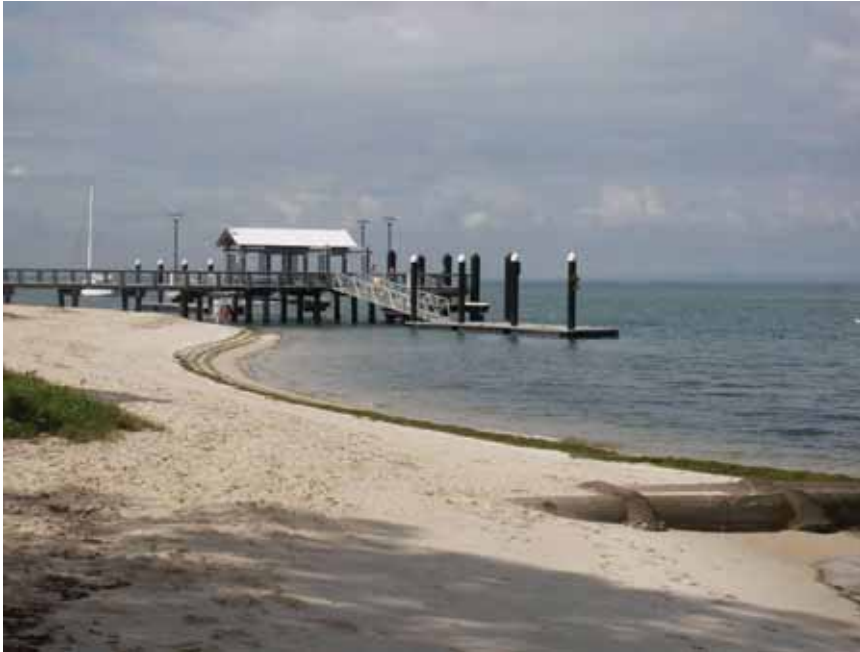
Photo Plate 4-1 Bongaree Jetty

The Bongaree Jetty foreshore features park landscaping with large fig trees and some eucalypts attracting urban-adapted bird species. Areas of marine couch are present on the upper beach zone, particularly south of the jetty walkway. Bongaree Jetty features a build-up of sand on both sides of the walkway behind the pontoons (refer to [Photo Plate 4-1](#)). Two 650 mm diameter stormwater pipes extend to the tidal area north of the jetty.

As mentioned in the previous chapter, if accretion at the jetty is allowed to continue unchecked, eventually the tombolo will behave like a groyne and interrupt sediment supply further north. This will further exacerbate erosion of the beach to the north of the Jetty. Sediment supply to the beach north of Bongaree Jetty will only resume once the southern beach compartment is full. Sand accumulated in the tombolo may adversely impact on the functionality of the jetty for recreational use. Dredging to maintain navigational depths may be required to allow all tide access. Any sediment removed from the tombolo should be placed on the currently eroded foreshore north of the jetty.

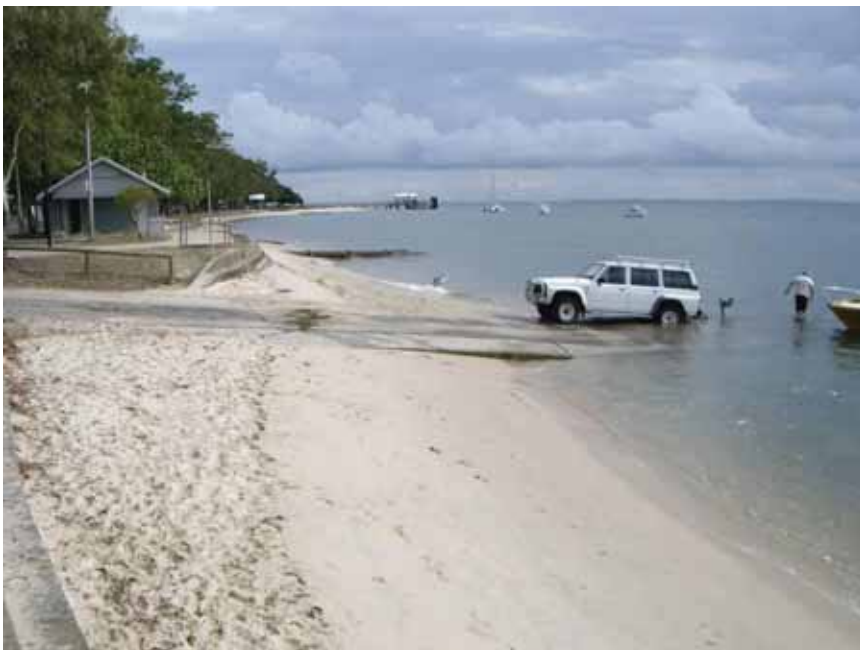
Photo Plate 4-2 Boat ramp north of Bongaree Jetty

Shirley Creek is approximately half-way along this study area and features an exposed stepped sea wall either side of the mouth of the channel. Sand spits are featured either side of this channel entrance (refer to [Photo Plate 4-4](#)). A bridge along Welsby Parade is located just inside the mouth of the creek with seawall structure along the banks (refer to [Photo Plate 4-3](#)), with mangroves present immediately upstream of the bridge. A boat ramp, car and trailer parking and picnic facilities are located south of Shirley Creek (refer to [Photo Plate 4-2](#)).

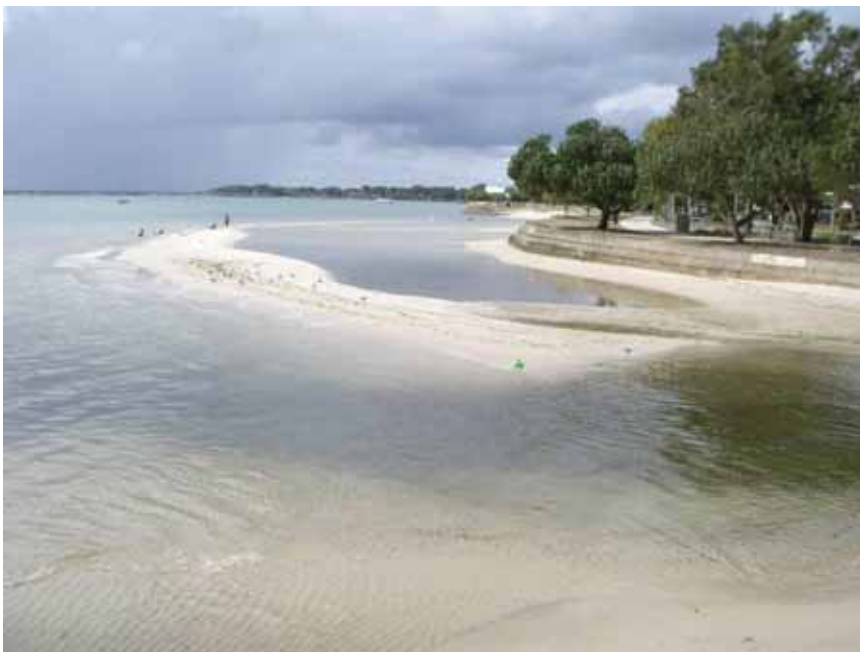
Photo Plate 4-4 Sand formation at Shirley Creek entrance

Localised erosion has also occurred around the mouth of Shirley Creek. The erosion is likely to have occurred in a similar fashion to that described for the small creek south of Bongaree Jetty. By 1999, the revetment wall had been extended southwards to limit further shoreline changes in the vicinity of Shirley Creek and southwards to Bongaree Jetty.

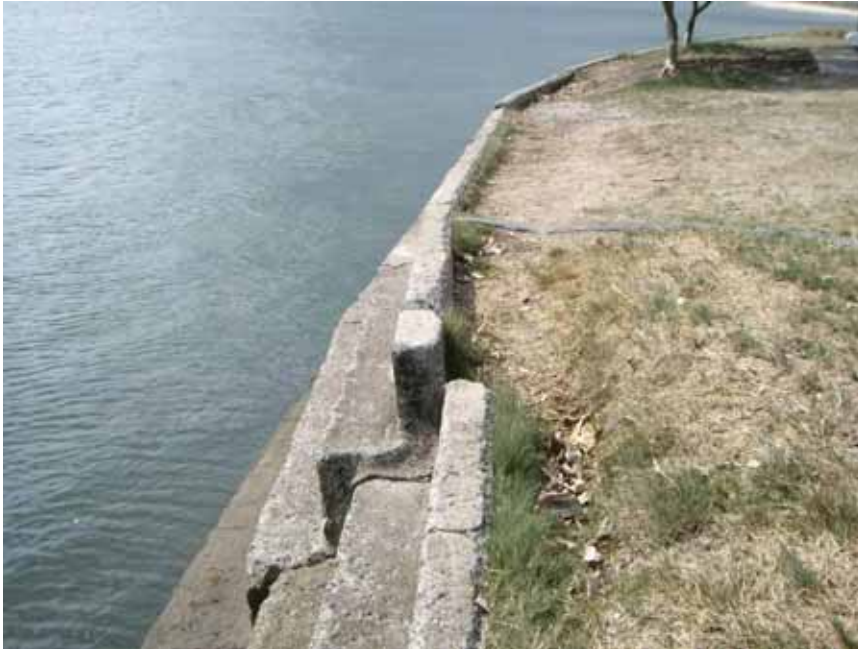
Photo Plate 4-5 Seawall movement north of Shirley Creek

Parts of the sea wall are de-stabilised along this study area (refer to [Photo Plate 4-5](#)).

Undermining of the existing revetment may also be an issue should beach lowering continue. This would be influenced by the design and construction standard of individual sections of revetment.

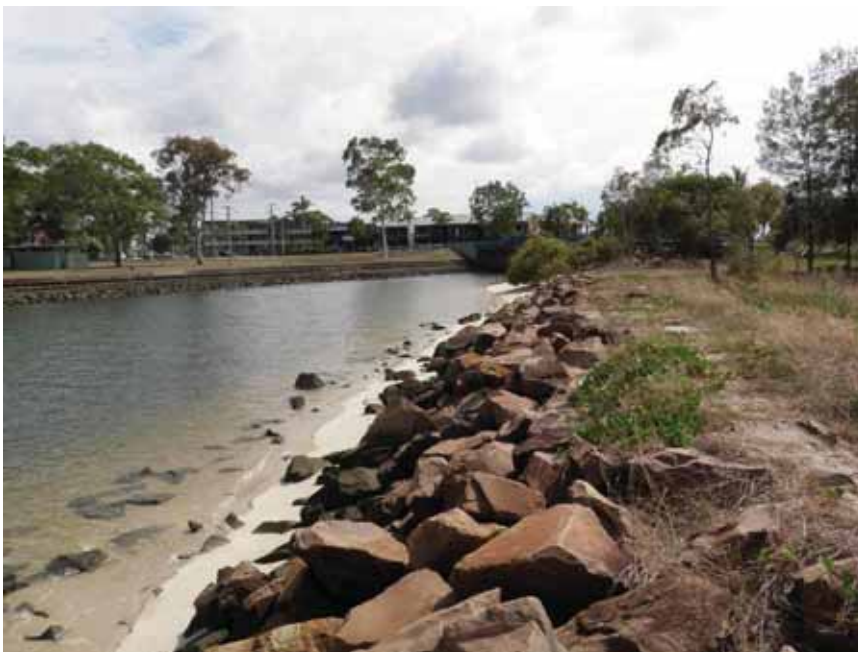
Photo Plate 4-6 Bribie Gardens Estate southern entrance of the canal

The canal at the Bribie Gardens Estate features a rock groyne that protects the entrance to the canal on both sides (refer to [Photo Plate 4-7](#)). On the southern side of the canal entrance, the sand has built up along this rock groyne and allowed for the establishment of some mangroves (refer to [Photo Plate 4-6](#)). There is also a large build up of sand south of the groyne; however further south of this the sea wall is exposed and there is little beach at low tide.

As the shoreline south of the southern breakwater at the mouth of the canal at Bribie Gardens Estate has filled, sediment is starting to bypass the breakwater. Initially, this sediment will deposit into the creek mouth, where it is likely to eventually become a concern for navigation. Ultimately, a regular program of dredging may need to be initiated in this area. Any clean sand removed through dredging should be used for beach nourishment purposes on beaches north of the canal mouth.

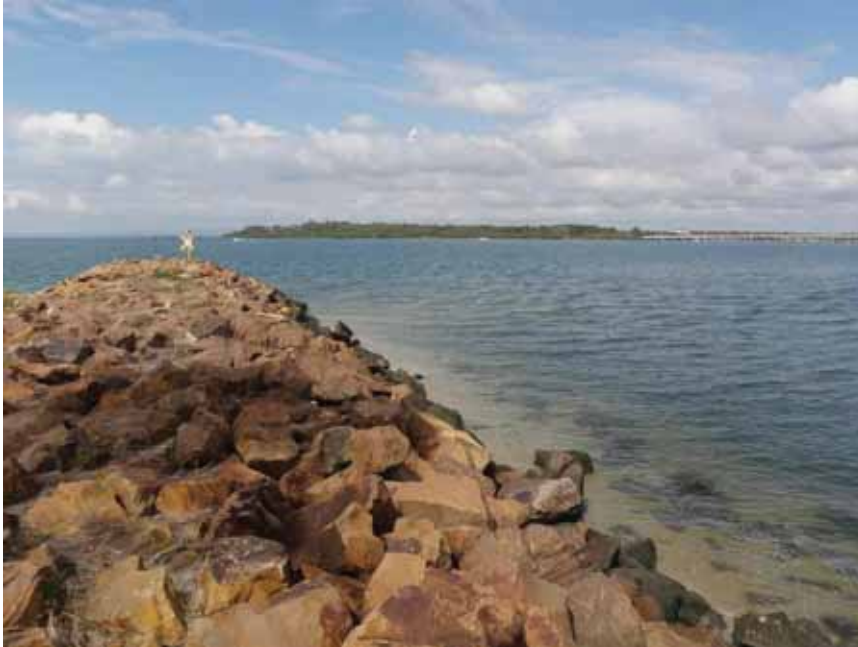
Photo Plate 4-7 Bribie Gardens Estate groyne structure in the canal

The southern breakwater has acted as a groyne, resulting in stabilisation of the beach from the creek south to the area where the initial revetment was constructed. However, this accretion has been at the expense of beaches further north, which have been deprived of this sediment (discussed in the next chapter). Recent aerial photography indicates that the groyne effect of the breakwater is at capacity and some sediment bypassing has started.
