## 7. Sylvan Beach North

Moreton Bay Regional Council  
Shoreline Erosion Management Plan

Job Number | 41-22291  
Revision | 0  
Date | FEB 2011

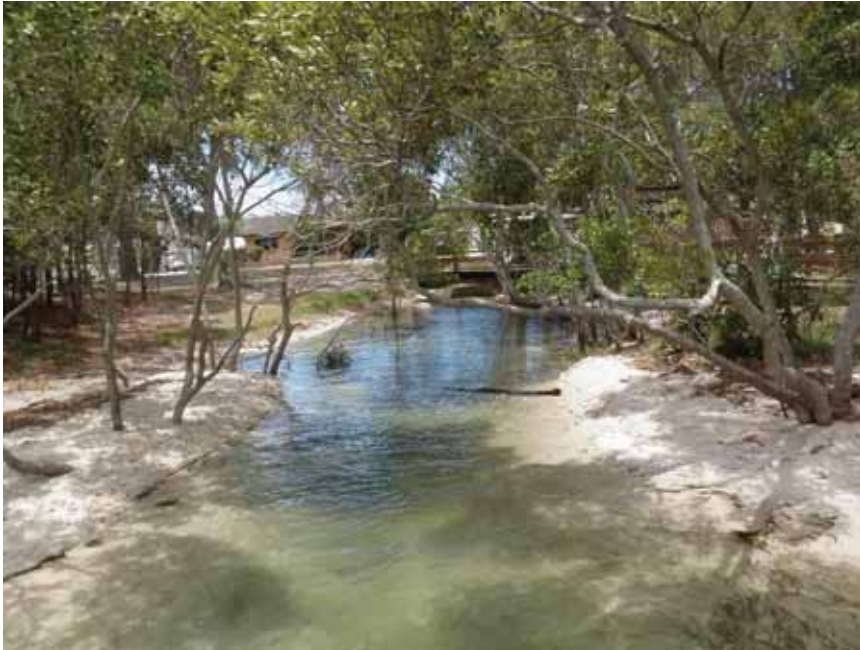
**Photo Plate 7-1 Culverts under road beside boardwalk**

There is a section of boardwalk adjacent to Sylvan Beach Esplanade that meanders through an area of mangroves surrounding a protected lagoon area (receiving drainage from three culverts under the road – refer to [Photo Plate 7-1](#)). Some of the timber boardwalk's concrete footings are exposed above the sand (refer to [Photo Plate 7-2](#)). There are some other areas protected by sand build-up that have mangrove seedlings established in the protected water. North of this area is Pirate Park containing open space and playground facilities, including a toilet block approximately 10 m from the shoreline.

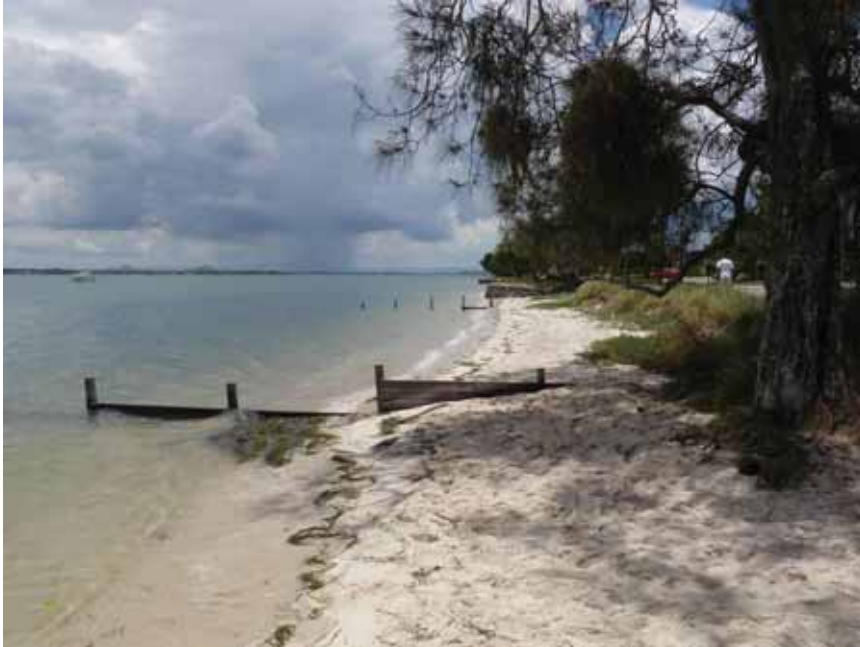
**Photo Plate 7-3 Northern Sylvan Beach with timber groynes**

Several timber groynes have been partially covered by sand in the north of the study area (refer to [Photo Plate 7-3](#)). Solander Canal features a rock sea wall along the entrance. Some sand has built up just inside of the canal entrance on the southern side.

The groyne field at the northern end of the beach is not visible in most of the aerial photography, and does not appear to have made a significant impact on the shoreline, although small localised changes may be evident at ground level. This indicates that the local sediment transport rates (north and south) are very low.

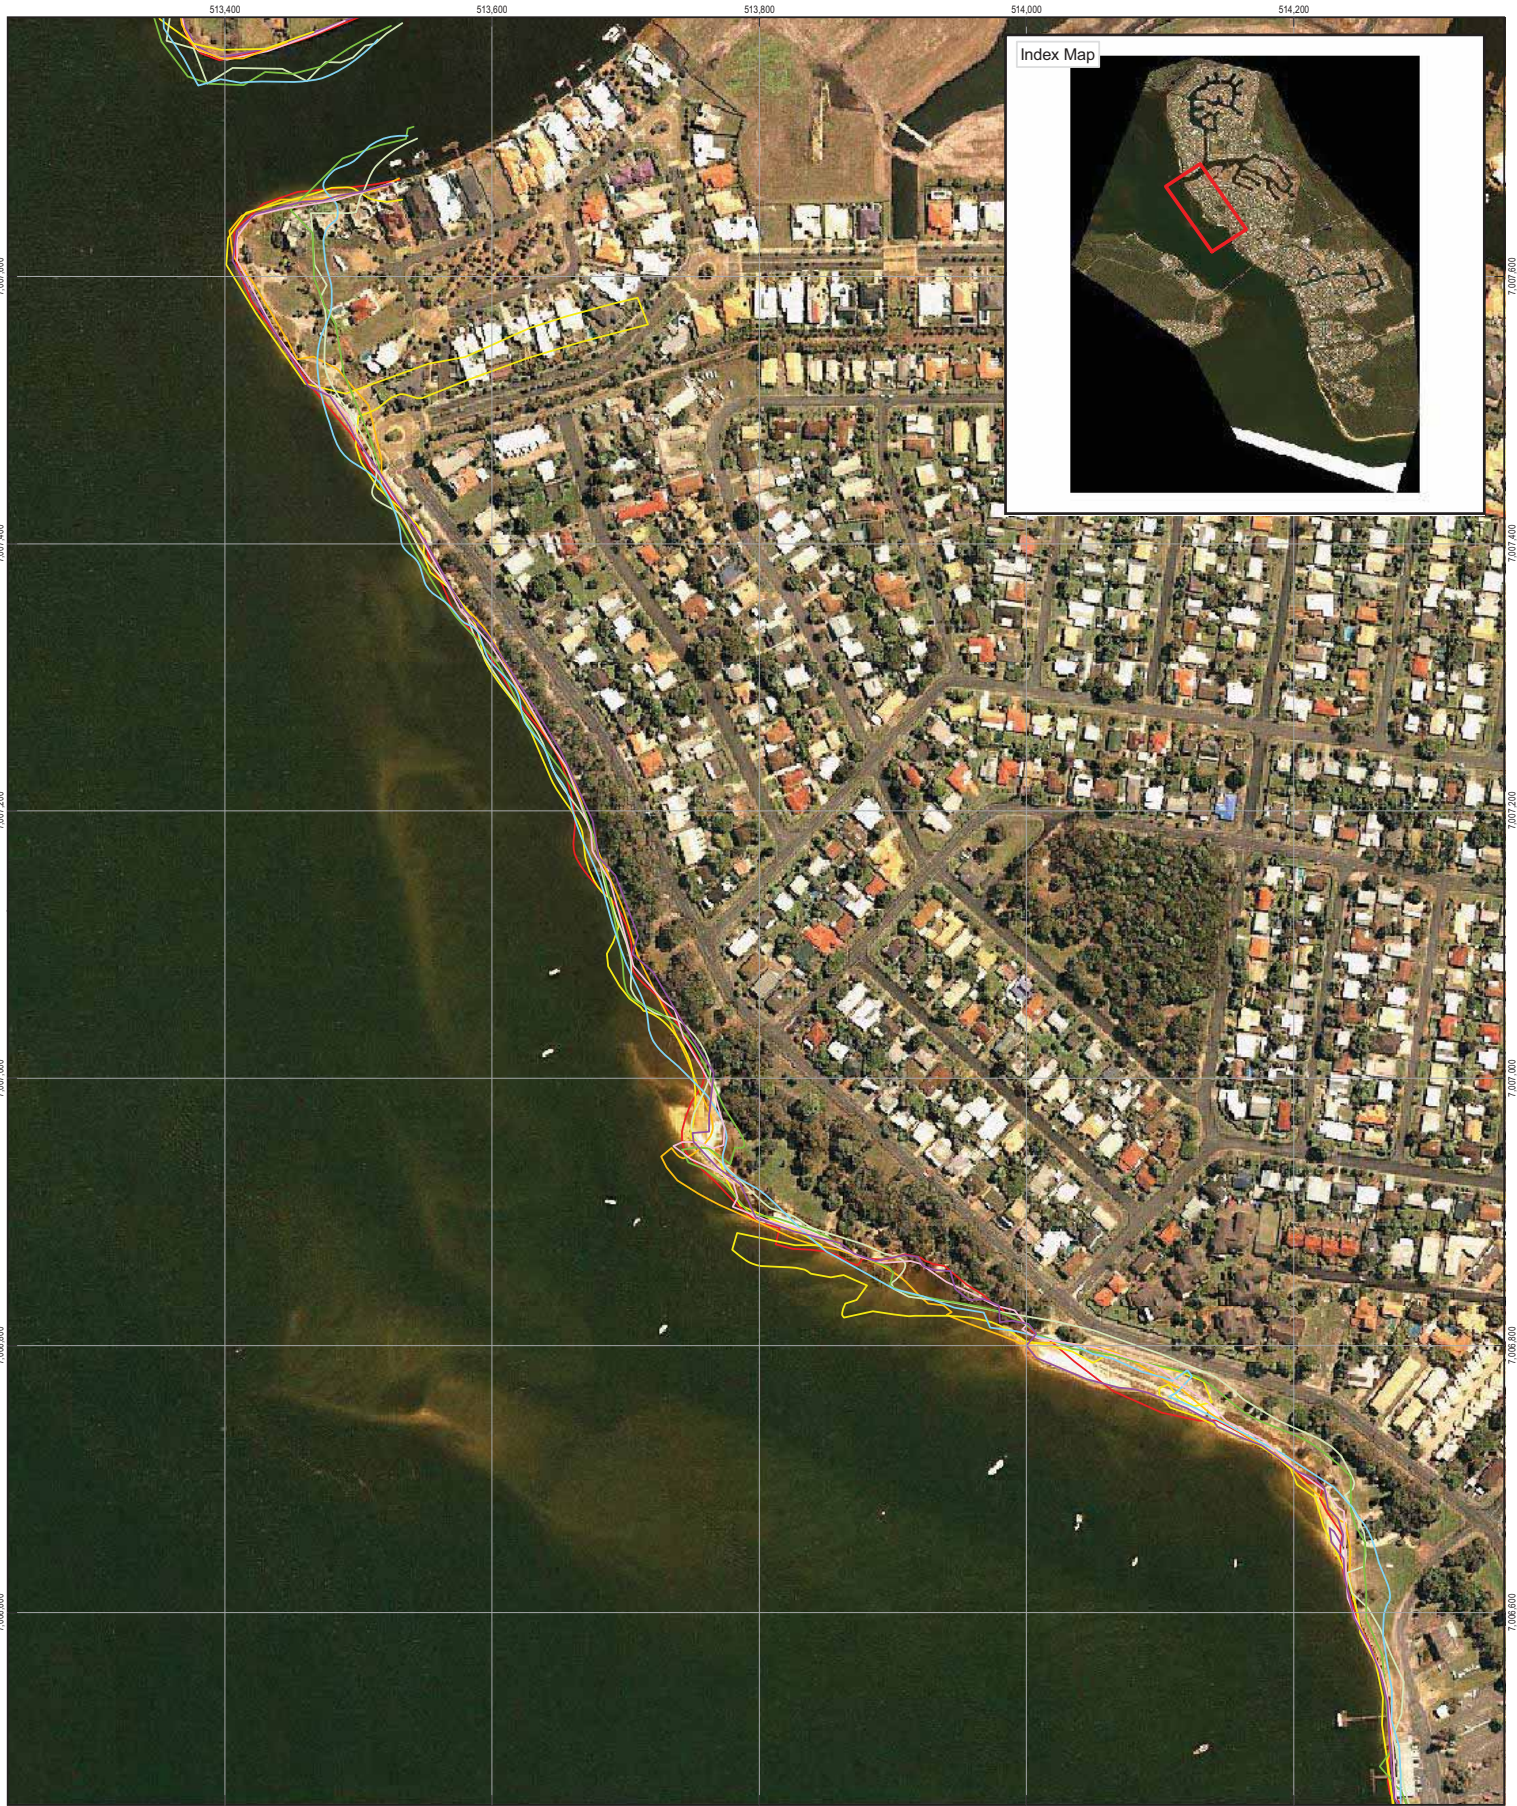
Figure 36

The southern section of the Sylvan Beach North study area (just south of Pirate Park) has undergone numerous minor shoreline movements over the record of photography. A summary of the aerial photograph analysis has been shown graphically in Figures [Figure 36](#) and [Figure 37](#). The maximum movement appears to be in the order of 30m, with most changes in the order of 10m. However, there does not appear to be a clear trend of recession as is evident along other sections of the Bribie Island western foreshore. The shoreline shows signs of pockets of erosion and accretion, which is consistent with a shoreline undergoing sporadic sediment supply. There are also localised changes associated with a small drainage line at the centre of this section of shoreline.

Along the northern part of this study area, the shoreline changes appear to be more consistent, but a clear trend is not apparent. This section of beach is oriented nearly north-south, and is afforded some protection by a wide sand flat that connects to the sand bar near the centre section of the beach. The shoreline changes along this section of coast over the 50 year period of record for the aerial photography all appear to be a maximum of approximately 10m. The present shoreline is largely in a very similar position to that evident in the 1958 and 1975 photography.

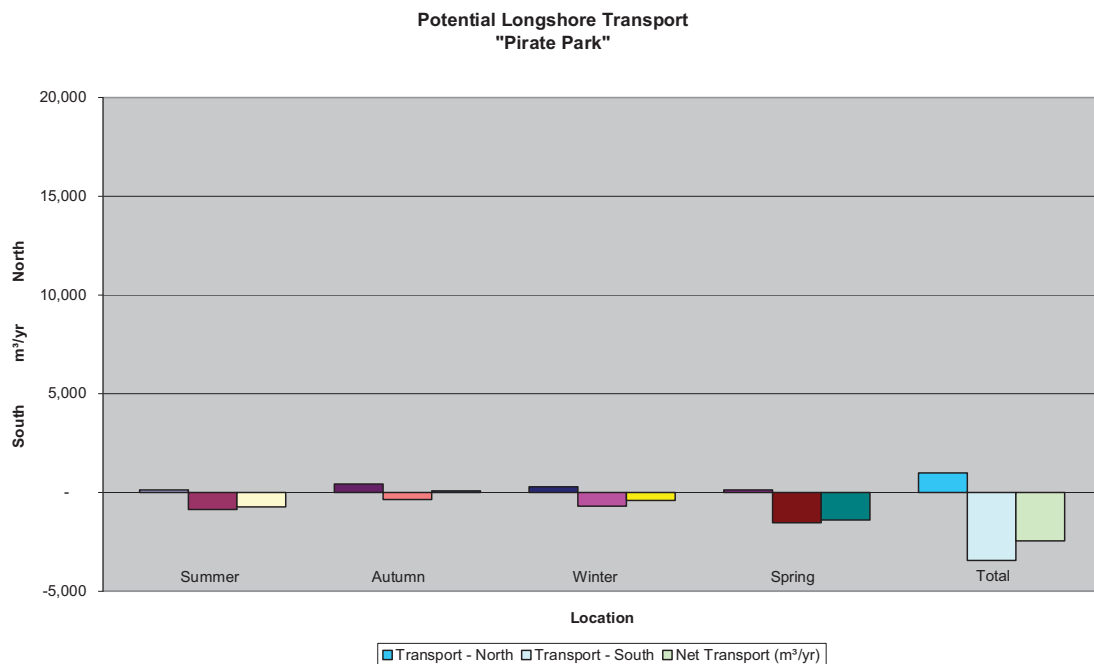
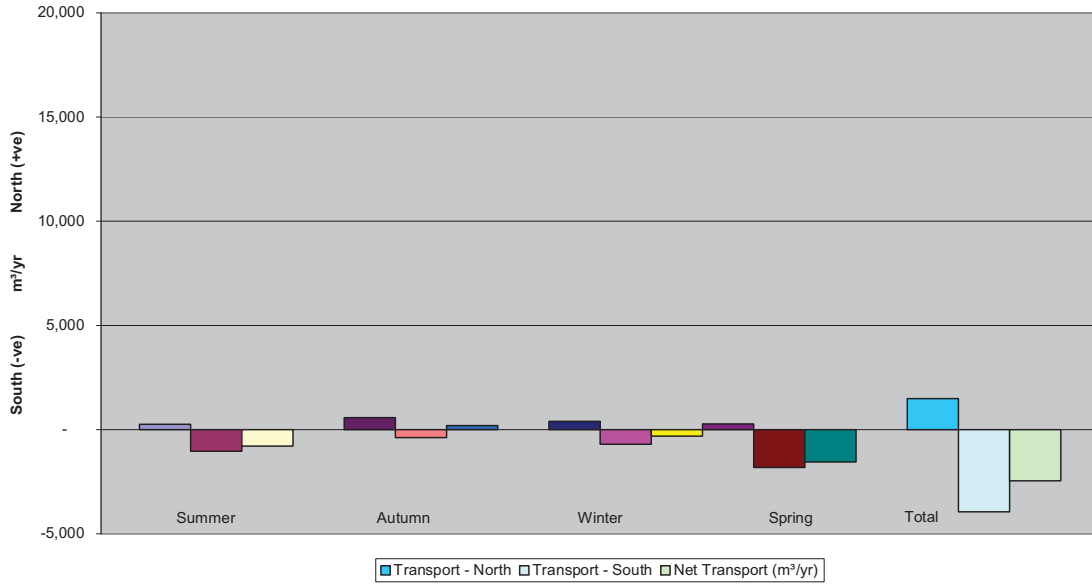
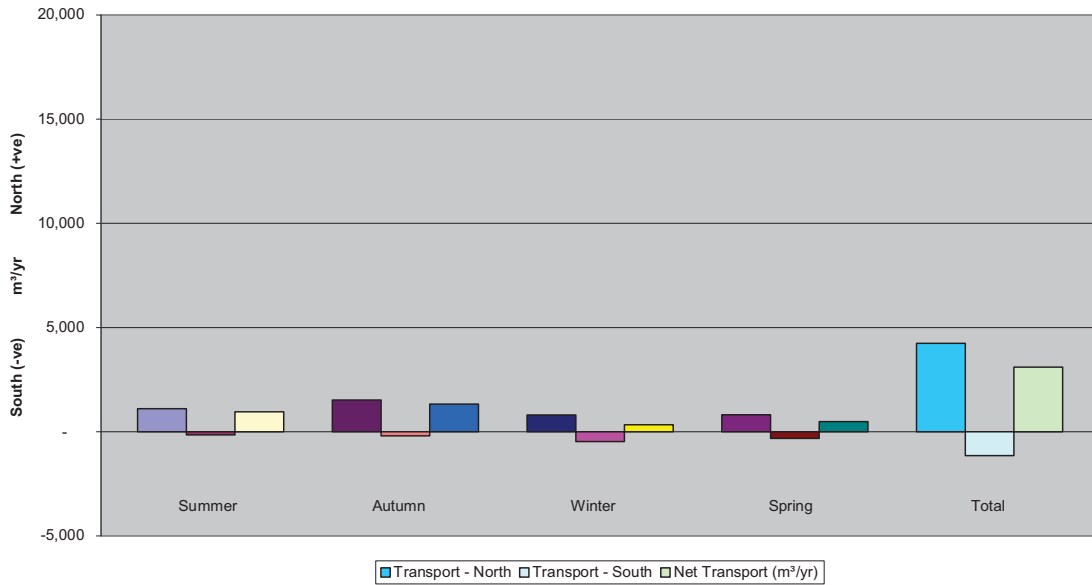
**Figure 38 Sylvan Beach – Longshore Transport**

- ▶ The transport rates along Sylvan beach are small as this beach is largely sheltered from waves from the south;
- ▶ There is some transport to the north at Sylvan Beach North due to the refraction of southerly waves around the sand shoals at the southern end of the beach; and
- ▶ The seasonal variation is similar to the annual results but the values of the transport are not large enough to draw any further conclusions.
