Northern Moreton Bay Shoreline Erosion Management Plan

Summary Report

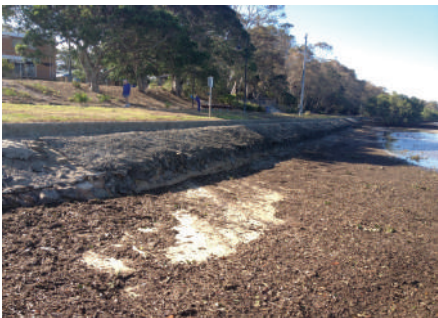
Shoreline lowering caused by storm erosion

Shorelines with hard structures, such as seawalls, resist landward recession and therefore the erosion pressure is re-directed downwards. This often causes the shoreline in front of the structure to lower.

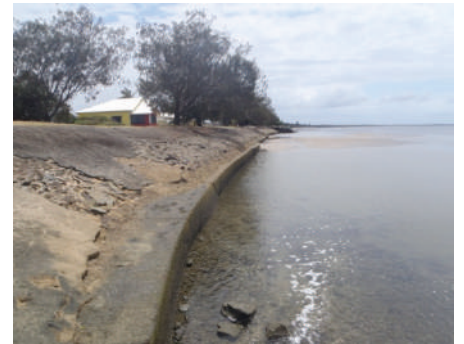
Due to ongoing erosion pressure and maintenance issues associated with existing structures in poor condition, Council has recently upgraded seawalls at the Beachmere Activity Centre and Albert and Myrtle Lehman Park. Conditional approval for seawall rehabilitation works at southern extent of Biggs Ave has also been gained.

Concrete seawall in poor condition (Section 10)

- Upgrade Section 10 seawall with a rock seawall design that better dissipates wave energy during severe storm conditions
- Community awareness program providing information on the maintenance of dune and shoreline vegetation on private land

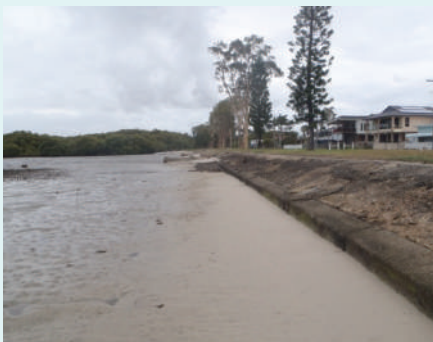
The sloping seawall that protects the Godwin Beach community foreshore is in a fair condition. While no major

assets or values appear to be under immediate threat, this seawall may require upgrade within a 10 year period (to be confirmed through a structural integrity assessment). In the interim, vegetation and landscaping of the foreshore area could be undertaken to enhance social and environmental values. Long term opportunities for the Godwin Beach open space could be explored through an Open Space Master Plan.

Sloping concrete seawall and narrow beach (Section 1)

- Structural integrity assessment of Section 1 sloping concrete seawall and drainage infrastructure

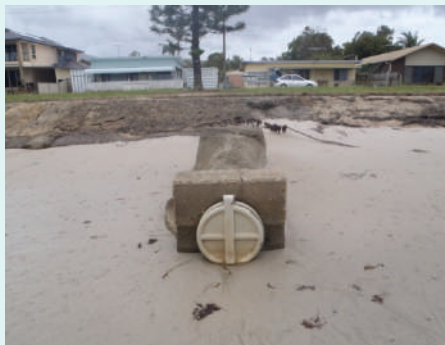
beach unit. The foreshore area stretching along The Esplanade is protected by a sloped concrete seawall with signs of previous repair works. A number of stormwater outlets that extend across the beach are having a minor “groyne-like” effect with sand accumulation on their up drift (northern) side. A small pocket of identified shorebird habitat is located within the intertidal zone toward the western end of the foreshore.

Stormwater outlet with minor sand accumulation on northern side

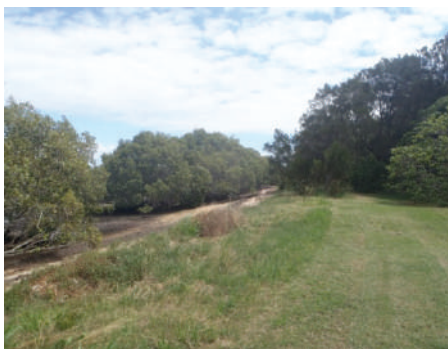
Access to the coastal trail with an identified safety hazard associated with a potential landslip should be formally closed. Site inspection of the Avoca Esplanade access point suggests this trail may still be used by some community members.

Avoca Esplanade shoreline access

- Formally close access to coastal trail where a safety hazard exists

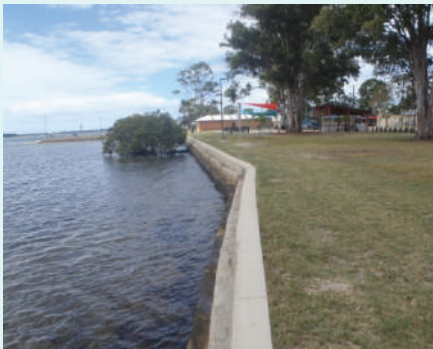
Repaired stepped concrete seawall (Section 5)

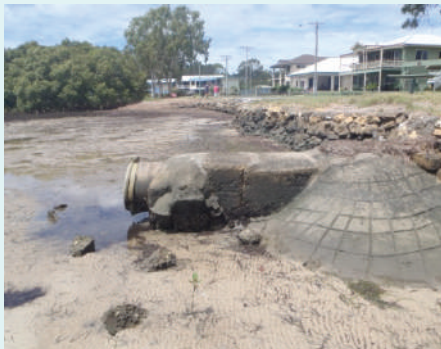
Council has identified a need to upgrade a section of seawall where significant damage occurred during ex-TC Oswald, January 2013. The seawall at this location was originally built by local residents in the 1970s and is therefore an unapproved structure. The proposed upgraded structure opposite Second Avenue will follow a straight alignment and is intended to protect the adjacent footpath and road. A development application for the proposed structure was submitted in early 2014

Seawalls to the north of the main public boat ramp have either undergone recent repair or are in a relatively poor condition. There is also a general concern that the geometries of the structures present safety hazards. It is anticipated that

Stone and concrete seawall identified for upgrade (Section 9)

approximately 500m of seawall will need to be upgraded within a 10 year timeframe.

- Upgrade and realign Section 9 unapproved seawall

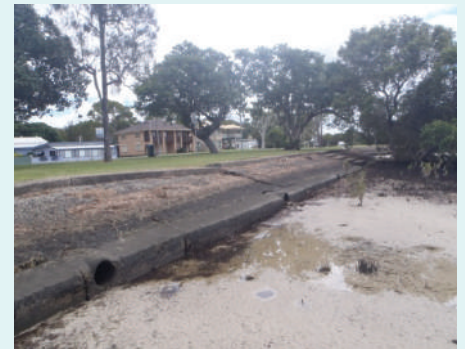
The sloping concrete seawall south of the Second Avenue is in a poor condition in some locations. Large cracks and subsequent slumping of the structure present a trip hazard and suggest a significant loss of sediment from behind the rigid structure. While the immediate risk to assets appears low, planning to upgrade this structure should commence.

Sloping concrete seawall slumping (Section 10)

- Rehabilitation and vegetation of shorelines without existing structures
- Structural assessment of all existing structures to inform repair and/or upgrade prioritisation
- Commence planning for significant seawall upgrade works within a 10 year timeframe

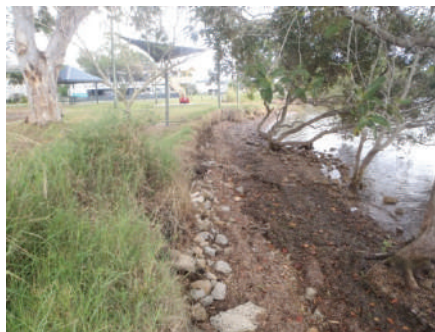
Grassy shoreline and playground equipment (Section 2)

- Relocation of playground equipment to a location outside of the erosion prone area

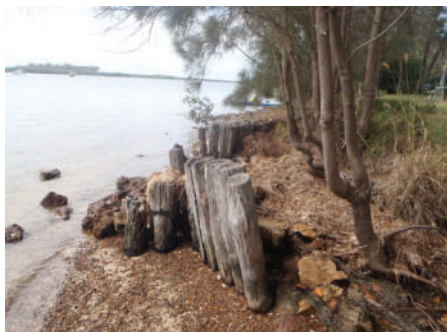
The shoreline is generally free of formalised structures however rock, timber and/or concrete have been used in the northern half of the study area to resist shoreline erosion at the Caravan Park foreshore. The original placement of these materials many

years ago was unlikely to have been part of an approved shoreline management strategy. These materials are not likely to be performing as intended and better erosion control outcomes could be achieved through shoreline realignment, foreshore landscaping and revegetation activities. The relocation (setback) of the playground equipment will ensure it remains outside of the erosion prone area.

Loosely placed rock and timber (Section 3)

- Removal of inappropriate materials used for shoreline erosion control
- Rehabilitation and vegetation of shorelines without existing structures
- Shoreline re-profiling and stabilisation to be carried out in conjunction with foreshore works recommended as part of the Open Space Master Plan for Donnybrook

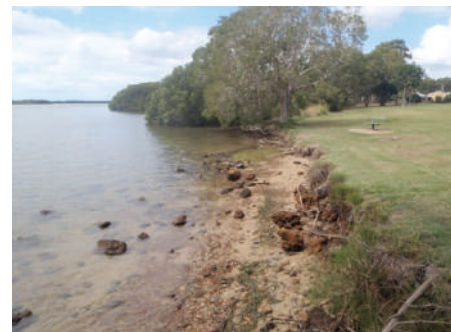
Loose rock and erosion scarp (Section 4)
