8. Banksia Beach

Moreton Bay Regional Council
Shoreline Erosion Management Plan

Banksia Beach - Locality Plan

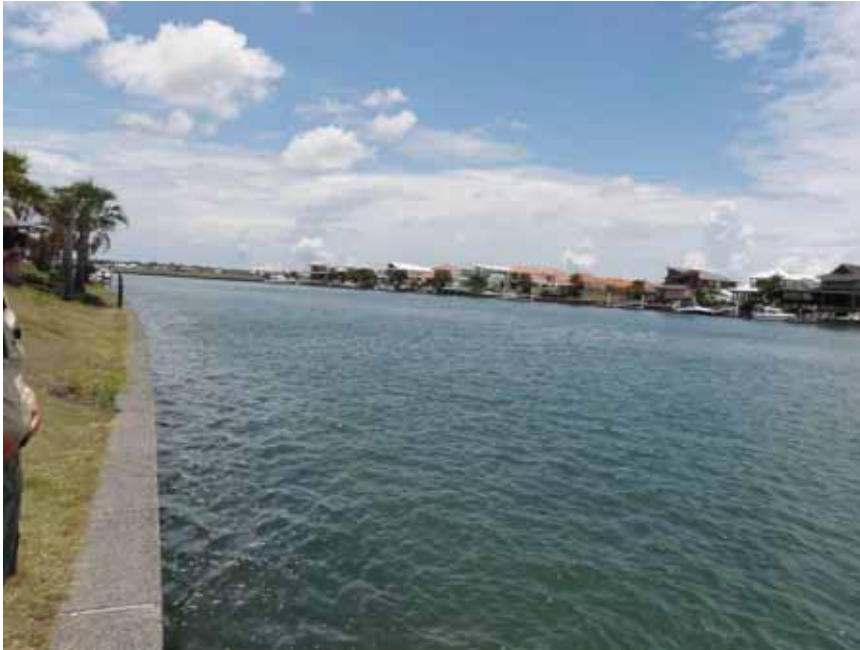
Photo Plate 8-1 Solander Canal

The northern side of Solander Canal features a concrete sea wall along the entrance with some vacant land and landscaped park directly adjacent (refer to [Photo Plate 8-1](#), [Photo Plate 8-2](#) and [Photo Plate 8-3](#)). A small number of mangroves have established along the north-western wall of the canal entrance. To the north of the sea wall is an area of sand bank developed out from the original shoreline.

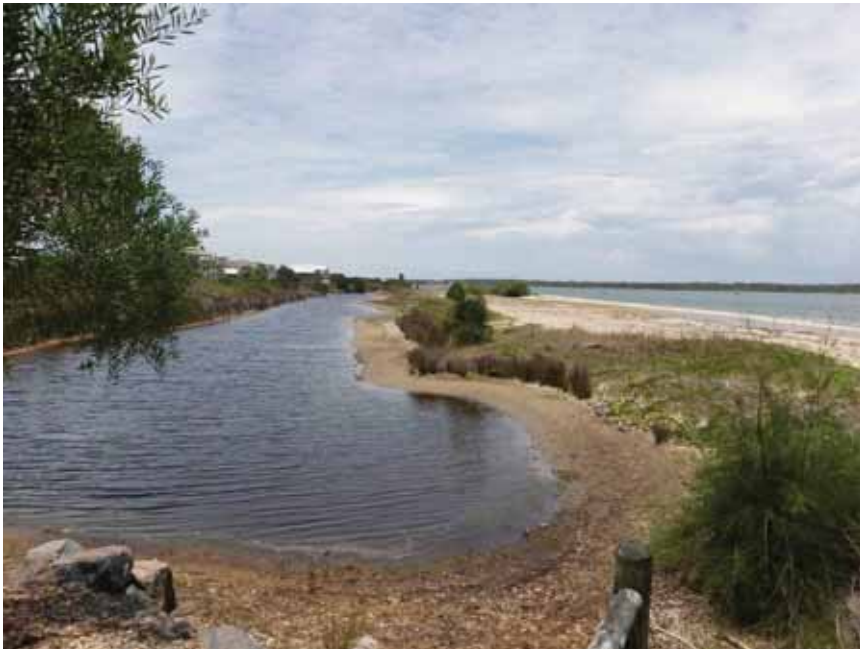
Photo Plate 8-4 Public Environmental Park and Shorebird Sanctuary

Beyond this to the north is the Public Environmental Park and Shorebird Sanctuary, which features a beach and bird roosting site that is fenced off to prohibit public access (refer to [Photo Plate 8-4](#)). This area is regarded as an important site for wader birds, shorebirds and migratory birds. Inland of the foredunes is a small lagoon. The shoreline has well-developed vegetation north of this protected area. This artificial sand mound on the beach adjacent to Kakadu Beach residential development is identified as a critical roost by the Queensland Wader Study Group (Milton *et al*, 2009). It is known to be used by large numbers of shorebirds on king tides and there are records of the 'rare' beach stone-curlew nesting at this site. This area needs regular maintenance to retain its viability as a roosting site. Access is restricted by fences and signage; however it is reported to have one of the highest rates of disturbance when compared to any other roost studied during the project (Milton *et al*, 2009).

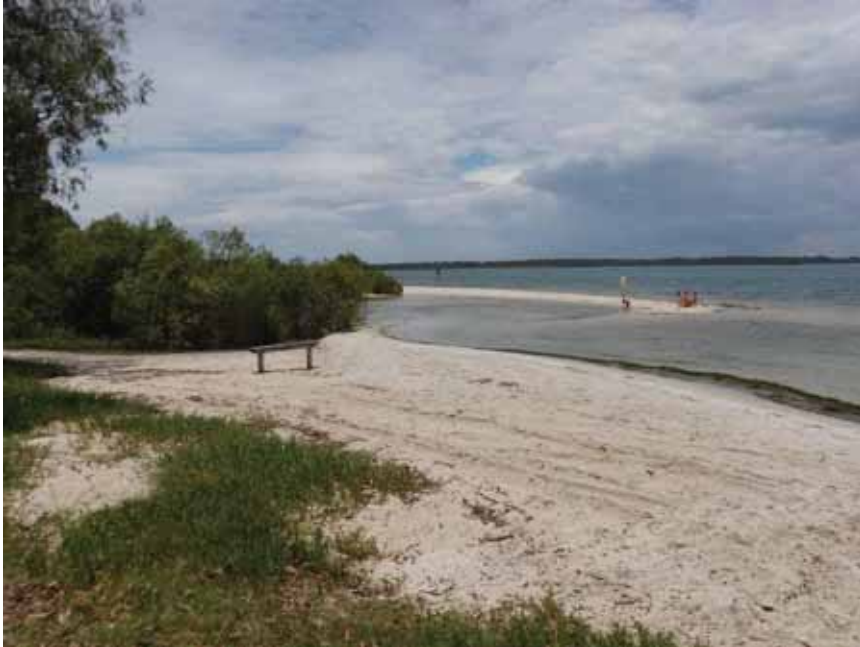
Photo Plate 8-5 Shoreline south of boat ramp

The boat ramp at Banksia Beach features a sandbank to the south and beach build-up around the ramp (refer to [Photo Plate 8-5](#) and [Photo Plate 8-6](#)) at the time of inspection.

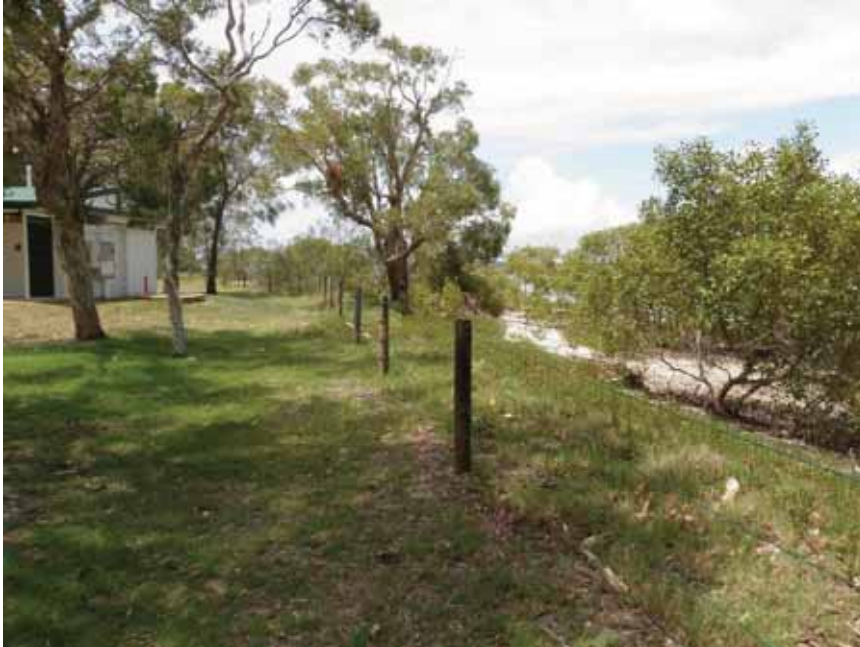
Photo Plate 8-7 Fenced rehabilitation area

Along the northern extent of Banksia Beach, Council has fenced off an area of the shoreline to restrict public access to the foreshore, and this has assisted the mangroves and groundcover to continue to establish well in this area (refer to [Photo Plate 8-7](#)). Adjacent to this fenced-off area is a basketball half-court, toilet block and sewage pump station, and sculpture installation. The sewage pump station is approximately three metres from the fenced-off rehabilitation area. A 750 mm diameter stormwater pipe is south of this infrastructure and fencing.

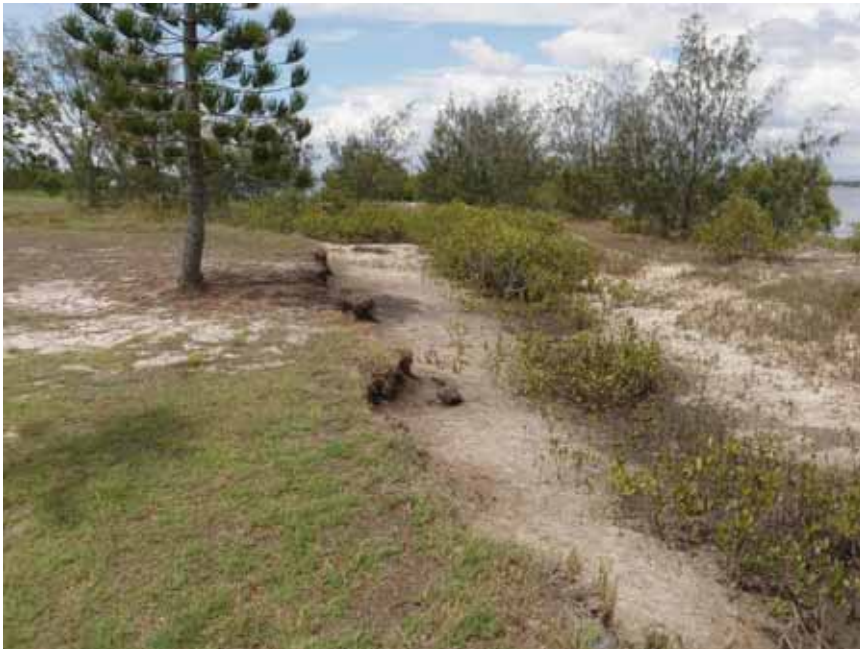
Photo Plate 8-8 Wrights Creek canal entrance

Wrights Creek forms the northern boundary of Banksia Beach comprises a wide shallow mouth with a small channel running along the eastern side of the mouth (refer to [Photo Plate 8-8](#)). Also at the northern end of the beach there is a tidal drain/canal with a weir across its entrance

where it joins Wrights Creek, and a bridge connecting the park areas on each side. Mangroves have established along this canal that is bordered by a revetment wall consisting of vertical corrugated asbestos sheeting and a concrete capping beam. Sand has been placed in areas adjacent to the wall where the corrugated asbestos sheeting has been exposed. Council is aware of the presence of asbestos at this location. Potential health risks are being contained and monitored with a future plan to remove the material at the same time as maintenance works are undertaken in the area.

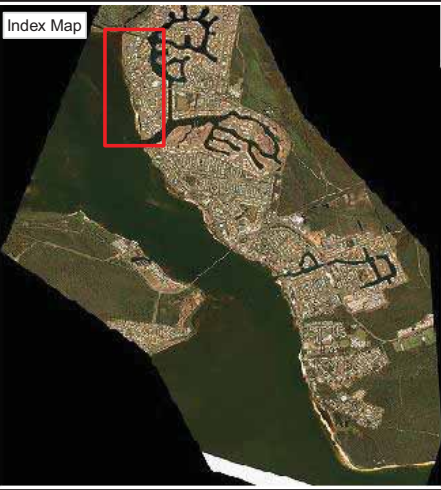
Figure 40

Start at the same time the artificial channel was created, significant modification of the parkland adjoining the sand flat was made (indicated by the hatch area in Figure 40). All vegetation was removed, and the shoreline appears to have been straightened. Since this time, the shoreline has been reasonably stable, with small localised pockets of erosion and accretion. The aerial photography indicates that the net sediment transport is still to the north in this area, with slugs of sand observable along the shoreline.

Area of significant change to foreshore between 1982 and 1990 during construction of Pacific Harbour Canal development

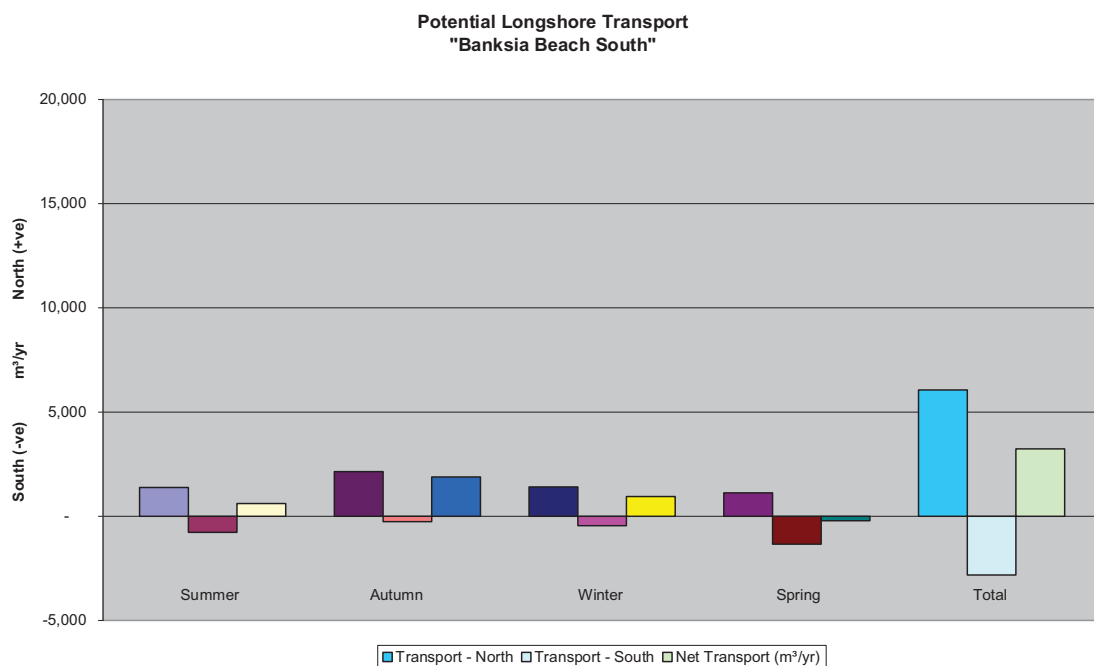
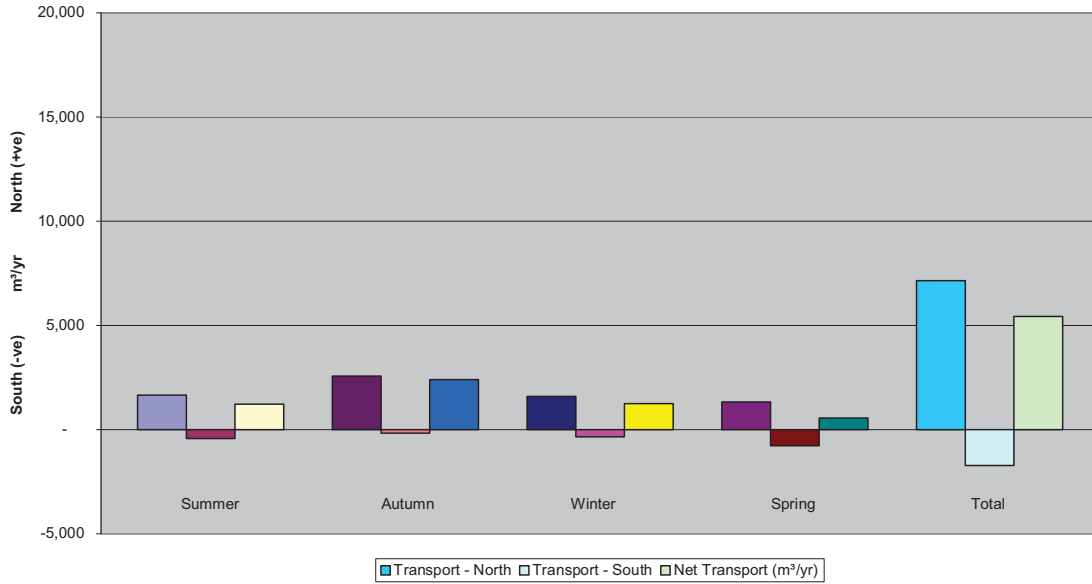
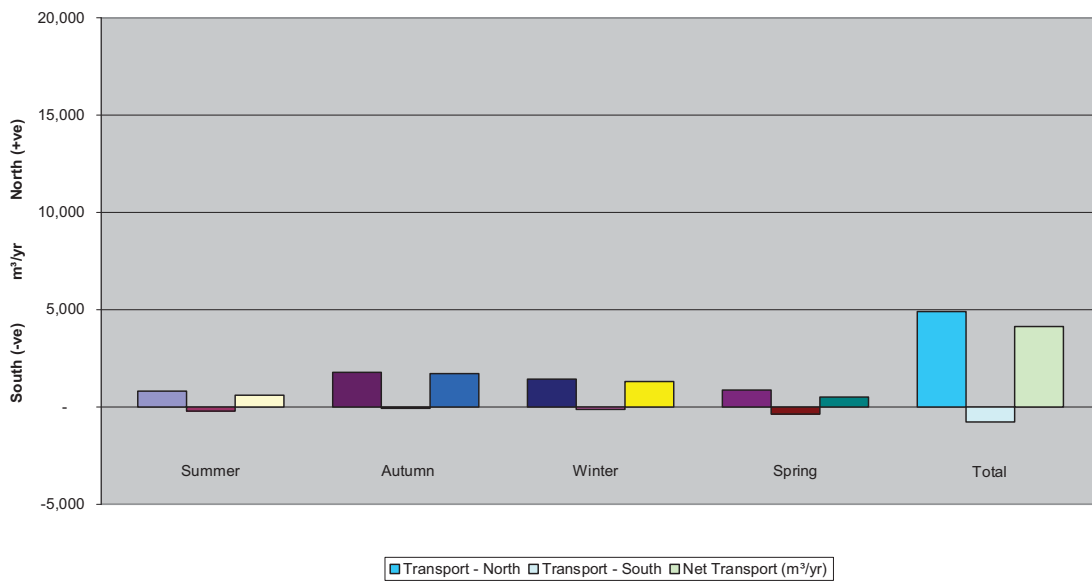
Figure 42 Banksia Beach – Longshore Transport

- ▶ The transport rates along Banksia Beach are relatively small as this beach is largely sheltered from waves from the south;
- ▶ The transport rates are higher than for Sylvan Beach due to the increased exposure to winds from the south-westerly sector; and
- ▶ Banksia Beach North is less exposed to the northerly sector than the southern part of the beach and this is reflected in the reduced net southerly transport.
