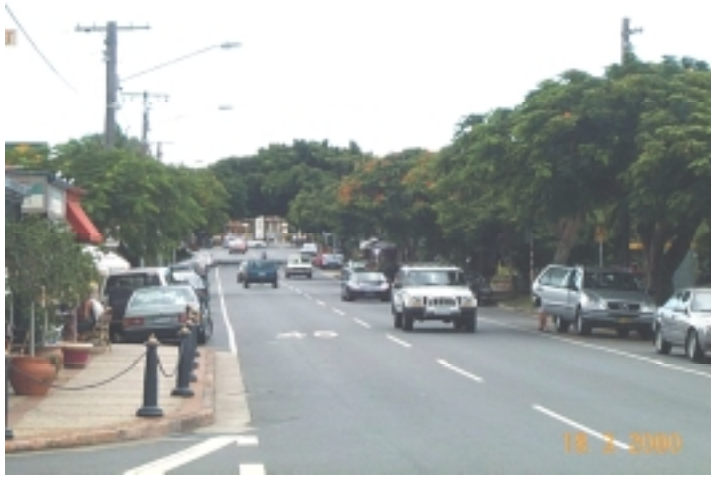
Image 11 – Acceptable
Kerb build outs and pedestrian
accessibility contribute to a
pedestrian friendly environment.

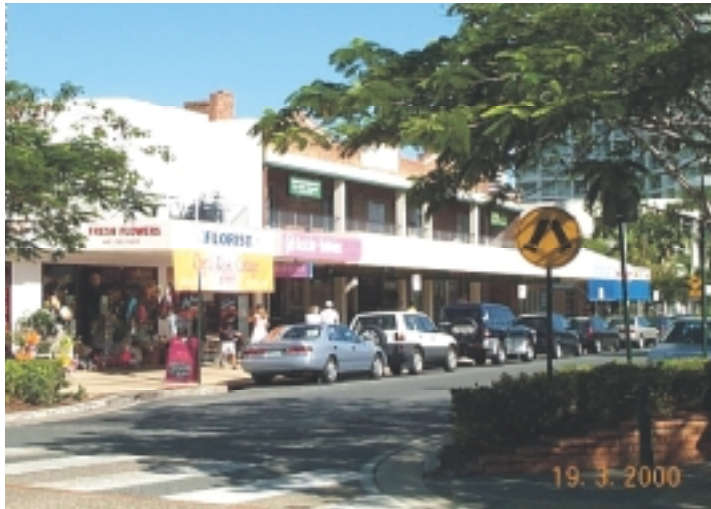
Image 12 – Acceptable
Development integrated with
landscaping and paving
treatments create a main street
environment.

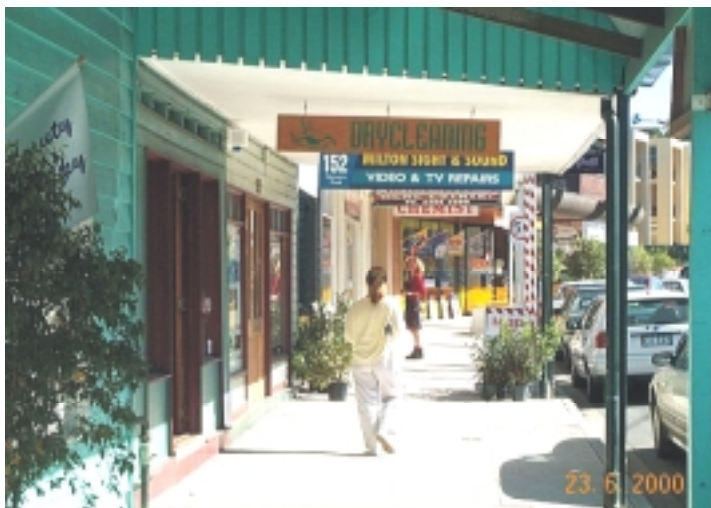
Image 13 – Acceptable
Development will present active
frontages addressing the street.

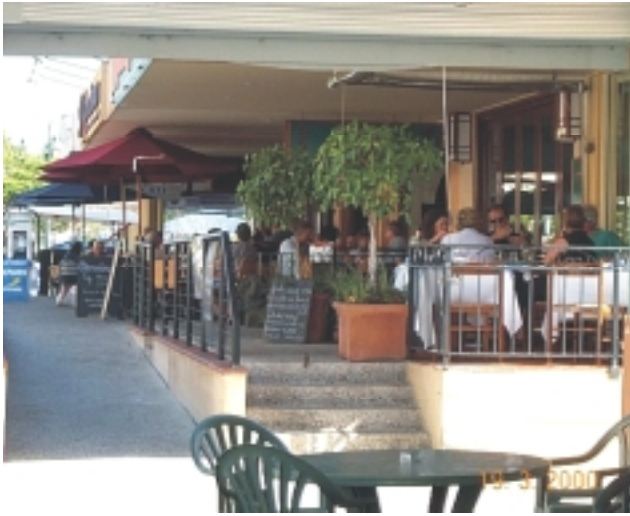
Image 14 – Acceptable
Changes of grade appropriately
handled while maintaining open,
active frontages.

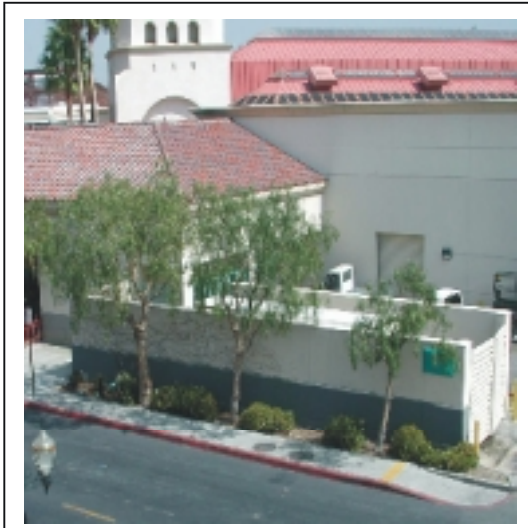
Image 15 – Acceptable
Appropriate screening of service
bays

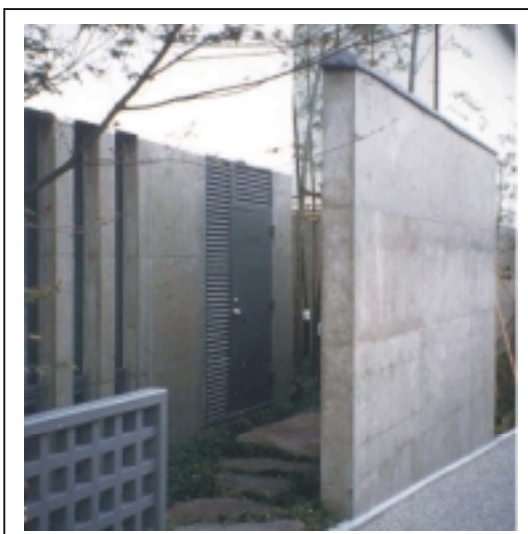
Image 16 – Acceptable
Appropriate screening of service
areas where CPTED principles
are not compromised.
