3 Beachmere

3.1 Council Controlled Areas and Current Condition

3.2 Shoreline Management Approaches Considered

3.3 Proposed Management Strategy

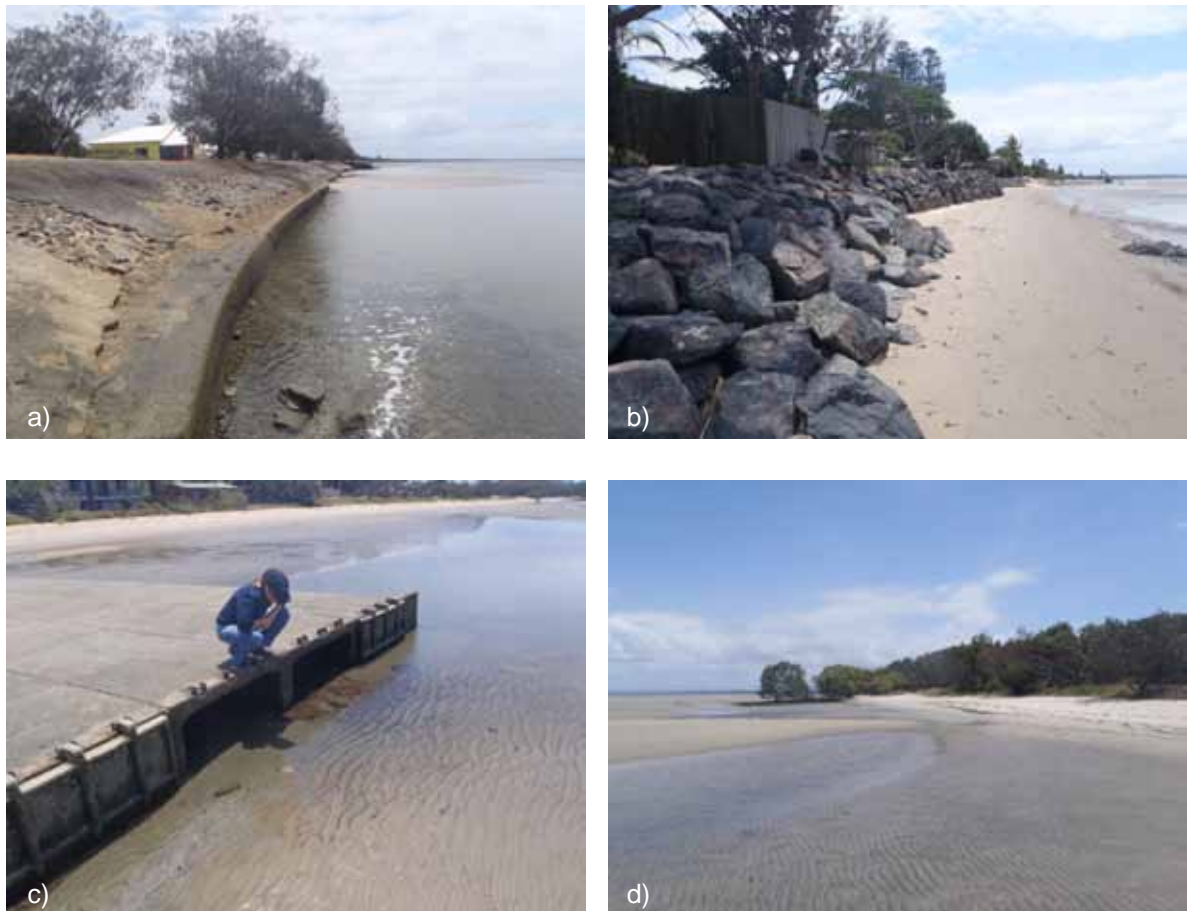
Moving south from the Albert and Myrtle Lehman Park to the Caboolture River entrance, the beach progressively narrows and the shoreline is armoured with seawalls (refer Figure 3-2a and Figure 3-2b). The south-westerly directed longshore sediment transport along this section has gradually lowered the beach which now becomes completely submerged at high tide. Over time, the sediment eroded from this location has been deposited in a series of sand spits adjacent to the north bank of the Caboolture River (refer Stage 1 report, Section 5.5.2).

Figure 3-2 Example Shoreline Condition throughout Beachmere Study Area: a) Stone Pitched Seawall with Shotcrete Repair; b) Loosely Placed (foreground) and Tightly Packed (background) Rock Seawalls; c) Storm Water Culvert and Low Vegetation Shoreline (background); d) Beach with Dense Coastal Vegetation

Conditional approval for seawall rehabilitation works at the southern extent of Biggs Avenue (previously Huntley Street) has been granted. The existing seawall (stone pitched with shotcrete repair, refer Figure 3-2a) is in poor condition and the impermeable structure enhances seawater overtopping associated with extreme storm events. Storm surge and wave conditions generated by ex-TC Oswald (January 2013) caused geotechnical failure (sink hole damage) behind the crest of the existing structure and contributed to flooding of the adjacent areas. The approved seawall design is a permeable structure intended to cause greater wave and current energy dissipation during extreme events and therefore reduce seawater overtopping.

(refer Figure 3-2c) located at Prince Street and Phillip Street do not appear to be significantly influencing the adjacent shoreline alignment.

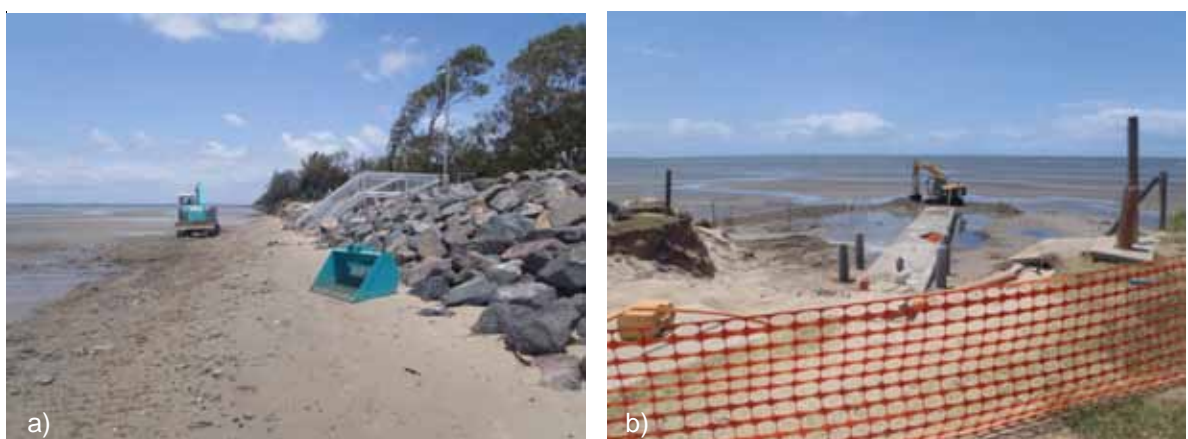
Construction of a rubble seawall at the Beachmere Activity Centre was completed in 2013 and is shown in Figure 3-3. Shoreline works at Albert and Myrtle Lehman Park were completed in early 2014 with a revetment seawall constructed following the necessary upgrade of the stormwater culverts (refer Figure 3-3b). At both locations the upgraded structures are intended to enhance social values and public safety, protect Council assets and reduce ongoing maintenance requirements.

Figure 3-3 Recent Upgrades to Council Controlled Areas: a) Beachmere Activity Centre Rubble Seawall and Beach Access; b) Albert and Myrtle Lehman Park Culvert Upgrade

Recent seawall and culvert upgrades at Albert and Myrtle Lehman Park and the Beachmere Activity Centre following damage caused by ex-TC Oswald in 2013 has addressed two immediate shoreline management issues within the study area. The shoreline and foreshore assets at these locations are now protected by rock seawalls. These structures are more consistent with seawalls at neighbouring private lots and have significantly reduced the potential for erosion of public land.

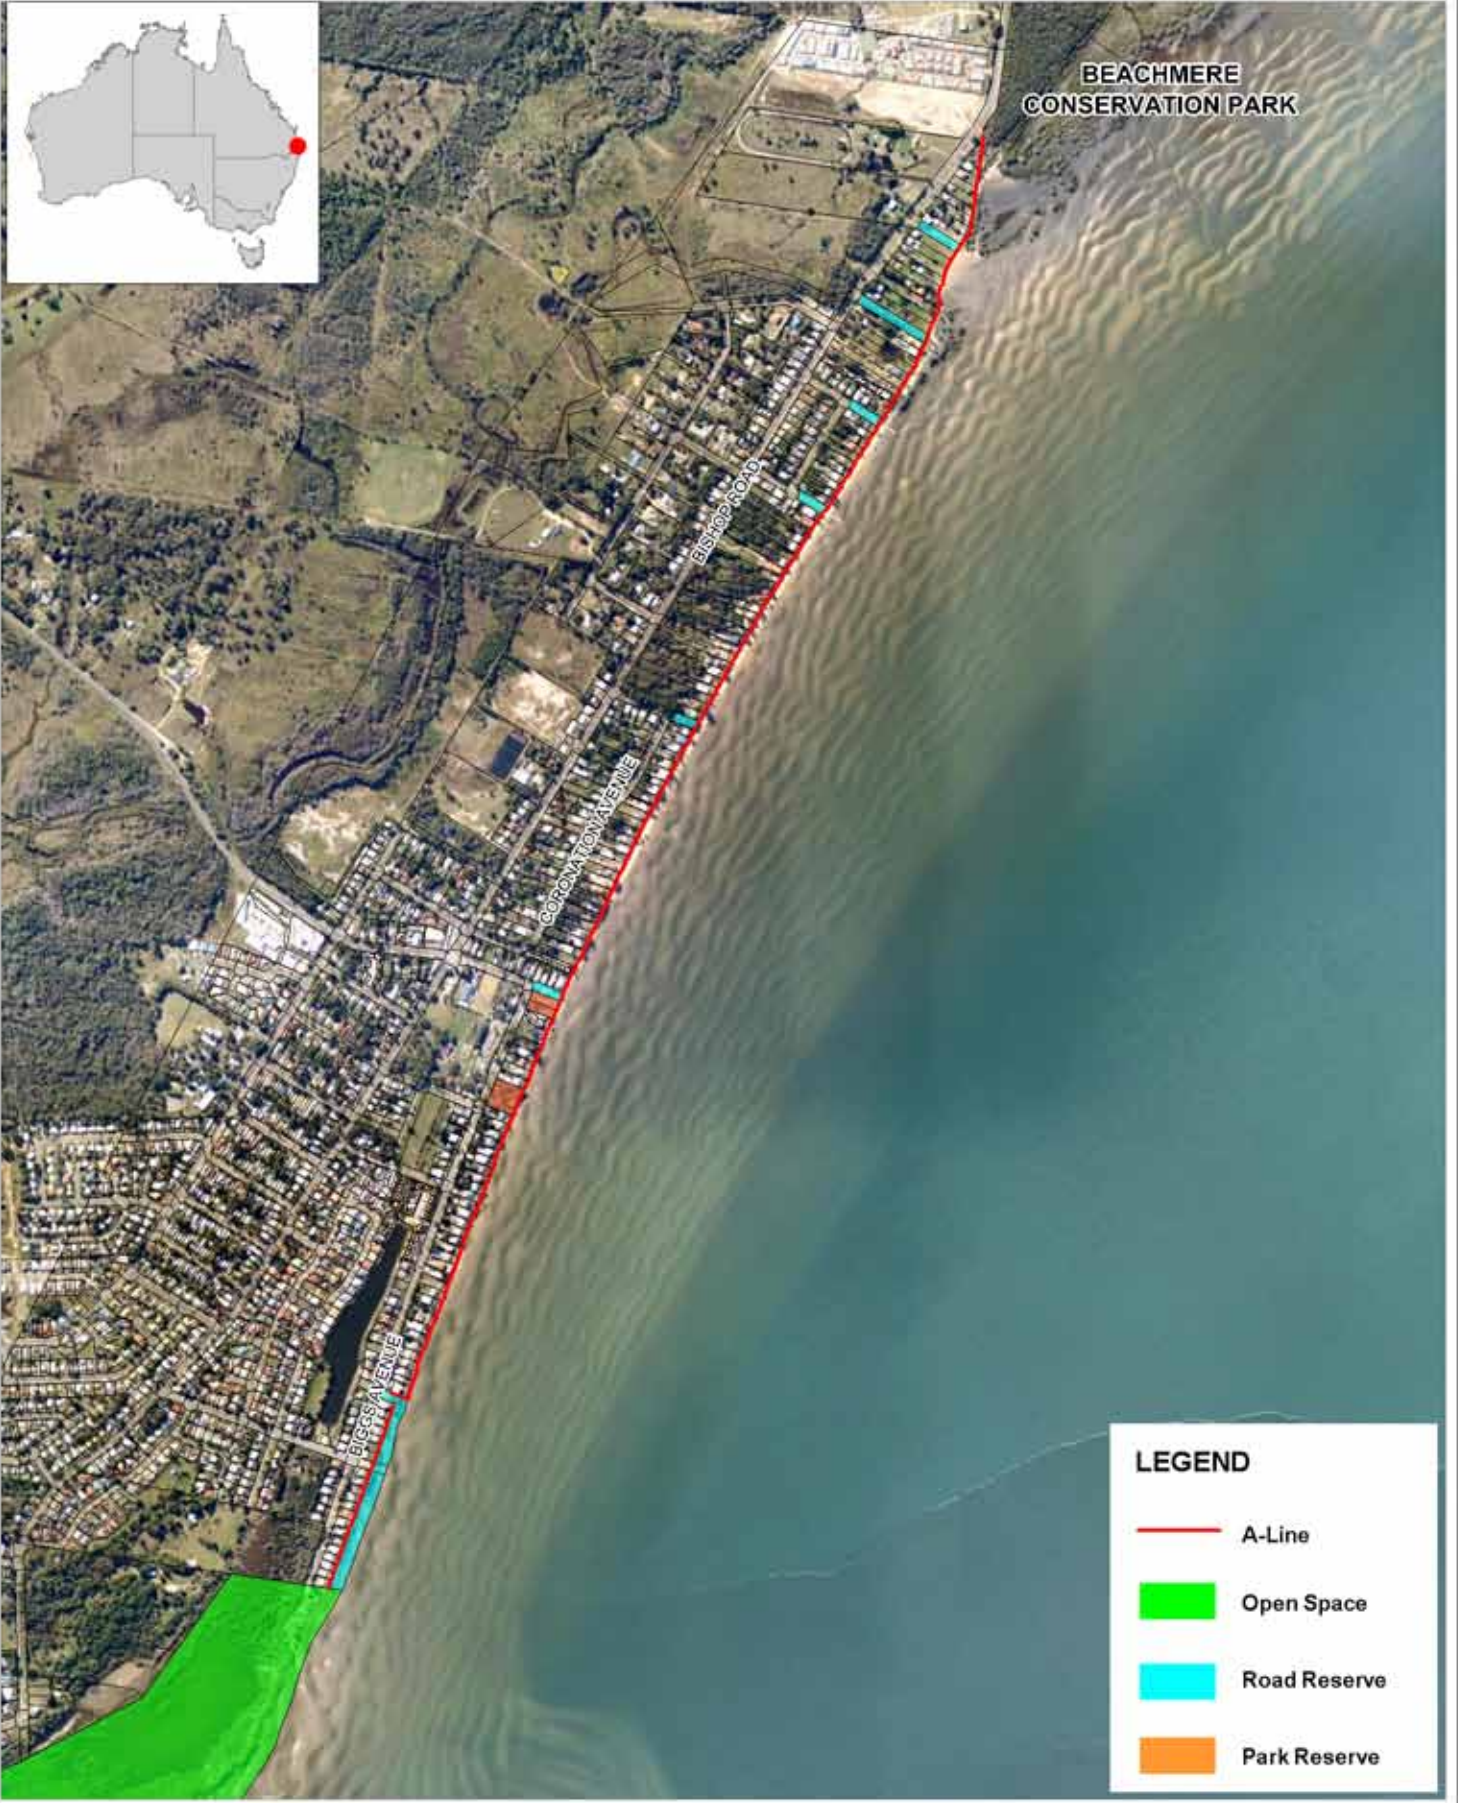
Figure:
3-6

wish to combine resources when considering formal erosion control measures. The proposed alignment for the toe of shoreline structures introduced to private or public land, referred to as the “A-Line”, is presented in Figure 3-6 and Figure 3-7.

Title:
Proposed A-Line South of the Beachmere Conservation Park

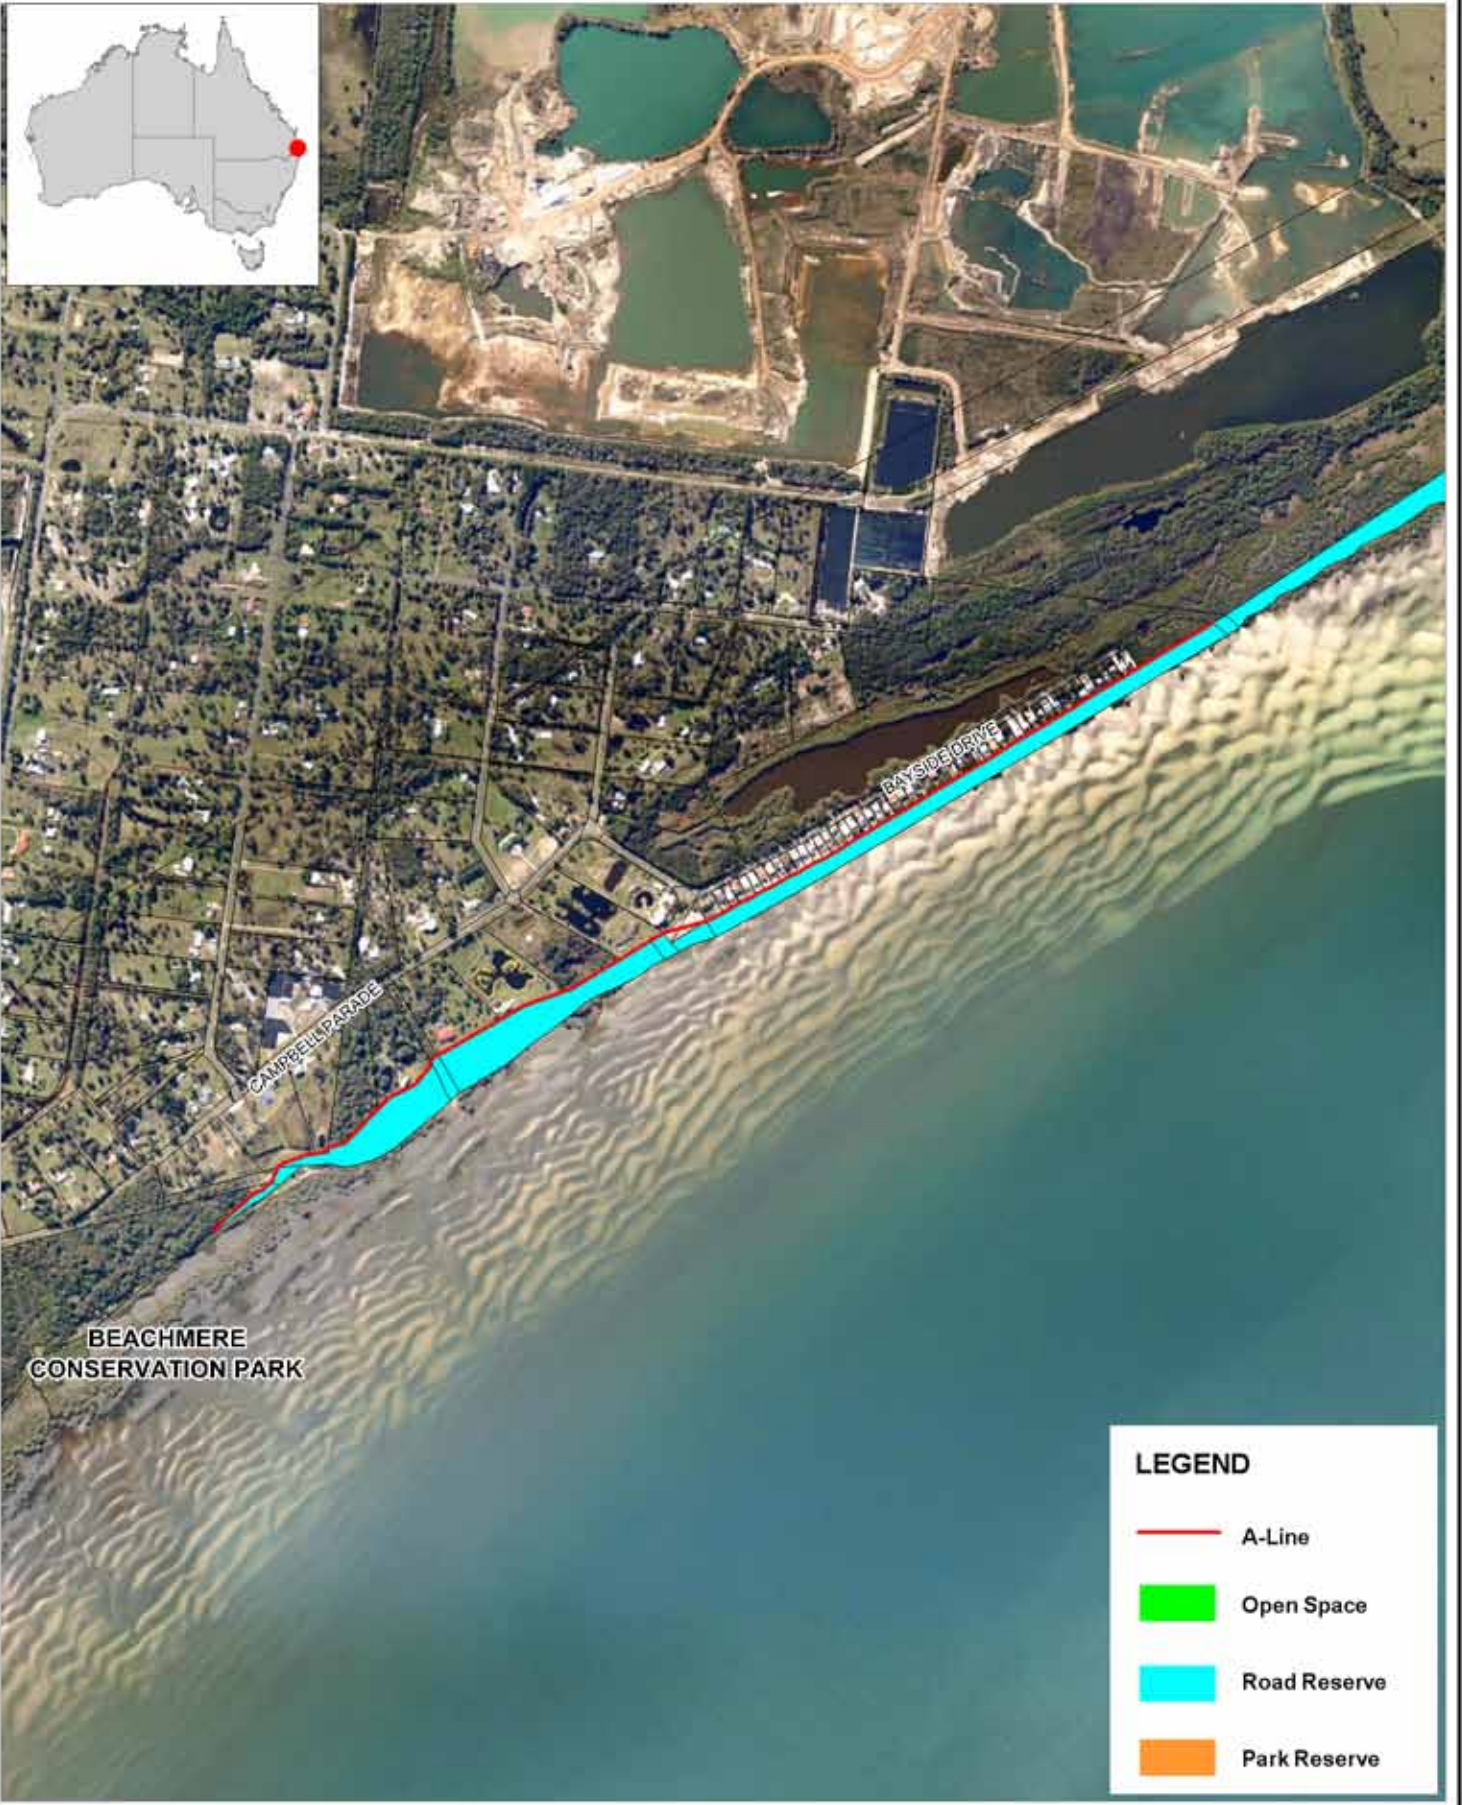
Title:
Proposed A-Line North of the Beachmere Conservation Park

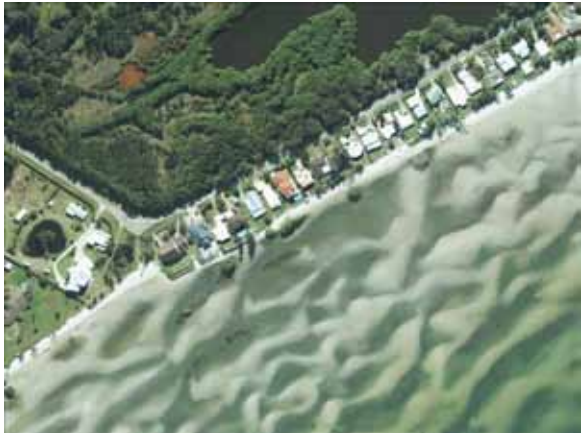
<ul style="list-style-type: none"> • Shoreline designated road reserve • Wide tidal flat offshore 	<ul style="list-style-type: none"> • Maintain status quo including ongoing foreshore and vegetation management • Consider long term policy regarding Council’s position to protect undeveloped road reserve
<p>4. Campbell Pde – approx. 910m</p>

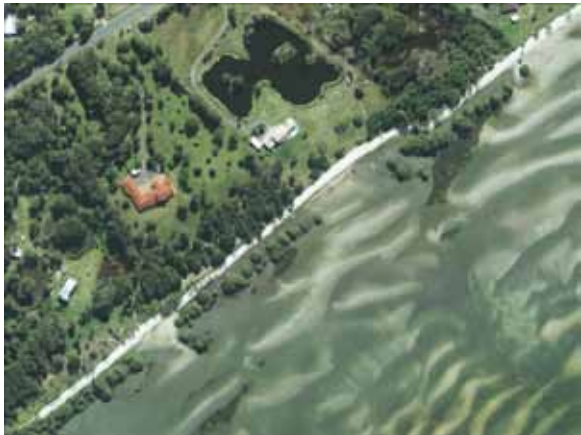
<ul style="list-style-type: none"> • Sandy shoreline forming private lot boundary • Wide tidal flat offshore • No Council controlled land at shoreline 	<ul style="list-style-type: none"> • Provide residents with information regarding appropriate erosion control strategies with a focus on foreshore vegetation and mangrove management

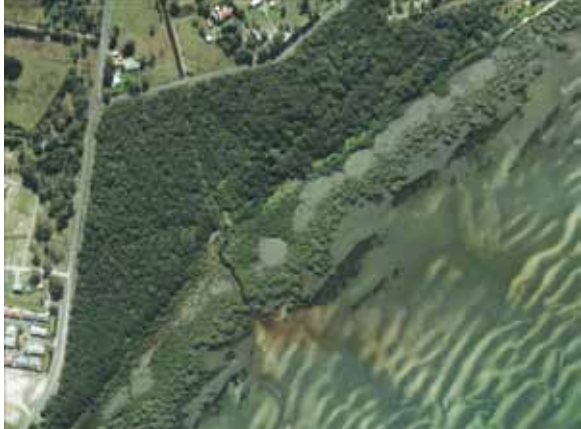
<ul style="list-style-type: none"> • Dense mangrove community • Wide tidal flat offshore 	<ul style="list-style-type: none"> • Maintain status quo
<p>6. Bishop Rd – approx. 2100m</p>

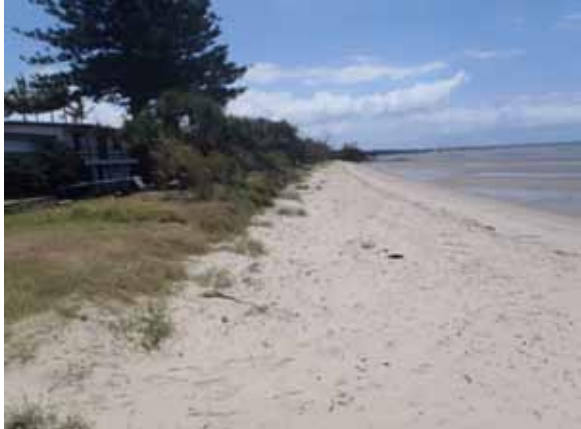
<ul style="list-style-type: none"> • Sandy shoreline forming private lot boundary • Wide tidal flat offshore • Small sections of Council controlled land at seaward end of road reserves • Stormwater culverts and outlets at shoreline 	<ul style="list-style-type: none"> • Provide residents with information regarding appropriate erosion control strategies • Maintain status quo at seaward end of road reserves • Inspect shoreline following severe storm conditions

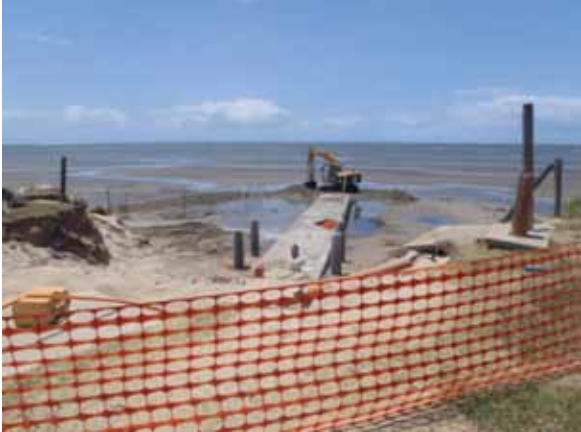
<ul style="list-style-type: none"> • Recently upgraded culvert and rock seawall • Wide tidal flat offshore 	<ul style="list-style-type: none"> • Maintain status quo • Inspect foreshore following severe storm events
<p>8. Beachmere Activity Centre</p>

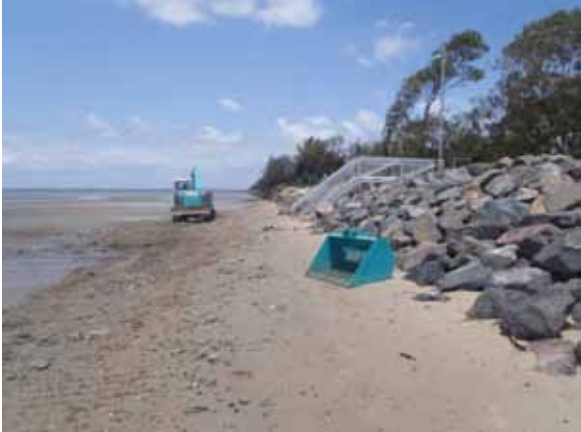
<ul style="list-style-type: none"> • Recently upgraded loosely placed rock rubble seawall • Wide tidal flat offshore 	<ul style="list-style-type: none"> • Maintain status quo • Inspect foreshore following severe storm events
