3 COASTAL PROCESSES & CAUSES OF EROSION

An appropriate understanding of the fundamental coastal processes affecting the Redcliffe shoreline is needed in order to make an informed decision on the most reliable management strategy to be adopted.

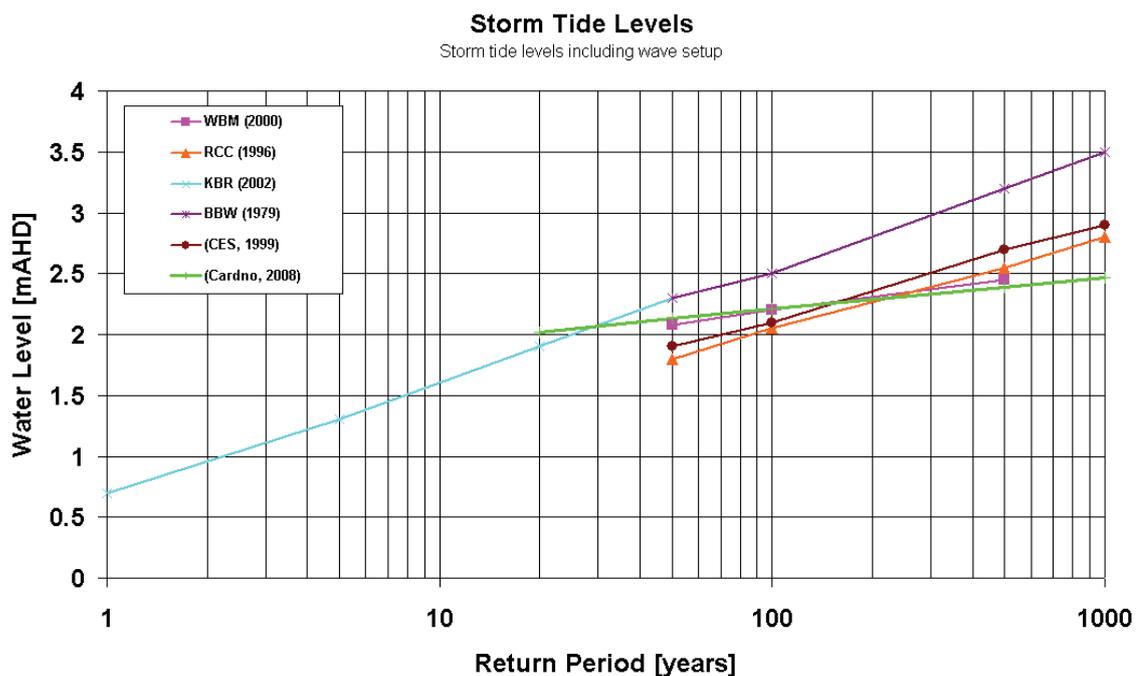
Potential storm tide levels for design purposes have been assessed by a review of existing studies including a recent storm tide study for the Redcliffe District (Moreton Bay Regional Council's Storm Tide Hazard Study (Draft) - Cardno, 2008). Other studies considered in the review are: Impact Assessment Study for Port Expansion at Fisherman Islands, Port of Brisbane (WBM, 2000), Redcliffe Coastal Process Study (KBR, 2002) and Moreton Bay Regional Council internal report (RCC, 1996). A summary of the results of these investigations is presented in Figure 3-1.

Figure 3-1 Summary of Storm Tide Levels for Redcliffe

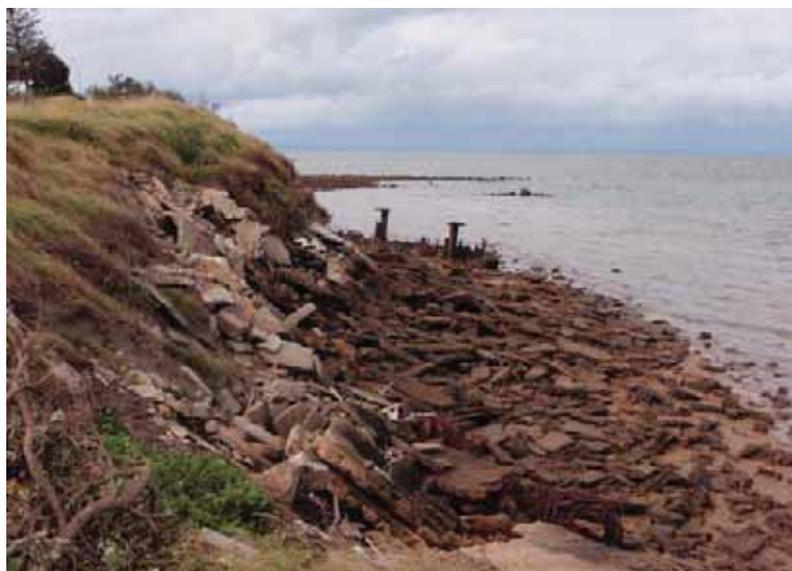
In the vicinity of the "Gayundah" wreck, there have been several uncoordinated efforts by adjacent property owners to arrest the foreshore erosion by dumping materials onto the foreshore. The armouring material consists mostly of rubble and broken concrete slabs. A photograph of the foreshore near the "Gayundah" wreck is presented in *Figure 3-2*. The resulting foreshore is not only aesthetically unattractive, but also likely to be of limited value in protecting the shoreline during significant storm events.

Figure 3-2 Uncoordinated armoring of the foreshore near "Gayundah" wreck

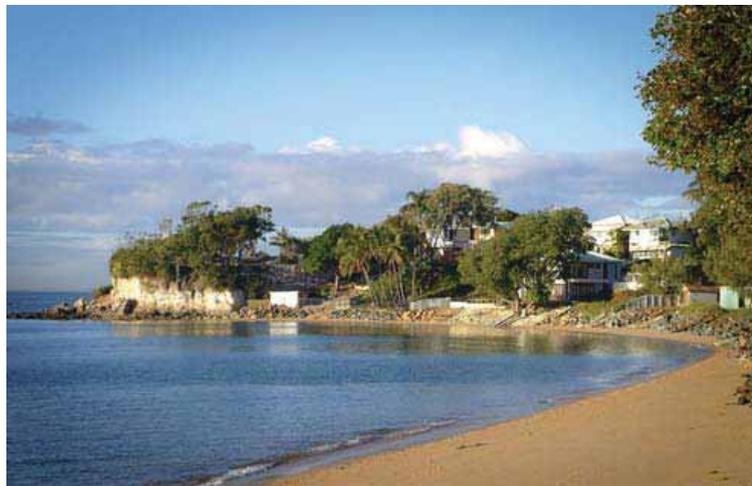
Figure 3-3 Scott's Point and Scott's Point Beach

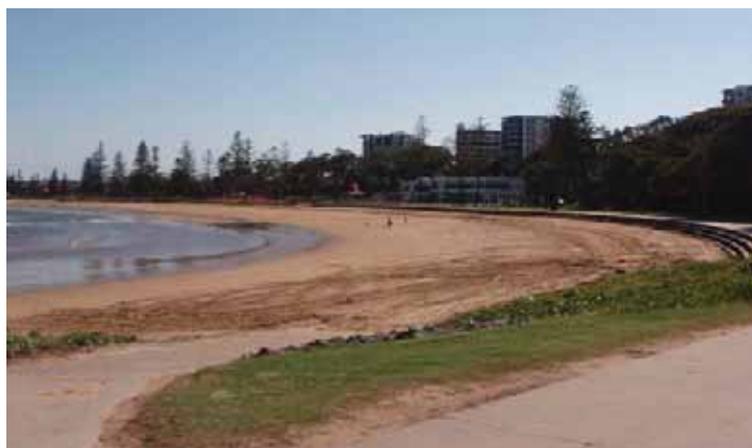
Figure 3-4 Suttons Beach

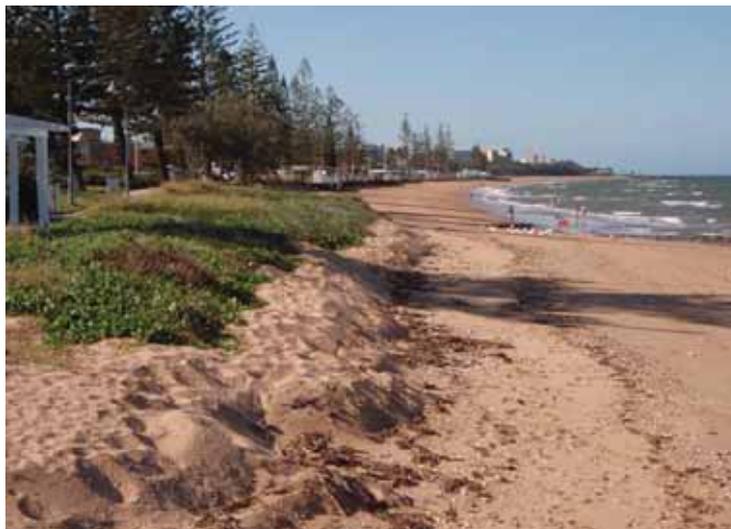
Figure 3-5 Recent dune top-up at Margate Beach

Between Woody Point Park and Mabel Street (Margate Parade) a boardwalk/footpath, the Margate Bathing Pavilion (a place of cultural significant) and some other Council buildings (eg. toilet blocks) and parts of the road on Margate Parade are located within the 16m short term erosion zone.

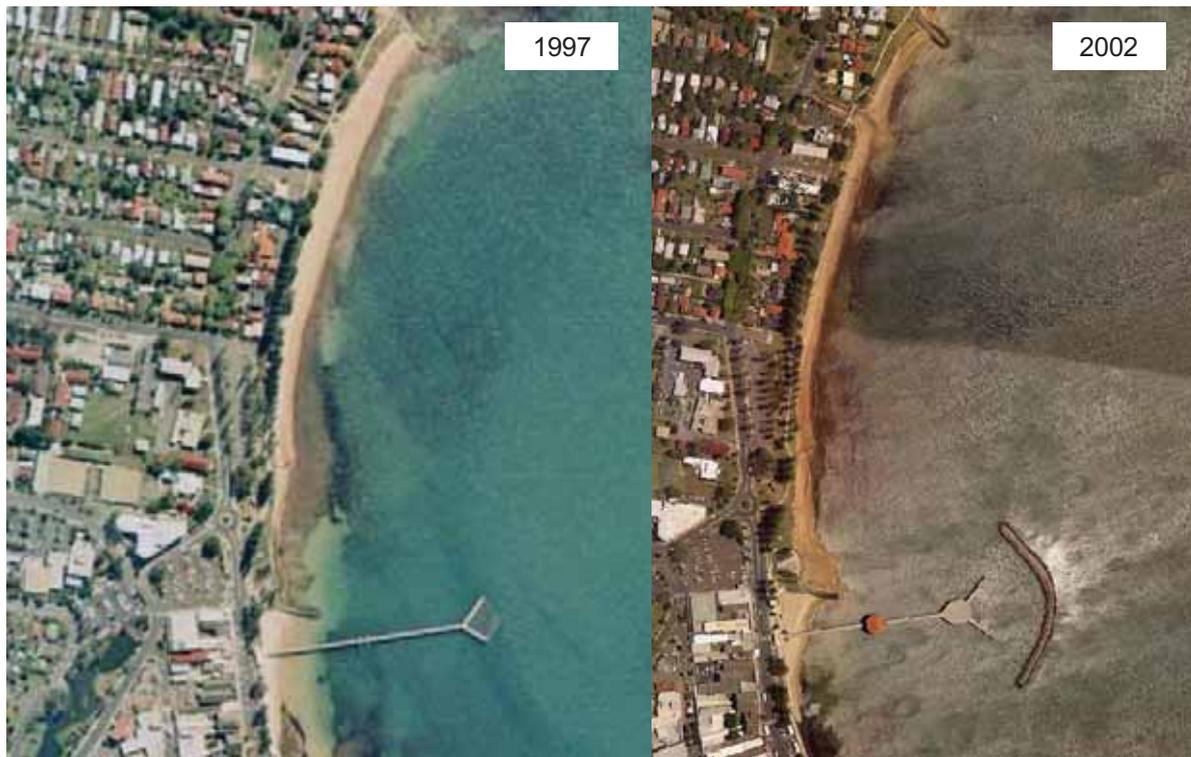
Figure 3-6 Accretion at Redcliffe Pier since construction of offshore breakwater

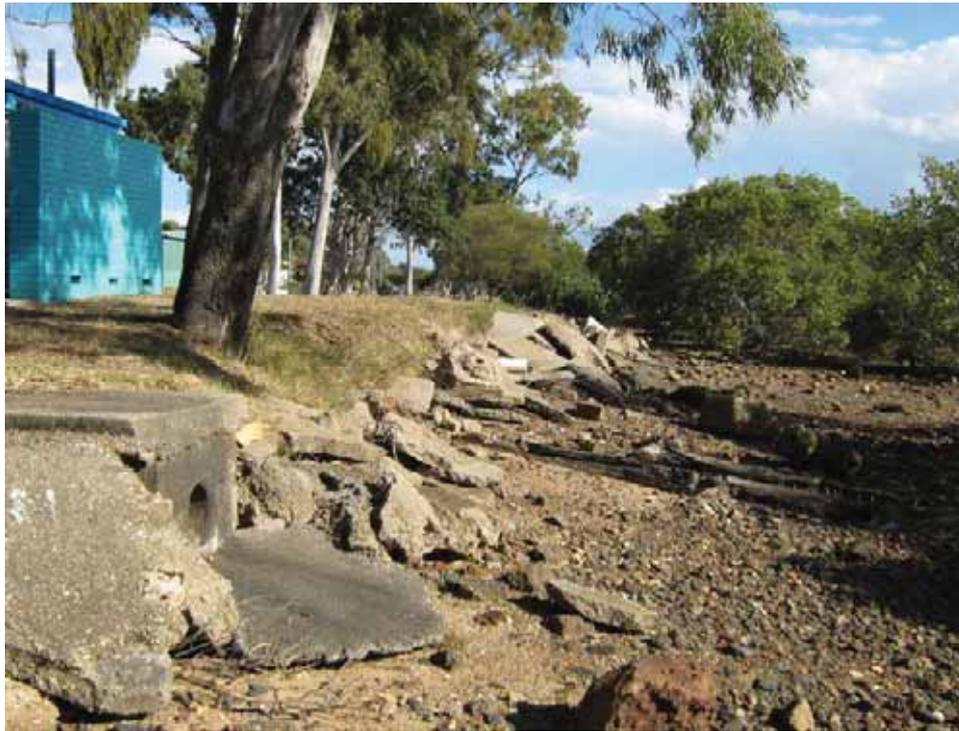
The erosion at this shoreline is due to the lack of sediment supply caused by the presence of the Scarborough Boat Harbour breakwaters and the ongoing maintenance dredging that is undertaken at the marina by Queensland Transport. Consequently, the transport of sediment from around Oyster Point has stopped. This has reduced the sand supply to the Scarborough Boat Harbour to Albatross Canal shoreline resulting in persistent erosion. The rate of erosion is relatively low because the sediment transport processes along this shoreline are expected to be low as the wave exposure of the shoreline is limited.

Figure 3-7 Dumped Rubble on Dune Front at a public toilet block near Michel Road

Most of the shoreline along Oyster Point Esplanade is fronted by mangroves. There is evidence of erosion along the 300m of shoreline immediately to the west of the Scarborough Boat Harbour and near Michel Road and rubble and broken concrete slabs have been dumped onto the dune front in an effort to prevent further erosion at a public toilet block. A photograph of the shoreline near Michel Road is presented in Figure 3-7.

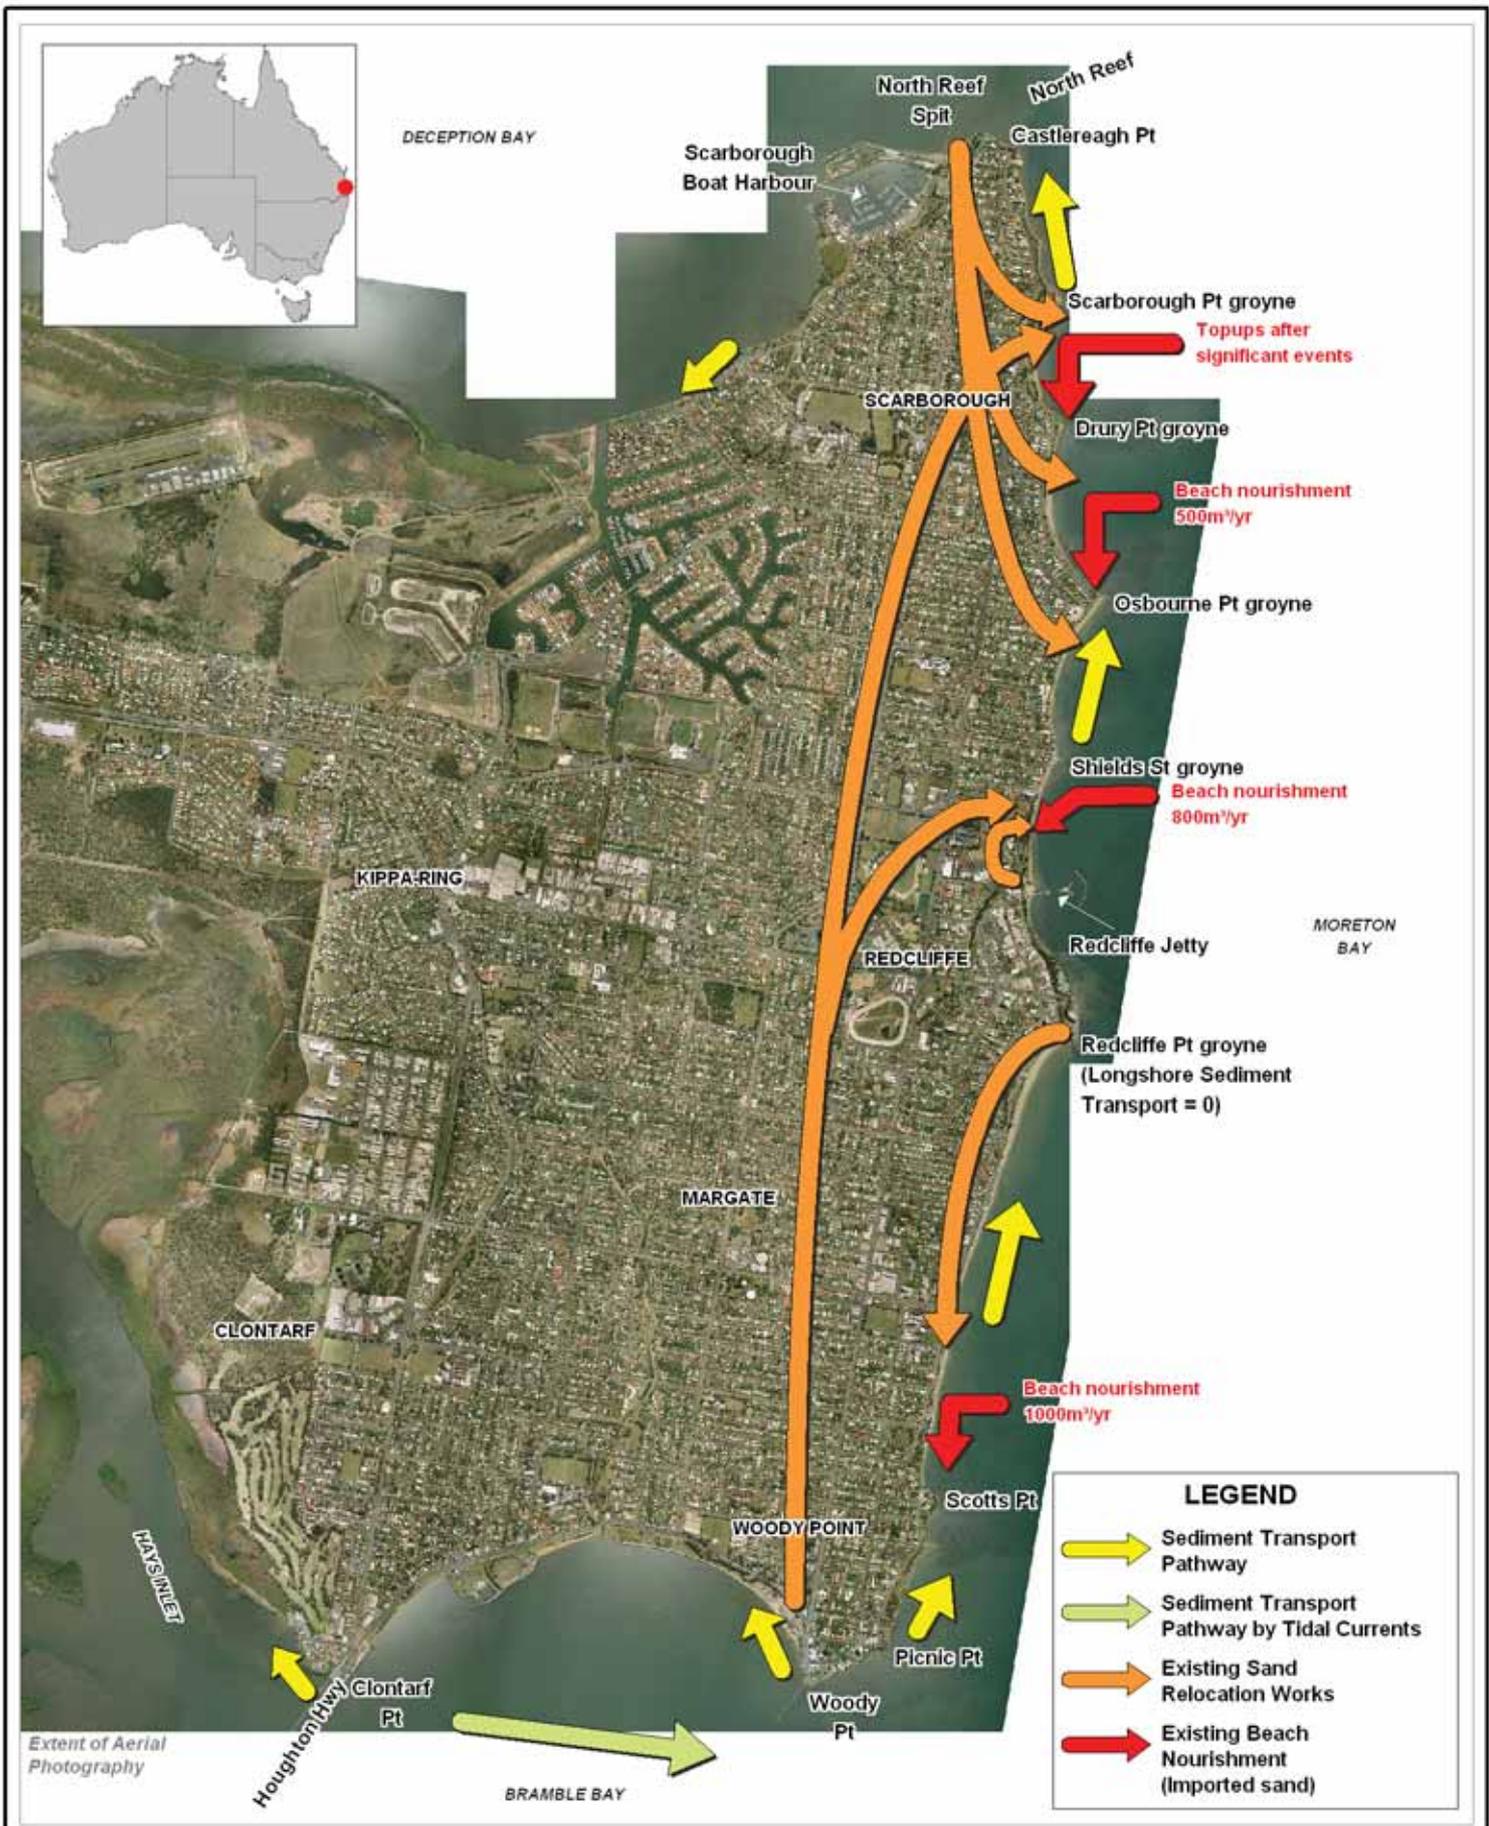
Figure: **3-8**

Title: **Sediment Transport Pathways, Existing Beach Nourishment and Sand Relocation Operations at the Redcliffe Shoreline**

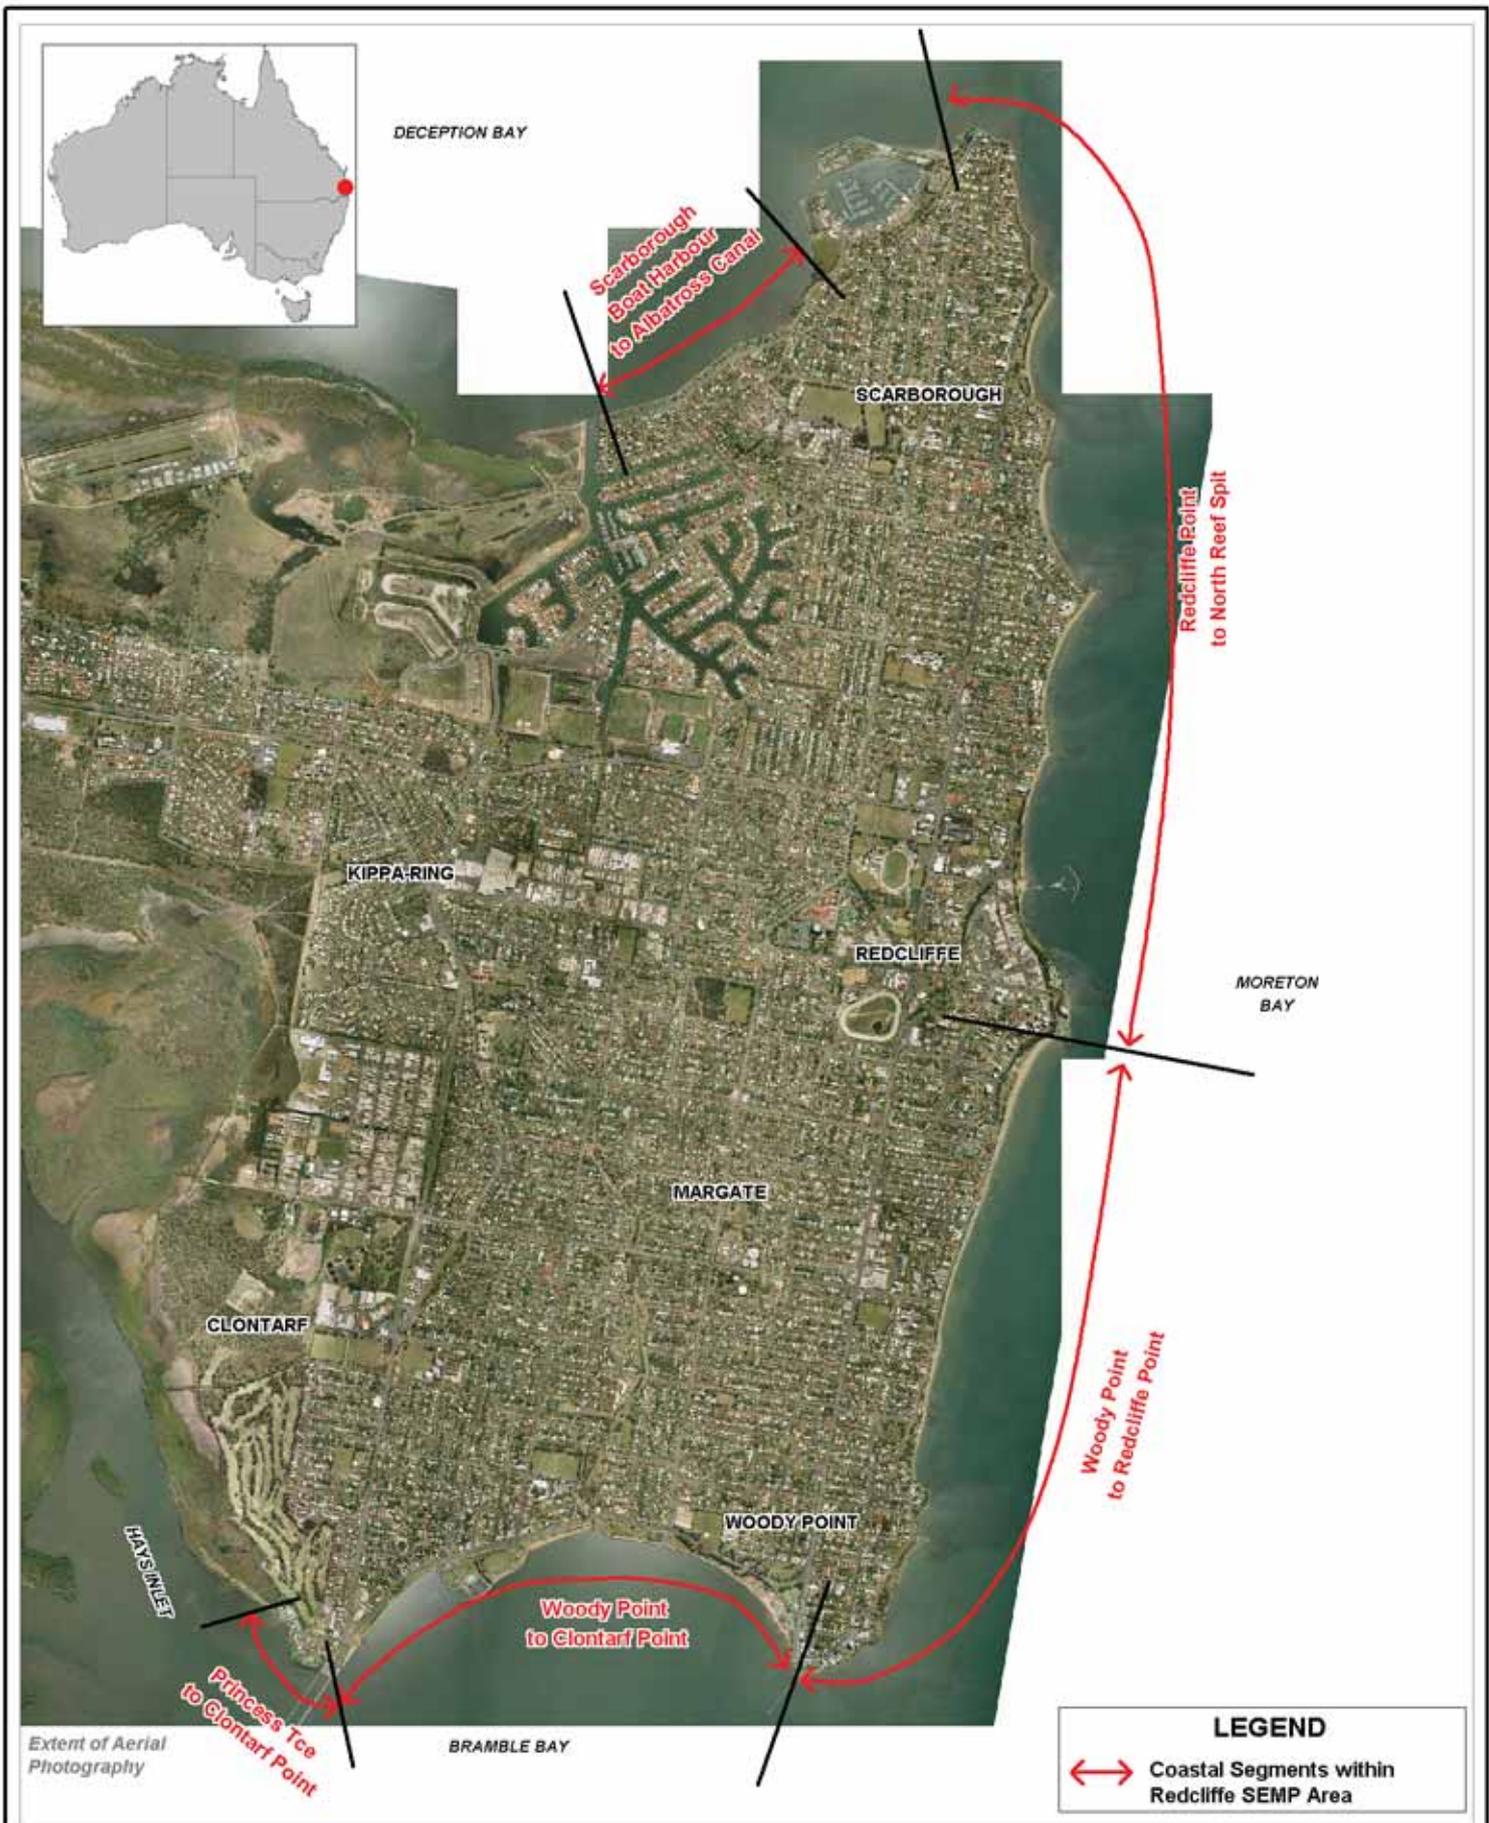
Figure:
3-9

Title:
Coastal Segments within Redcliffe SEMP Area

The sections below discuss the erosion issues and primary coastal processes that may cause these issues for each of these coastal segments. The extent of the five coastal segments is shown in Figure 3-9. The shoreline type and existing coastal structures within each segment are presented in Appendix N.
