5 Learmonth Street

5.1 Background

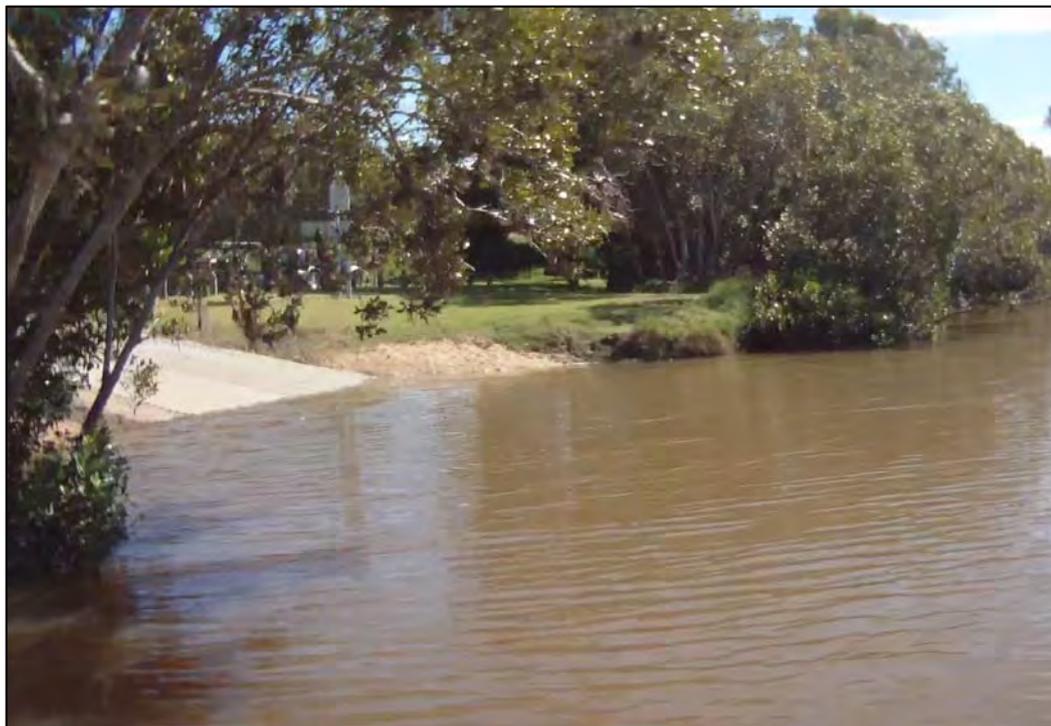
Figure 5-1 Boat Ramp at Bob Bell Park

Bob Bell Park is located along a relatively straight section of river, and therefore is exposed to relatively low erosive forcing on the bank. Much of the river bank along Bob Bell Park is lined with vegetation, which shelters the bank from erosion. The bank vegetation is cleared at a concrete boat ramp (see Figure 5-1).

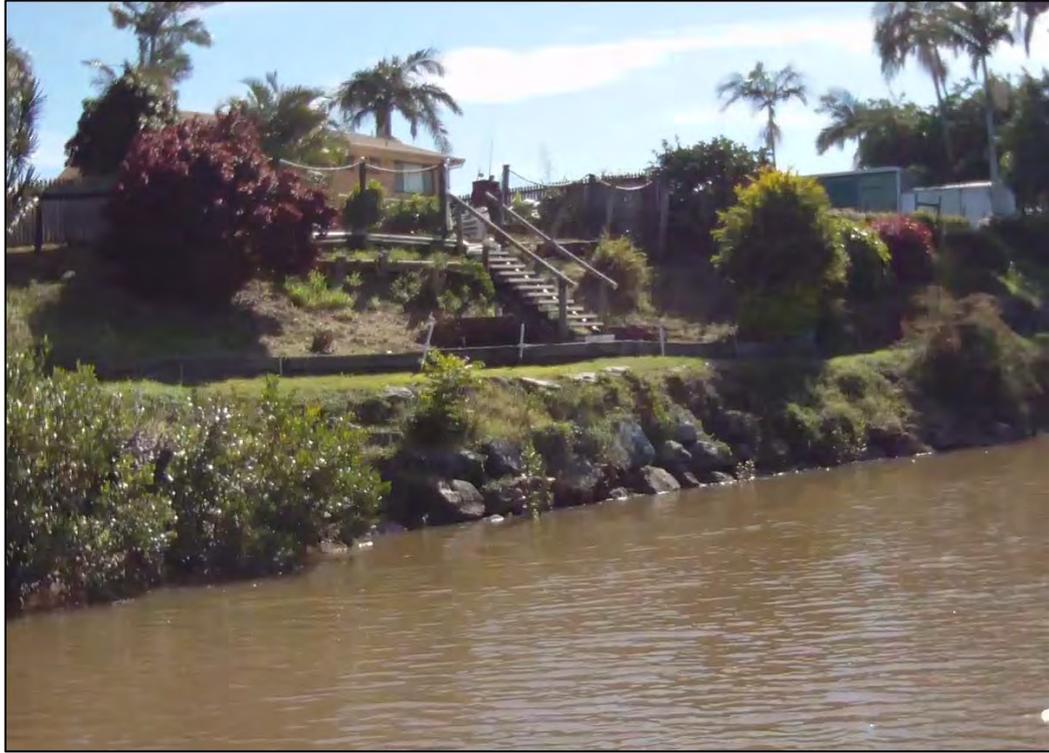
Figure 5-2 Example Private Erosion Protection (Rock Lining)

Further downstream, the river passes private dwellings on Learmonth Street. Towards the northern end of Learmonth Street the river bends at Reach 'I'. The private dwellings are on the outside bank of this bend. Thus, it is expected that erosive forces are exerted on the river bank in front of the dwellings. Private erosion protection systems have been installed by the owners of dwellings situated in close proximity to the river bend (northern portion along Learmonth Street (see Figure 5-2 and Figure 5-3). The private erosion protection appears to have functioned successfully, with little evidence of bank migration.

- Re-profiling the bank and lining with rock. This approach has been used successfully further downstream along Learmonth Street to protect residential property (see Figure 5-2 and Figure 5-3);
- Re-profiling the bank and lining with rock filled gabion mattress;

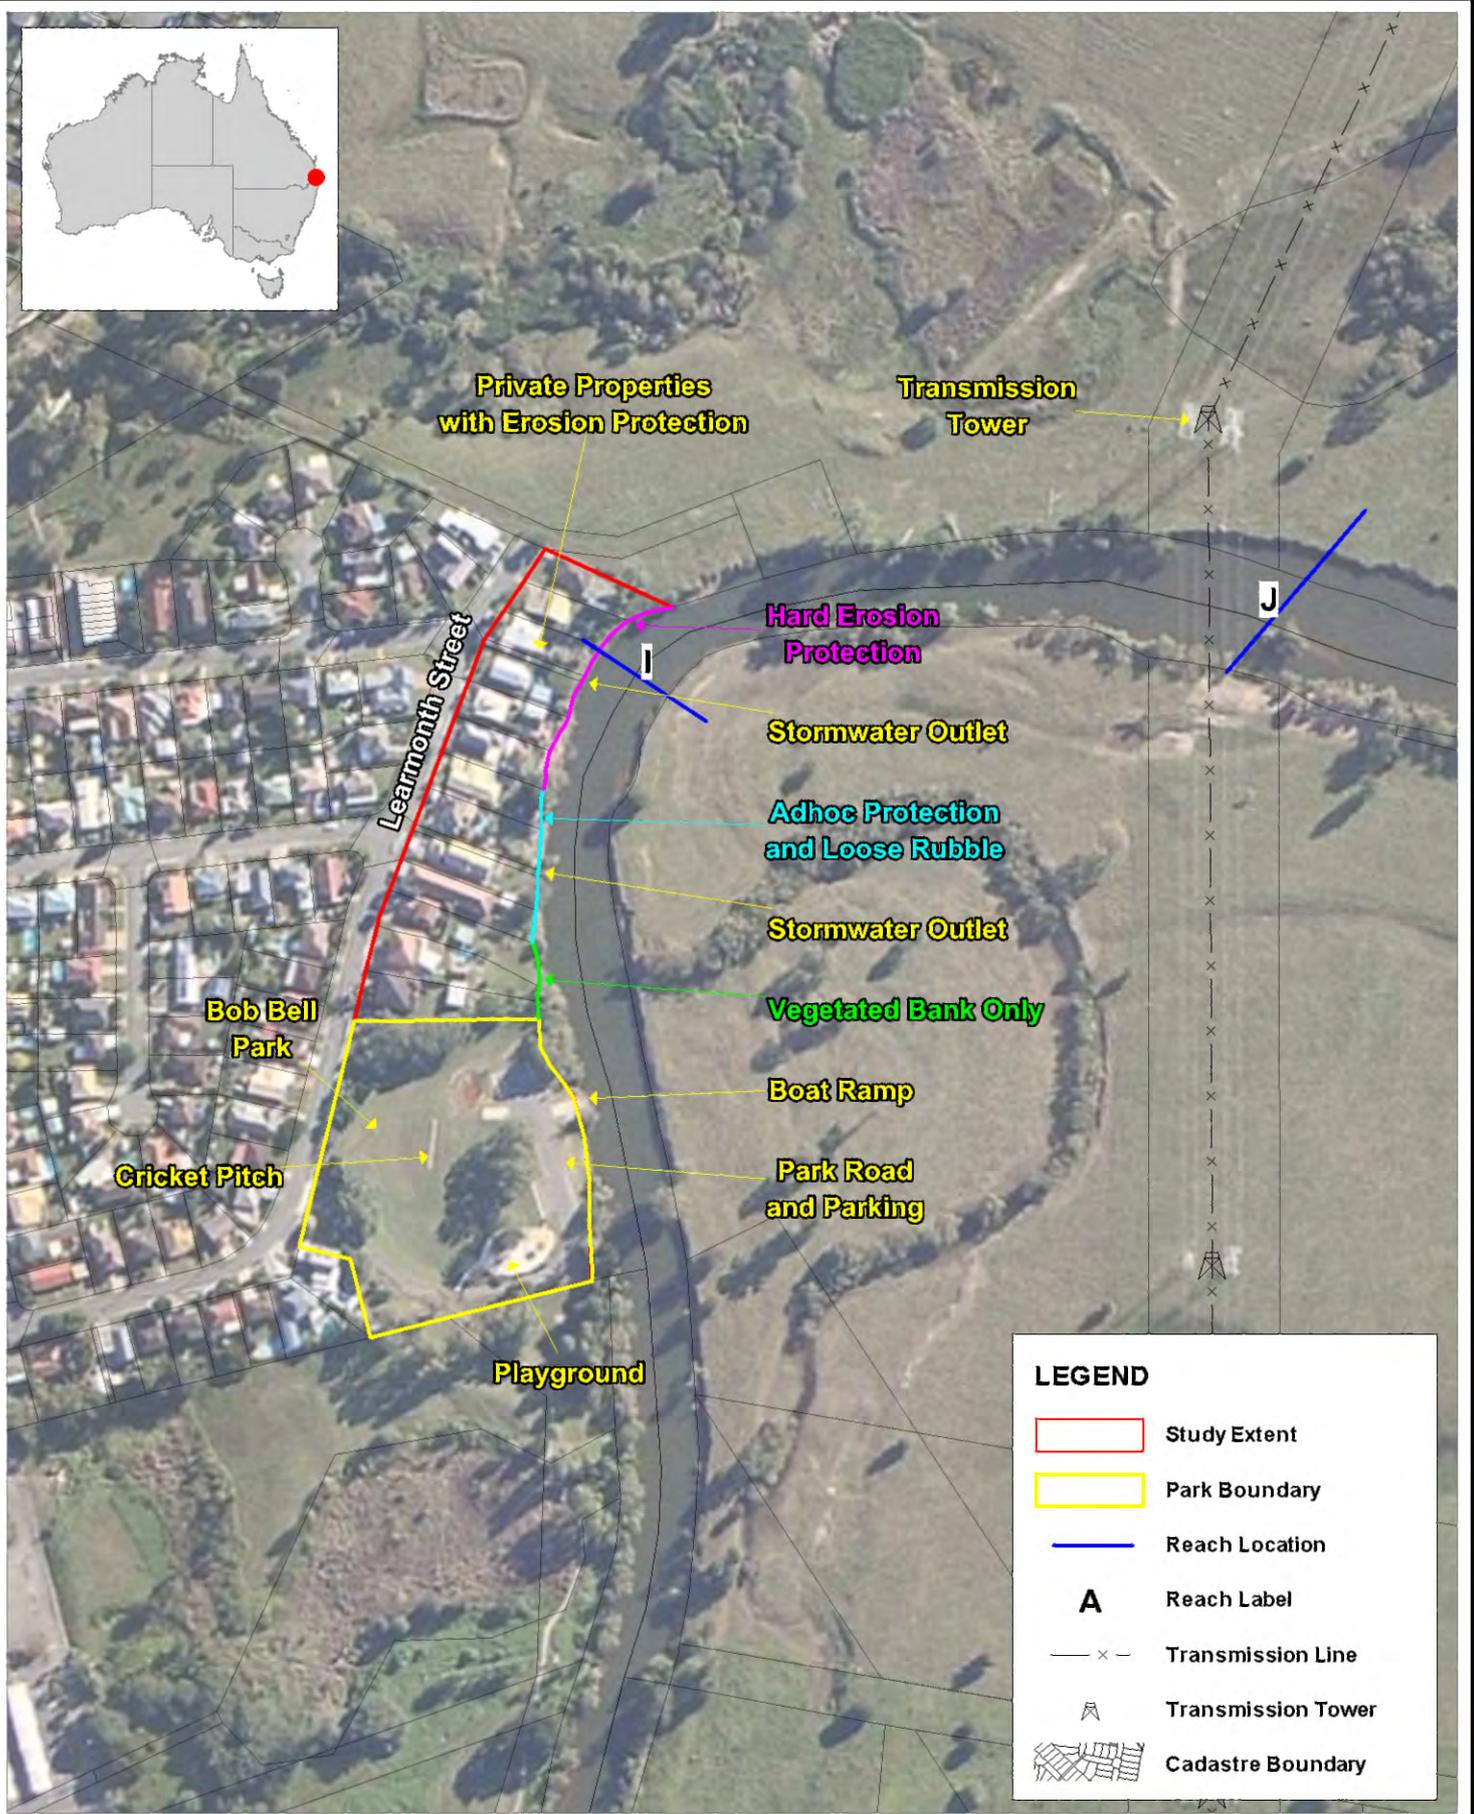
Figure:
5-3

The Learmonth street area extends from Bob Bell Park in the south up to a bend on the South Pine River (Reach 'I'). At this bend the river turns east and flows away from private dwellings along the river front on Learmonth Street (see Figure 5-3). There has been little movement in the river alignment along this reach in recent history.

Title:
Learmonth Street Layout

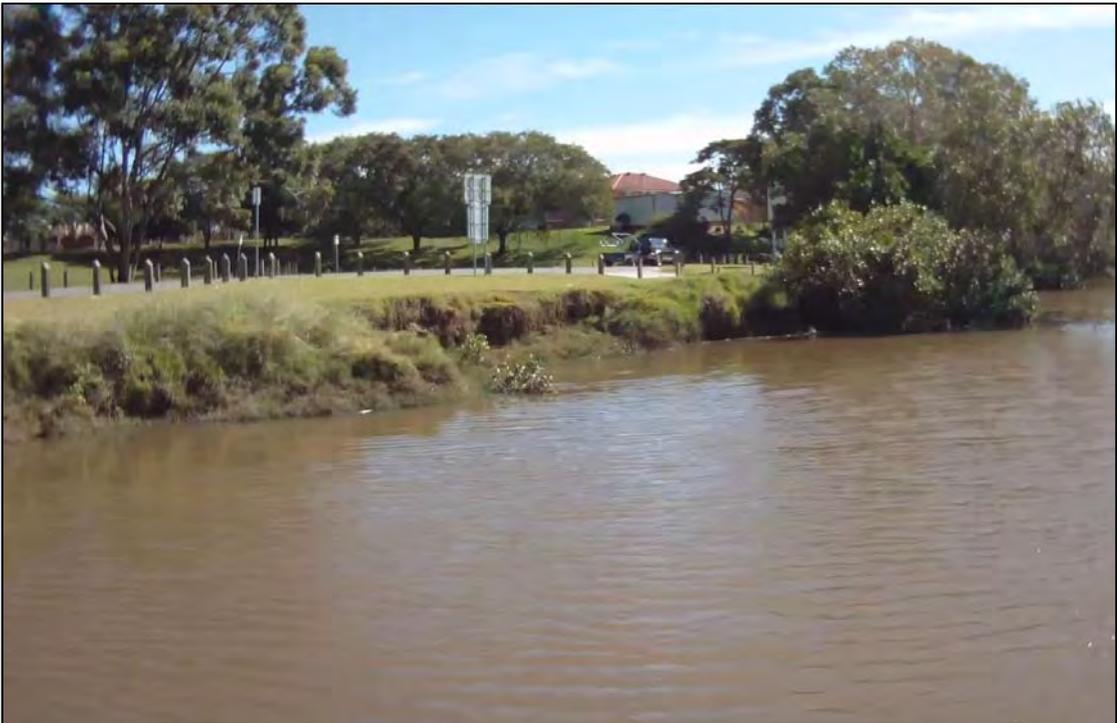
Figure 5-4 Exposed Bank at Bob Bell Park

At Bob Bell Park there is a short pocket (approximately 20m) of exposed bare earth along the bank where vegetation has been cleared (see Figure 5-4). The park road passes relatively close to this area – approximately 10m from the river bank. As such, there is little buffer sheltering the road from potential damage through bank scour.

As can be seen in Figure 5-4, there is one section along Bob Bell Park where erosion has led to minor bank slumping. The river bank slope is relatively shallow. Thus, two soft engineering options are presented below.

Given that the erosion threat is minor, and that the channel slope is relatively shallow, promotion of revegetation in isolation from other erosion protection techniques is feasible adjacent to Bob Bell Park. Mangroves neighbour this stretch reach of the river bank. Thus, effective promotion of colonisation by mangroves to the short pocket of bare bank would be a reasonable option for mitigating bank erosion in this area.

- Option C in the form of mangrove rehabilitation at a pocket of bare bank with minor bank slumping at Bob Bell Park. If this option does not prove effective, and the river bank continues to encroach towards the road, it is recommended that a hard engineered option is reverted to.
- Option D to prevent the river bank from encroaching toward the transmission tower, such as a rock filled gabion basket retaining wall structure. Hard engineered systems have a tendency to cause localised accelerations in flow at the edges where they tie into the river bank, which can lead to scour. It will be important that the design mitigates this potential for scour.

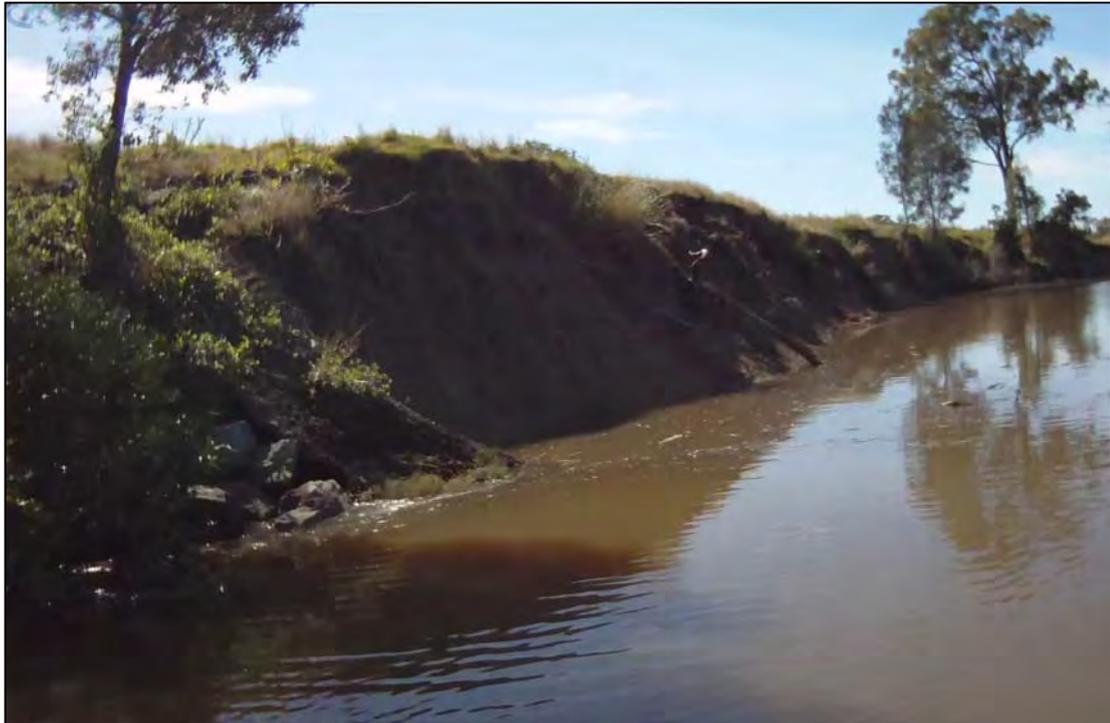
Figure 5-5 Downstream End of Learmonth Street Private Erosion Protection

The private erosion protection terminates at the northern most dwelling on the river bend. Past this point the river bank is bare. Here bank erosion is apparent in the photographic survey (see Figure 5-5). There is a risk that, in time, bank erosion in this area will undermine the adjacent private erosion protection system.
