4 Pitonga and Normanby Way

4.1 Background

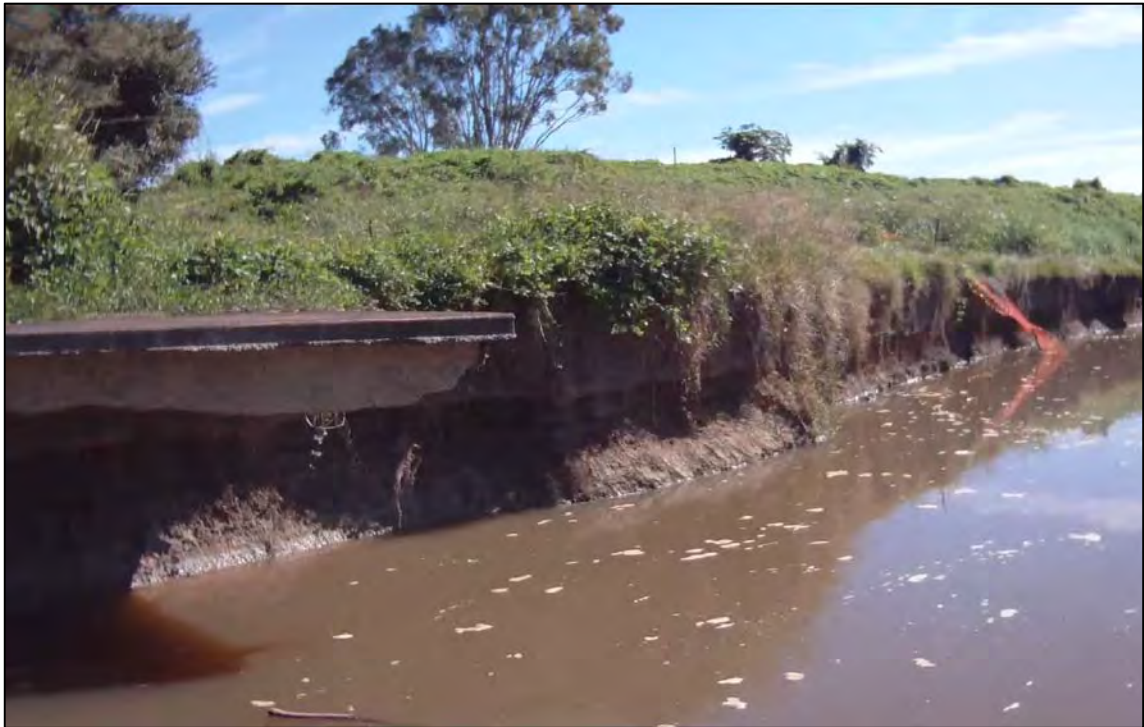
Figure 4-2 Pitonga Way Erosion

- Extensive erosion on Reach 'F' has washed away a large section of Pitonga Way (see Figure 4-2). The erosion extends through the Pitonga Way lot and into the adjacent privately owned lot (Lot 3 RP864226). Without protection, erosion of the adjacent lot will continue in a westerly direction towards the Strathpine Village residential development.

As can be seen in Figure 4-2, there are sections of channel bank where erosion has led to steep, unstable channel banks. In some areas, erosion has led to undermining and slumping failure of the bank (Reach 'F'). This presents an opportunity to rehabilitate the channel banks, by profiling the banks to a stable slope. The exposed re-profiled banks would be covered in a 'soft' erosion protection system. This may be in the form of a geotextile consisting of a woven mat, roll or bag of natural fibre or synthetic material. Additional protection of the toe of the embankment may be required; e.g. using coir rolls or a 'harder' protection such as rock roll if required. It is envisaged that this will provide erosion protection in the short to medium term. The erosion protection would be augmented by vegetation; the re-profiled banks should be seeded/planted with appropriate tidal and non-tidal riparian vegetation to promote vegetation colonisation. This will provide natural, long term erosion protection to the channel bank.

Council's assets along Pitonga Way have been destroyed, and Council's land eroded away. As such, little remains to be protected. However, a footpath linking Pine Rivers Park and Normanby Way would be a valuable public amenity, and the river bank erosion management of a future reinstated linkage would need to be considered. If Council were to acquire land in this area to re-establish Pitonga Way, the overarching management strategy would support installation of an erosion protection system to protect the asset from bank erosion – see Section 2.

It is noted that a portion of the river bank in this location falls within the Soft Erosion Protection Zone shown in Figure 2-1-3. As such, this SEMP supports the implementation of soft engineering erosion protection on private land to protect the Strathpine Village residential development. It is noted that the private lot in front of the Strathpine Village development is a separate lot, thus consent would be required from the landowner.

Should Council reinstate the Pitonga Way walkway, the erosion protection works could follow a similar approach as recommended for Pine Rivers Park. The river bank length is approximately half that of the Pine Rivers Park works. As such, the Pitonga Way works could be in the order of \$150,000 to \$600,000. There may also be cost efficiencies in installation of the Pitonga Way works together with the Pine Rivers Park works.

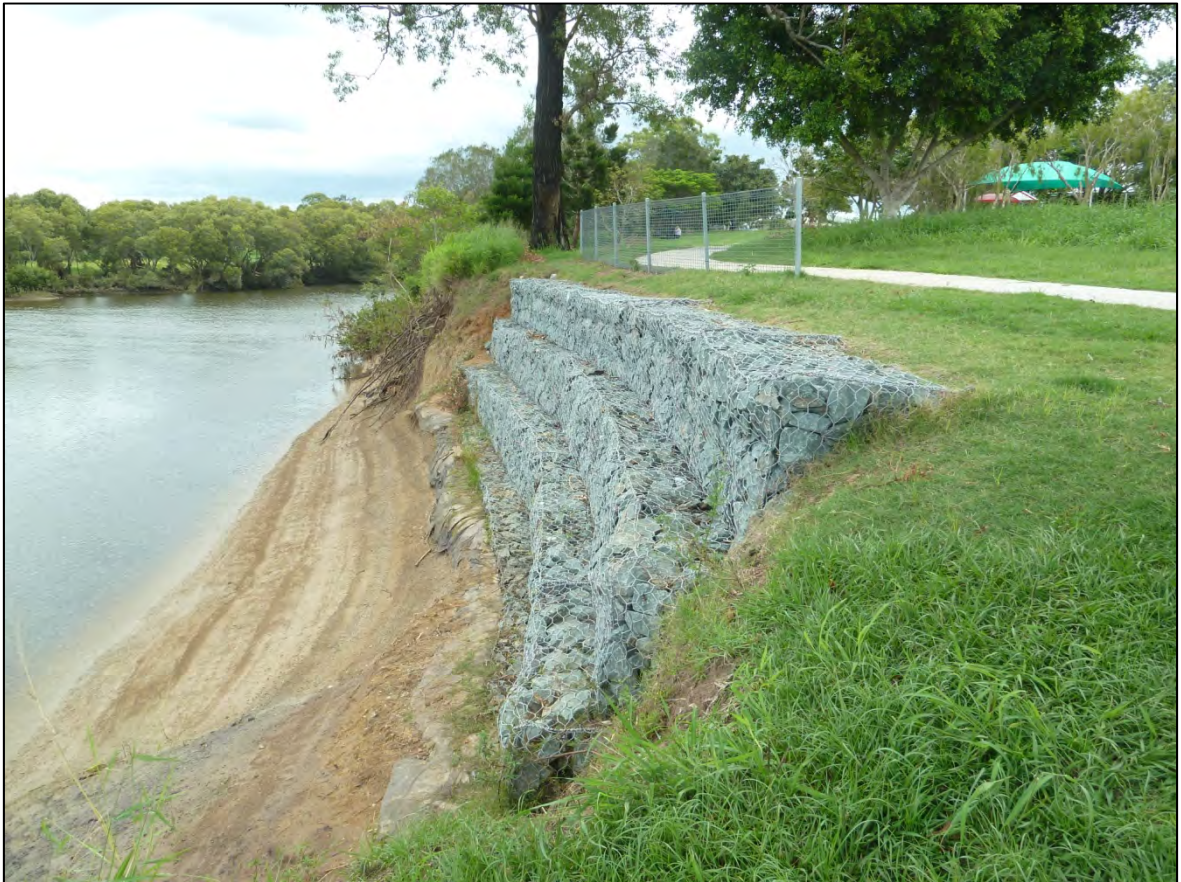
Figure 4-3 Erosion Protection on Normanby Way

- Erosion at Reach 'H' has occurred on the bank near the Normanby Way pathway. Council has mitigated this erosion by installation of a rock filled gabion basket retaining wall (see Figure 4-3). The implementation of this erosion protection structure is supported in this SPRSEMP due to:
 - The close proximity of the river bank to the concrete pathway asset;
 - The steep unstable bank slope; and
 - Continued erosion threat to the bank.

- Re-profiling the bank and lining with rock. This approach has been used successfully further downstream along Learmonth Street to protect residential property (see Figure 5-2);
- Re-profiling the bank and lining with rock filled gabion mattress;
- Re-profiling the bank and lining with interlocking concrete blocks; and
- Installing rock filled gabion basket retaining structure. This approach has been employed in a pocket of bank scour at Normanby Way (see Figure 4-3).

This option includes maintenance of the existing erosion protection on Normanby Way, whereby the monitoring programme would include a condition survey of erosion protection assets. Maintenance of the erosion protection would be triggered by the outcome of the condition survey.

The only noticeable erosion threat along Normanby Way has already been mitigated through implementation of a rock filled gabion basket retaining wall structure. This structure is considered suitable.

Portions of Normanby Way fall within the Soft Erosion Protection Zone in Figure 2-1-3. As such, this SEMP supports the implementation of further erosion protection works. However, the low erosion rates appear to offer little immediate threat to the path. Therefore, 'Option B – Monitor, Maintain and Defer' is considered suitable for this reach under current conditions. Should noticeable erosion occur, Council should consider installation of an engineered erosion protection system.
