# Woorim Beach Shoreline Erosion Management Plan

R.B16200.001.03.doc  
September 2007

## Shoreline Erosion Management Plan

Prepared For: Caboolture Shire Council

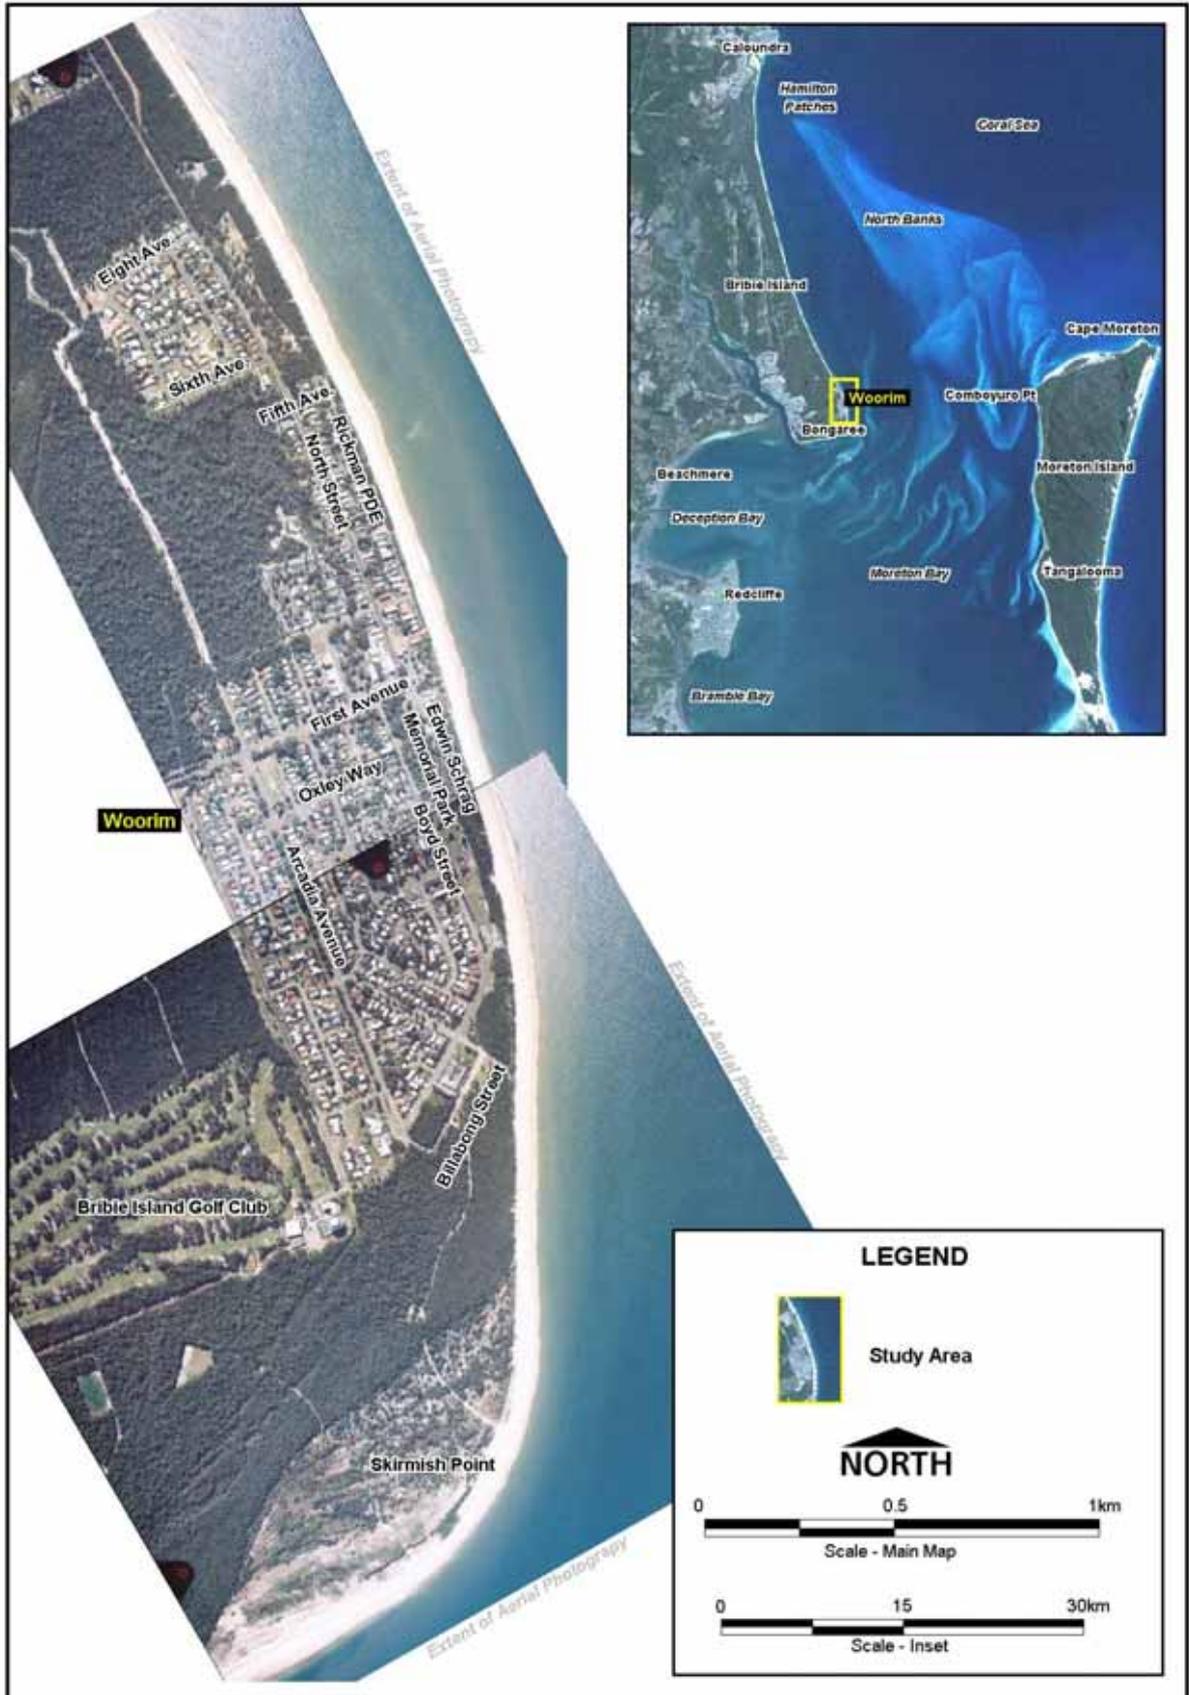
Figure 1-1 Woorim Beach

Woorim Beach is located towards the southern end of the east coast of Bribie Island (Figure 1-1). The beach sweeps in a gentle smooth curve around the southeastern part of Bribie Island. It faces east and is exposed to east to northeast ocean waves, but receives considerable protection by Moreton Island from the predominant southeast swell waves. The beach is exposed to winds and locally generated wind waves from the southeast to north sectors. The beach is backed by a substantial dune typically 5-8 metres in height.
