Basis of Design - Beachmere A-Line

Moreton Bay Regional Council
A10995
001
02
28 October 2022

Title	Basis of Design - Beachmere A-Line
Project No	A10995
Deliverable No	001
Version No	02
Version Date	28 October 2022
Customer	Moreton Bay Regional Council
Classification	BMT (OFFICIAL)
Author	Matthew Barnes
Checked By	Working draft
Project Manager	Matthew Barnes

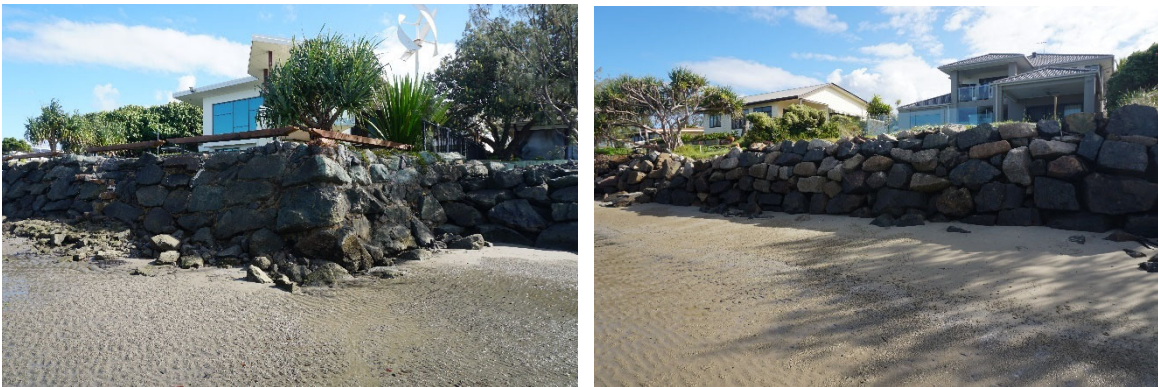
Figure 4.1 Examples of near-vertical gravity type seawalls comprised of placed boulders with mortar (left) and without mortar (right)

- 27 rock wall segments (steep vertical/near-vertical wall with square placed boulders) – see Figure 4.1
- 56 rubble slope segments
- 12 timber wall segments
- 33 segments of other assorted shoreline protection (timber retaining wall, blockwork wall)
- 71 segments identified with no practical protection.

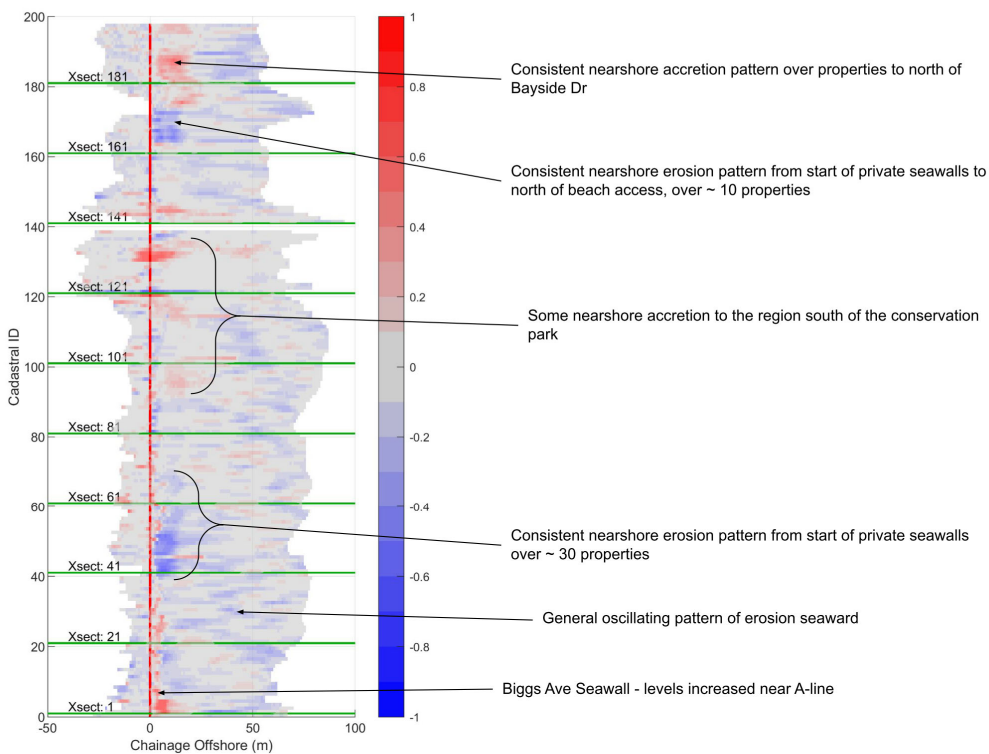
Figure 4.5 Aggregated erosion/accretion pattern on cross sections

Between 2014 and 2022, general patterns of erosion and accretion are evident, consistent with the pattern of assessed beach volumes (Figure 4.5).

Towards the southern end of each of the series of private seawalls for Biggs Ave and Bayside Dr, there is notable consistent nearshore erosion, with nearshore accretion to the north of each of these segments. Overall however, the trend is towards sand removal from the beach compartment.

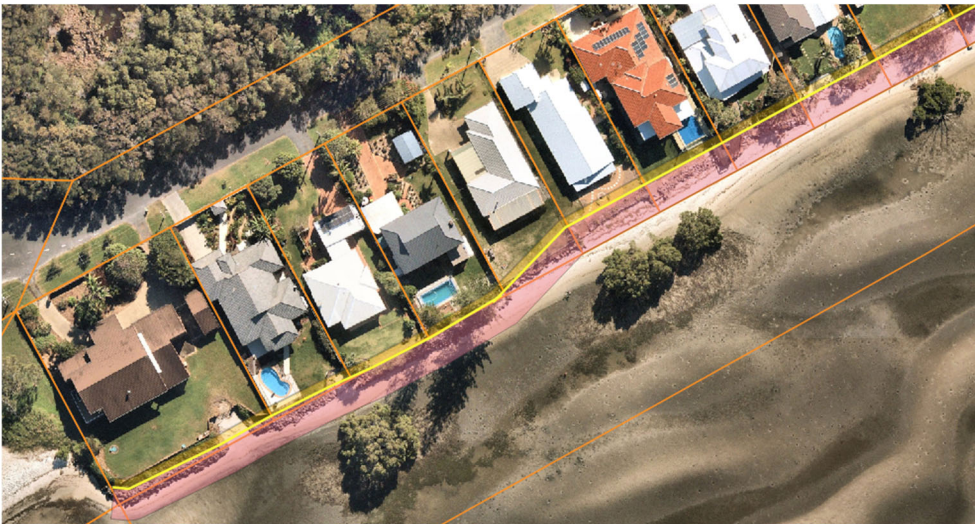
Figure 5.2 Bayside Drive South A-Line

The A-Line for the properties along Bayside Drive was developed through acknowledgement of existing seawalls, with an aim to situate the seawall footprint entirely on private land where appropriate. This approach was compromised at locations where there were significant existing structures. As seen in Figure 5.2, the southernmost 4 blocks of this segment have existing seawalls. From BMT's site inspection, these were all of good condition (Condition Rating 2), and considering the location of pools on the blocks behind, the A-Line follows the crest of these seawalls. This results in an encroachment of the A-Line total footprint onto the road reserve adjacent these blocks. Over the span of a single cadastral lot, the A-Line then transitions landward to be wholly located on private land.

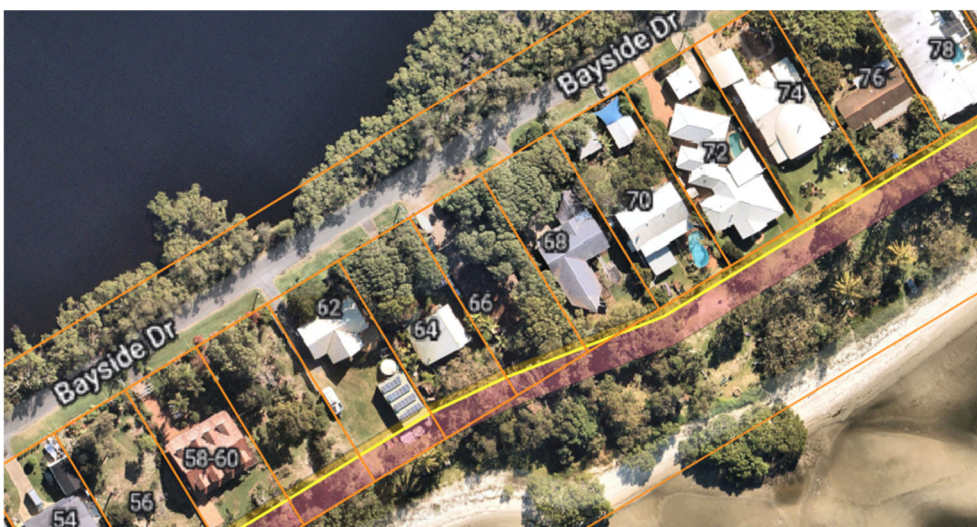
Figure 5.3 Bayside Drive North A-Line

The A-Line at northern Bayside Drive transitions such that the entire seawall footprint is situated outside the private property boundary (see Figure 5.3). This is due to significant existing lawful structures (e.g. dwellings and pools) located near the seaward lot boundary. A vegetated buffer exists between these properties and shoreline. Seawalls are not expected to be constructed until this vegetated buffer has been eroded.

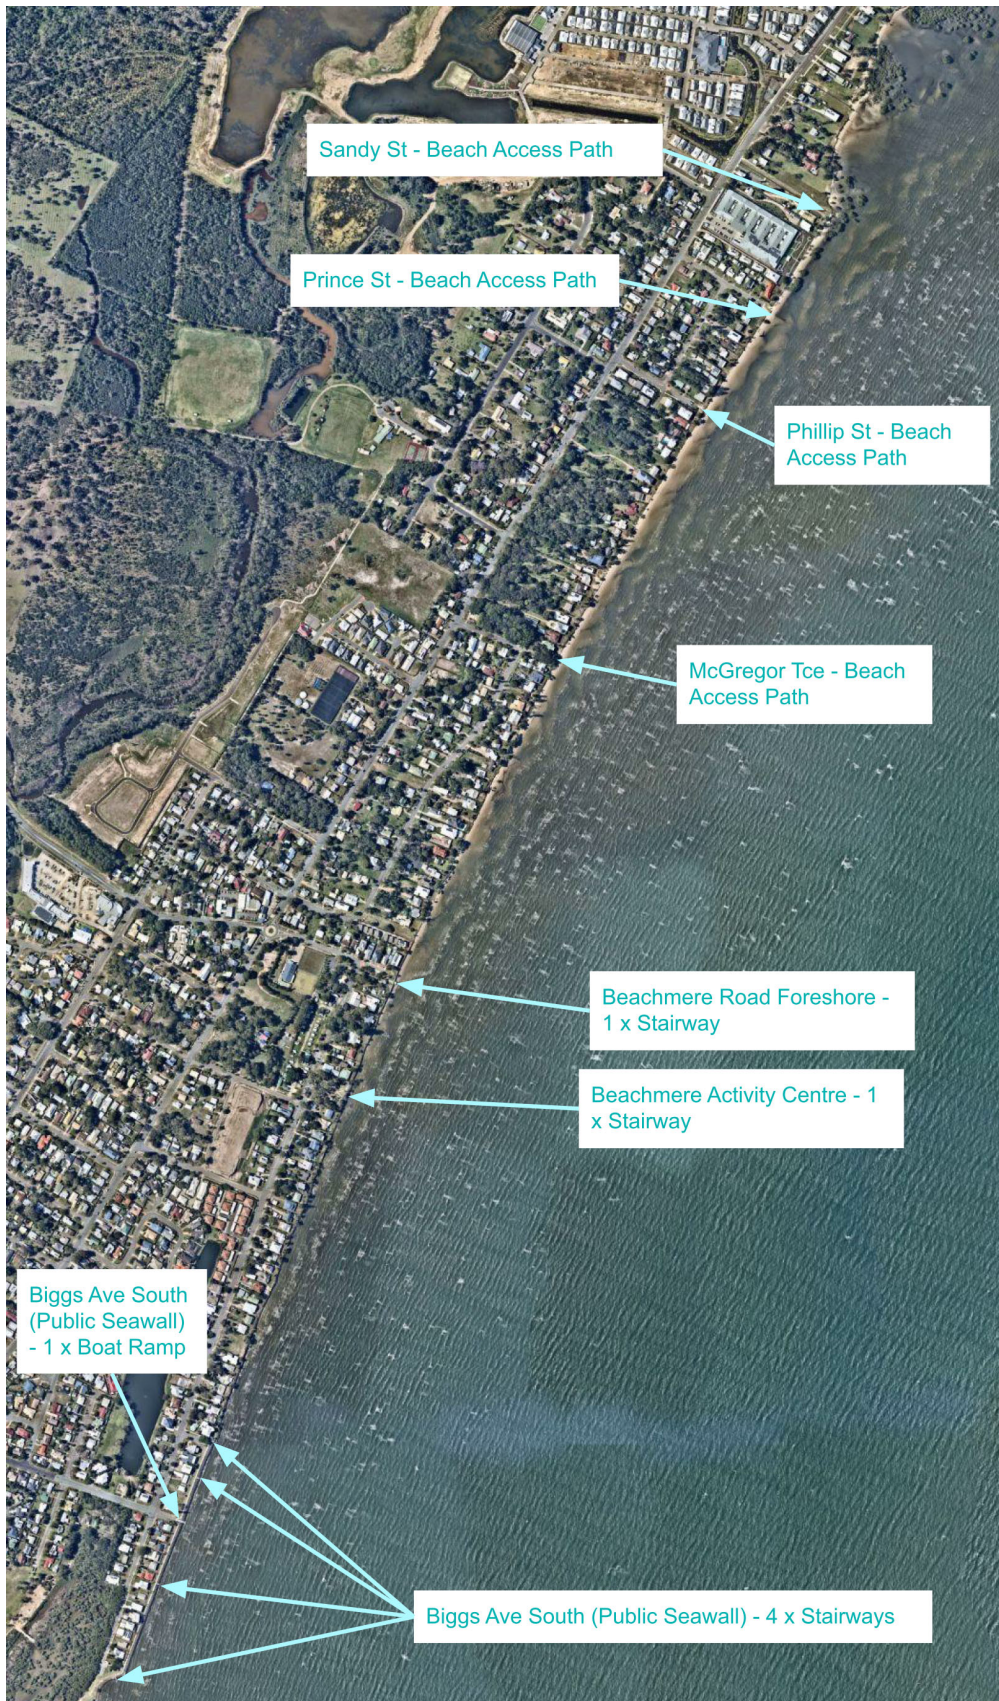
Figure 5.4 Beach access locations – Biggs Ave to Bishop Rd

For Biggs Ave to Bishop Rd (refer Figure 5.4), the current boat ramp integrated with Biggs Ave Public Seawall may be suitable for access by maintenance vehicles. Locations at McGregor Tce, Phillip St, Prince St, and Sandy St may also be amenable for access by maintenance vehicles subject to minor engineering works. The Biggs Ave boat ramp could then be expected to service the Biggs Ave seawall in addition to the southernmost private residences, while the four noted beach access points to the north are likely adequate to service private residences from Coronation Dve north.

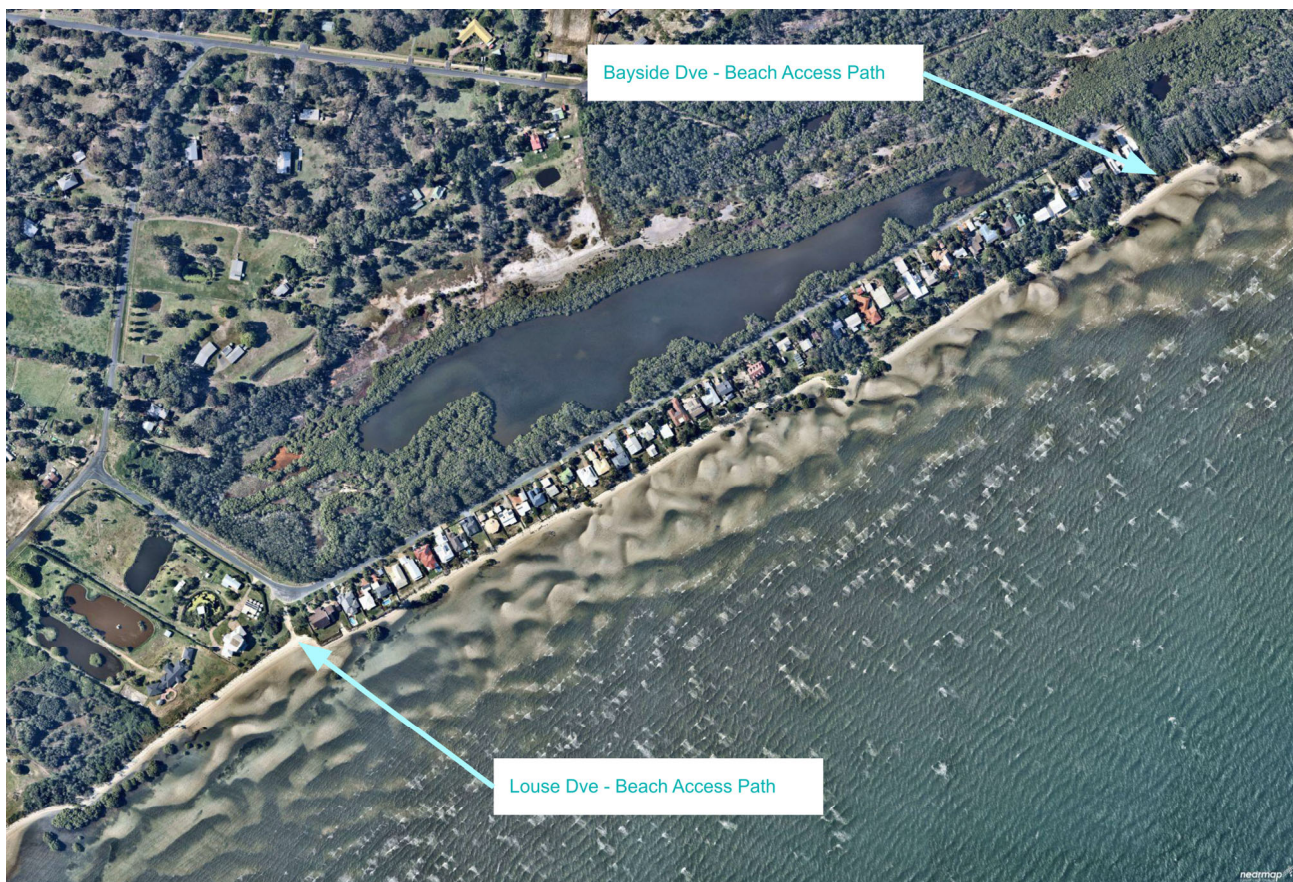
Figure 5.5 Beach access locations – Bayside Dve

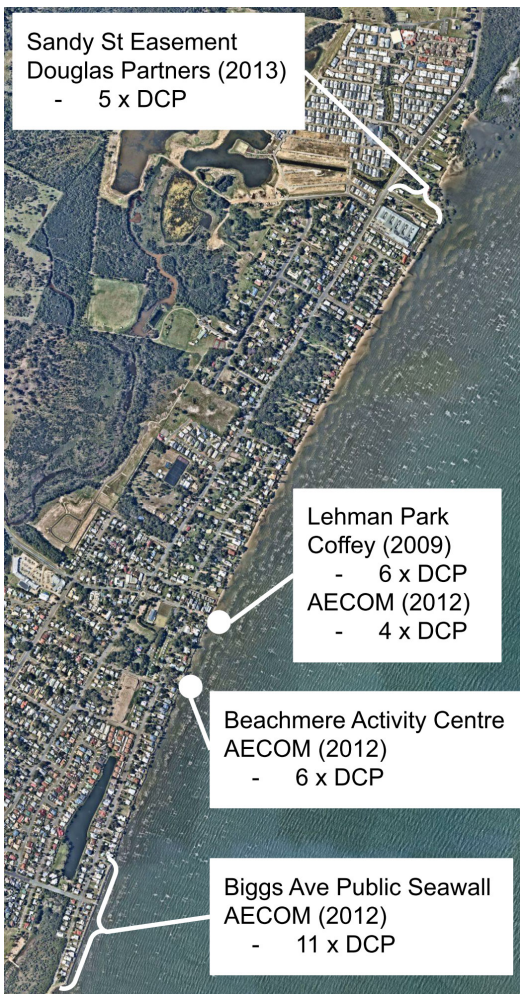
Figure 6.1 Historical geotechnical investigation sites – Biggs Ave to Bishop Rd

It is generally expected this will characterise the geotechnical conditions of the Biggs Ave – Bishop Rd extent, and most likely Bayside Dr to the north – however, further DCP testing would be required for larger seawall approvals remote to Biggs Ave. The studies were conducted to support a range of surficial structures including the Biggs Ave Public Seawall, and as a result the characterisation does not extend to large depths. The Sandy Street investigation by Douglas Partners extends inland from the coastline, while the AECOM investigation extends along the seawall frontage (on the beach), and the Coffey investigation focusses nearshore with a few boreholes located inland.

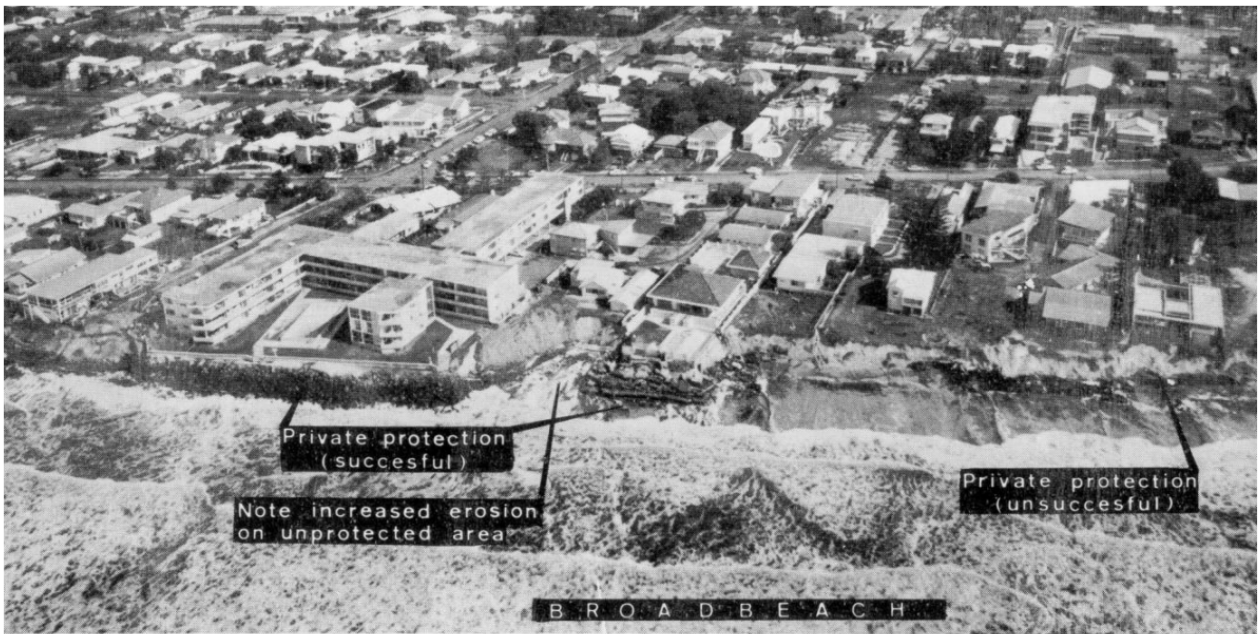
Figure 9.2 End Effects of Seawall (top) and example of successful and unsuccessful seawall terminations for private residences on the Gold Coast (bottom) (reproduced from WRL, 2012)

- Isolated Private Seawall on a single allotment – substantial seawall returns will be necessary to negotiate the cross shore effect and also allow for transition of the seawall profile from the toe level back to native bed levels. The result is a similar geometry to that indicated in Figure 9.2, resembling a breakwater head.
- Private Seawall at the end of a sequence of continuous seawalls – the required seawall return may need to extend >50m back from the A-line along the edge of the property to provide adequate protecting against flanking erosion. This is obviously a substantial imposition for a property of this nature.

It is likely to be advantageous for multiple properties to build their seawalls at the same time and to subsidise the additional cost of the seawall terminations whilst avoiding the cost of individual frontage terminations within the property confines.
