5. Bongaree North to Bellara

Moreton Bay Regional Council
Shoreline Erosion Management Plan

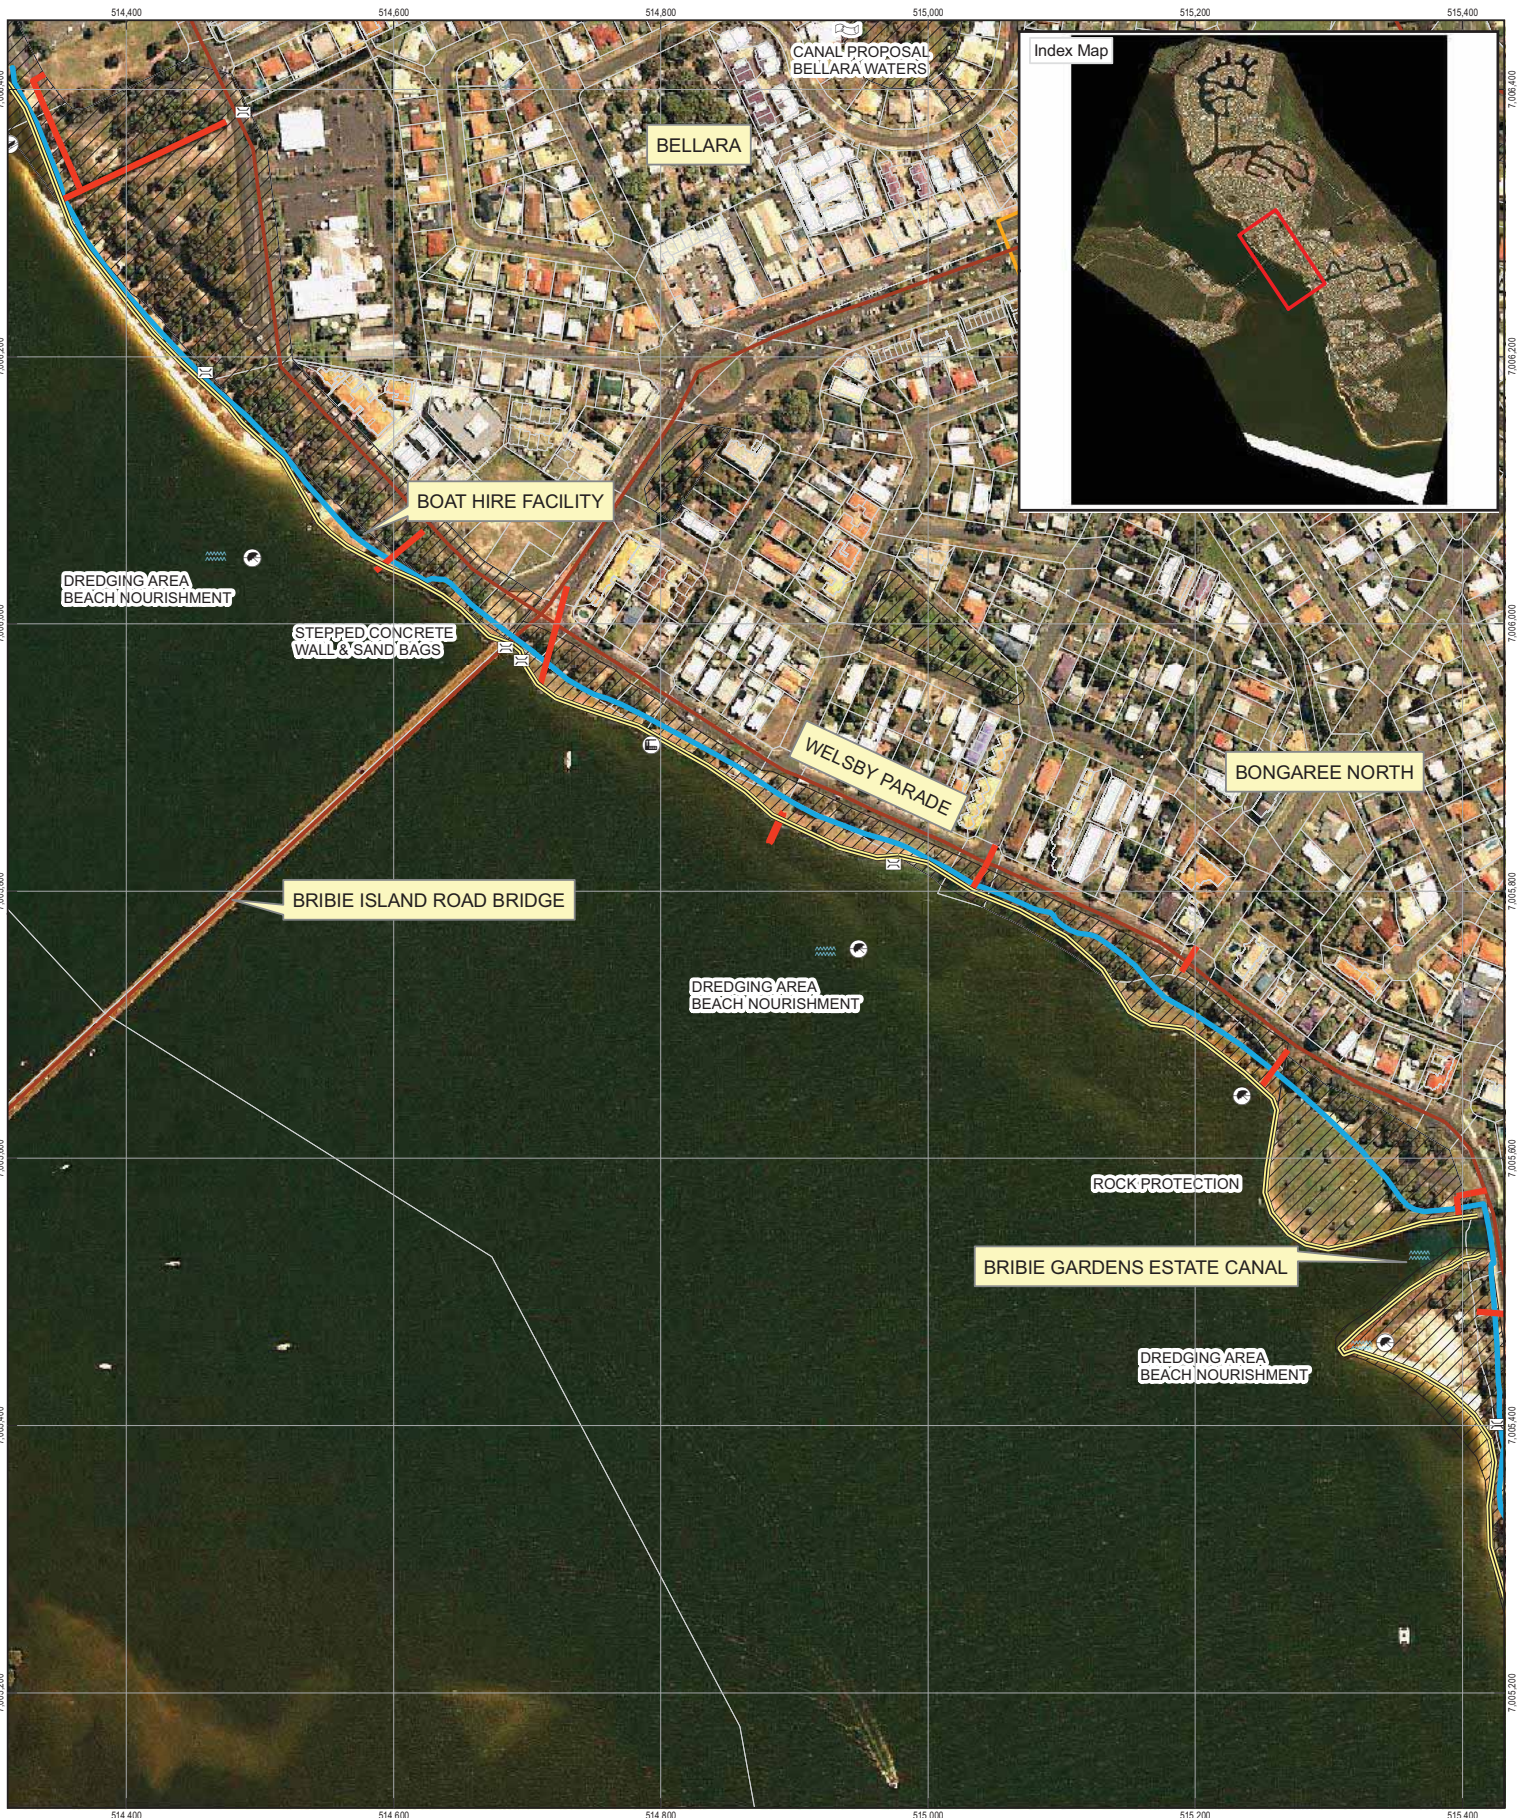
Figure 27

The study area extends from Bribie Gardens Estate to the northern side of Bribie Island Bridge on the western coastline of Bribie Island over a section of approximately 1.3 km distance (refer to [Figure 27](#)). The land tenure along the foreshore in this section consists of esplanade/foreshore and road reserve under the trusteeship of Moreton Bay Regional Council.

**Bongaree North to Bellara -
Locality Plan**

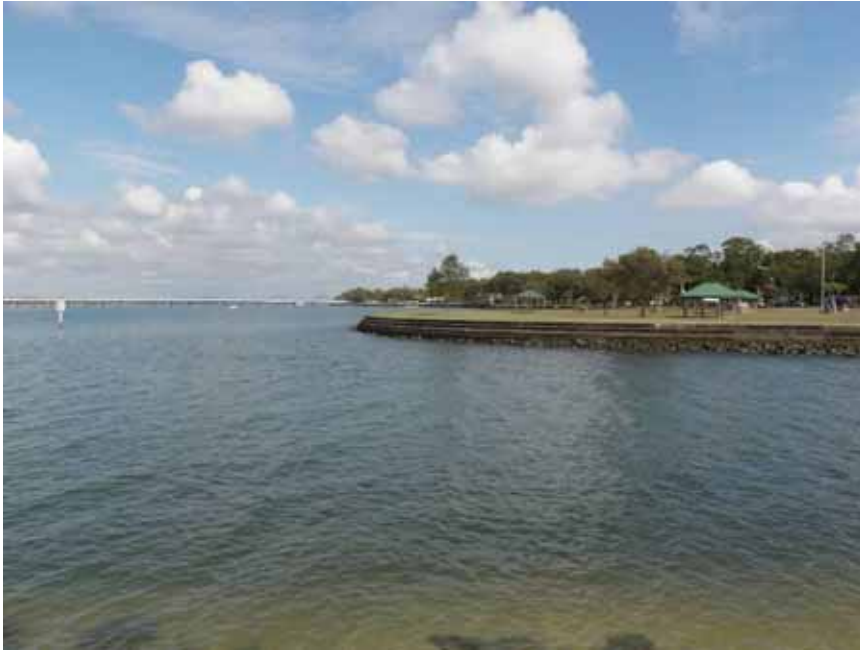
Photo Plate 5-1 Bribie Gardens Estate canal northern entrance

The canal at the Bribie Gardens Estate features a rock groyne that protects the entrance to the canal on both sides (refer to [Photo Plate 5-1](#)). A sea wall extends from the northern side of the groyne to the bridge, which is largely exposed and has been further protected by rocks (refer to [Photo Plate 5-2](#) and [Photo Plate 5-3](#)). There is no sand build-up and no beach at low tide, apart from a small area of beach at low tide immediately south of the bridge (refer to [Photo Plate 5-4](#)). A large area of parkland and picnic facilities has been established behind the seawall north of the rock groyne.

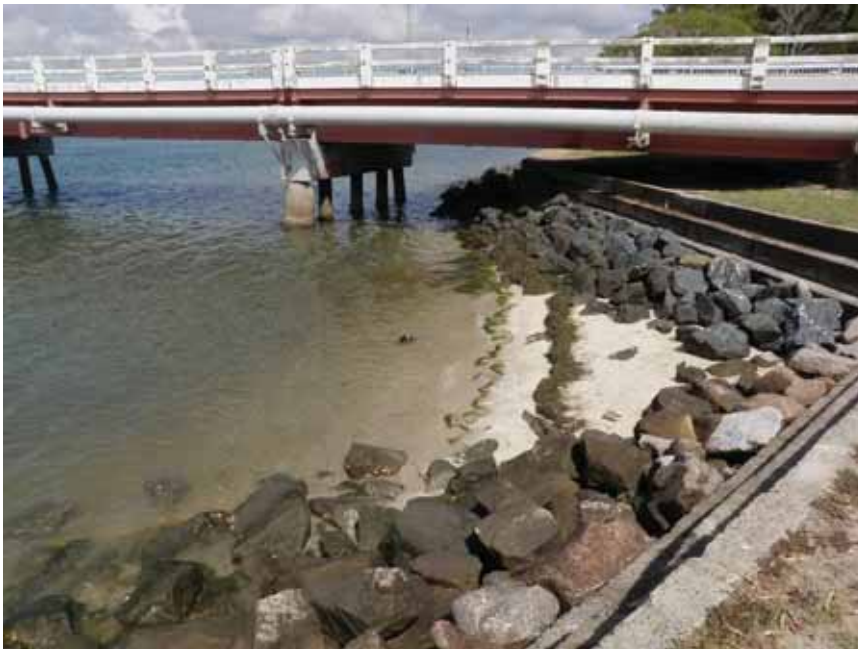
Source: GHD 21/12/2009 14:17

North of the Bribie Island Bridge, the sea wall continues (refer to [Photo Plate 5-5](#) and [Photo Plate 5-6](#)) with some added protection in the form of rock placement up to four metres wide, large sand bags, and some timber groyne structures. The sea wall appears to be destabilised in the area of the boat hire company, where steps are located for access to the water (refer to [Photo Plate 5-7](#)). A grassy sand spit is located north of the timber groynes. There is a dense stand of coastal cypress behind the boat hire company site.

Photo Plate 5-5 Sea wall and sandbags north of bridge

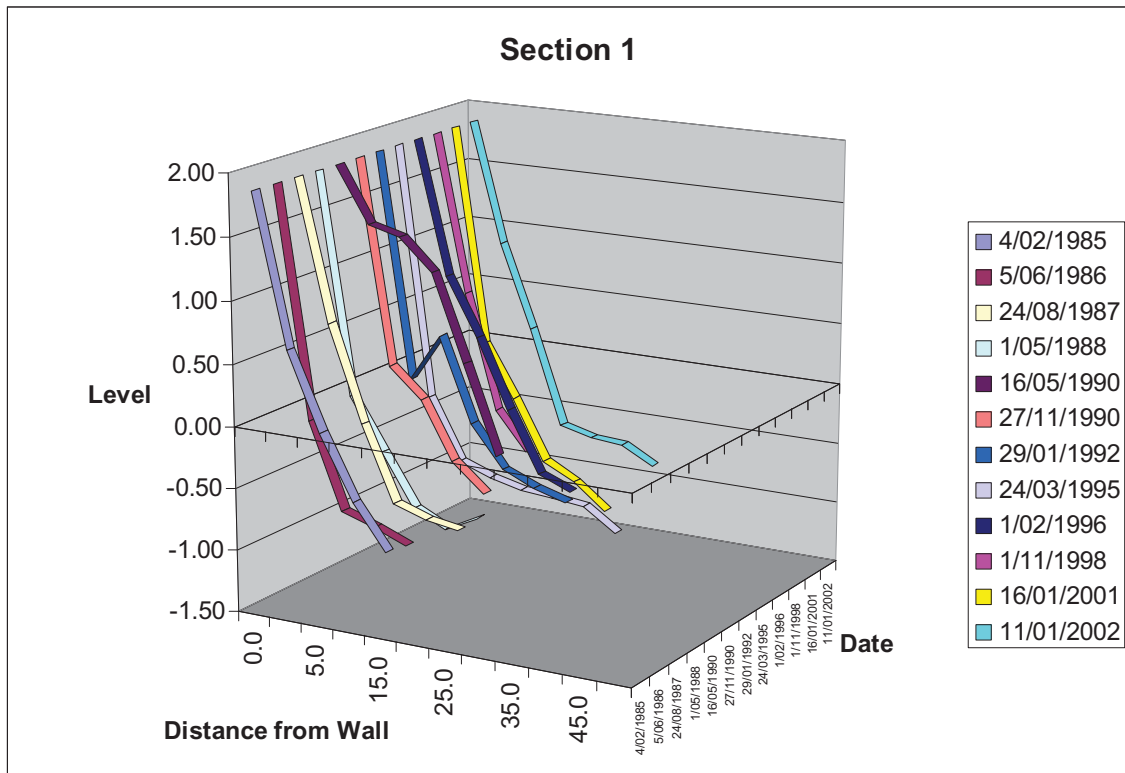
Between 1985 and 2002, the Council carried out a monitoring program consisting of regular repetitive surveys of a number of fixed cross sections across the foreshore. A preliminary analysis of the data from one of these locations south of the Bribie Bridge opposite Ferguson Avenue has been undertaken and the results are presented in the following plot. The plot shows the variation of the foreshore shape with time. Note the temporary buildup of sand in May 1990 is probably associated with the movement of a “sand slug” progressing through the section from the south. Smaller “sand slugs” are evident in 1992 and 2002.

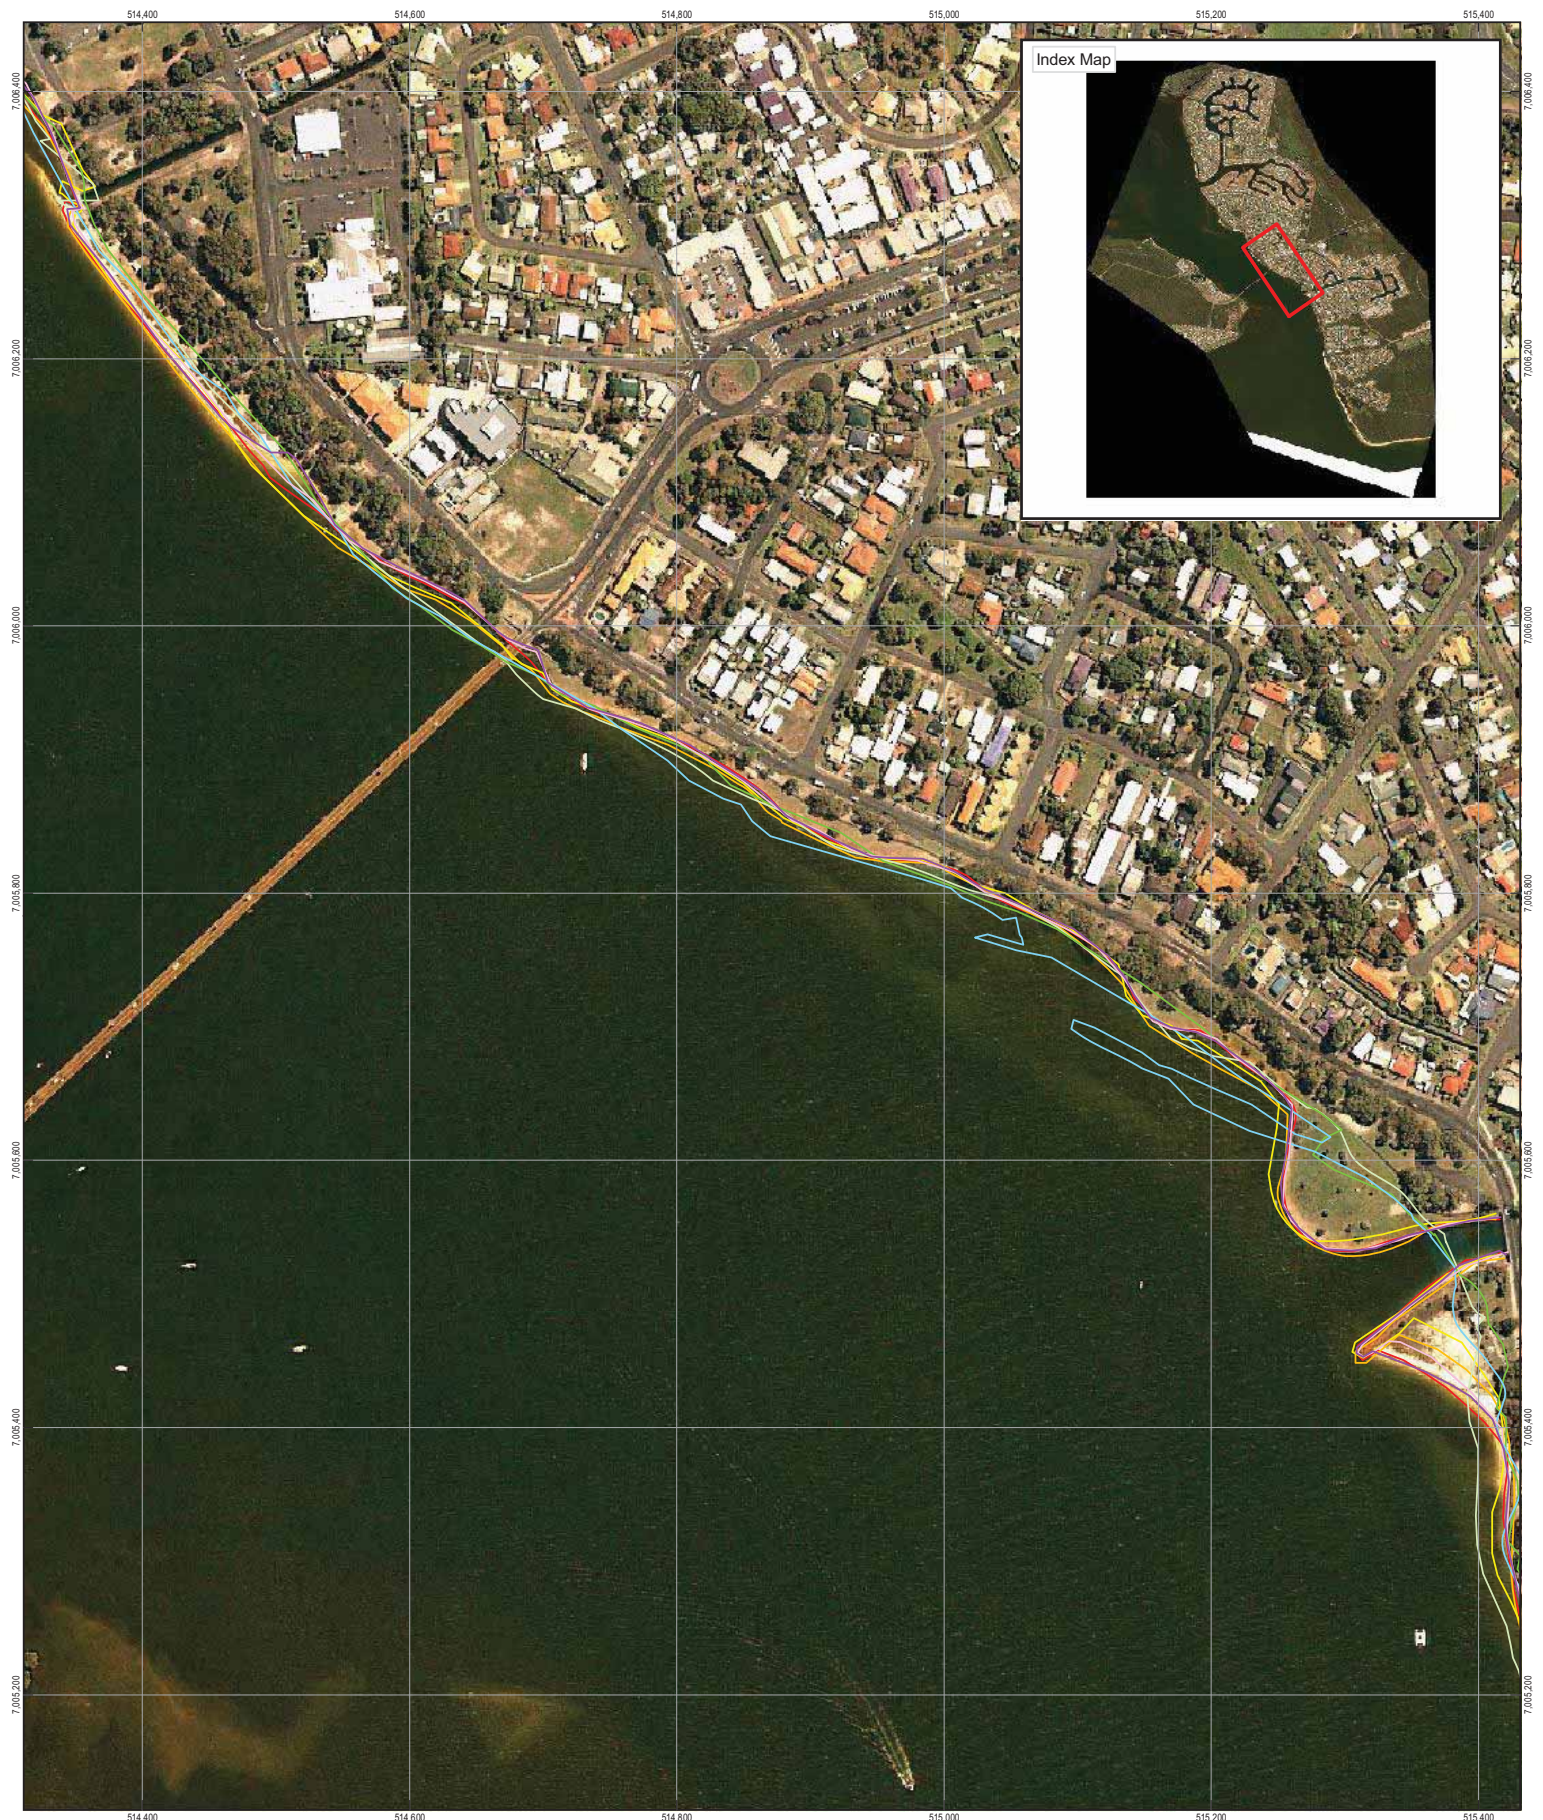
Figure 28

Aerial photography captured in 2009 shows no recreational beach at all along the entire beach compartment at high tide, indicating that further significant beach lowering has occurred. Details of the shoreline movement and the change in vegetation has been shown in [Figure 28](#) and [Figure 29](#).

The northern end of this section north of the Bribie Island Bridge appears to be quite stable, with very little shoreline changes over the period of photography. By 1982 however, narrowing of the shoreline at the southern end of the beach adjacent to the Bribie Island Bridge was starting to appear. Progressive narrowing was again evident in 1990, but by 1999 the shoreline along the entire beach compartment had been fixed by the construction of a stepped revetment wall. In 2010 there is now no recreational beach until approximately 100m north of the bridge, and the toe of the revetment has been reinforced with rock armour and sandbags. Close to the southernmost end of the recreational beach, there is evidence of the recent construction of a small timber groyne.

**Bongaree North to Bellara -
Shorelines**

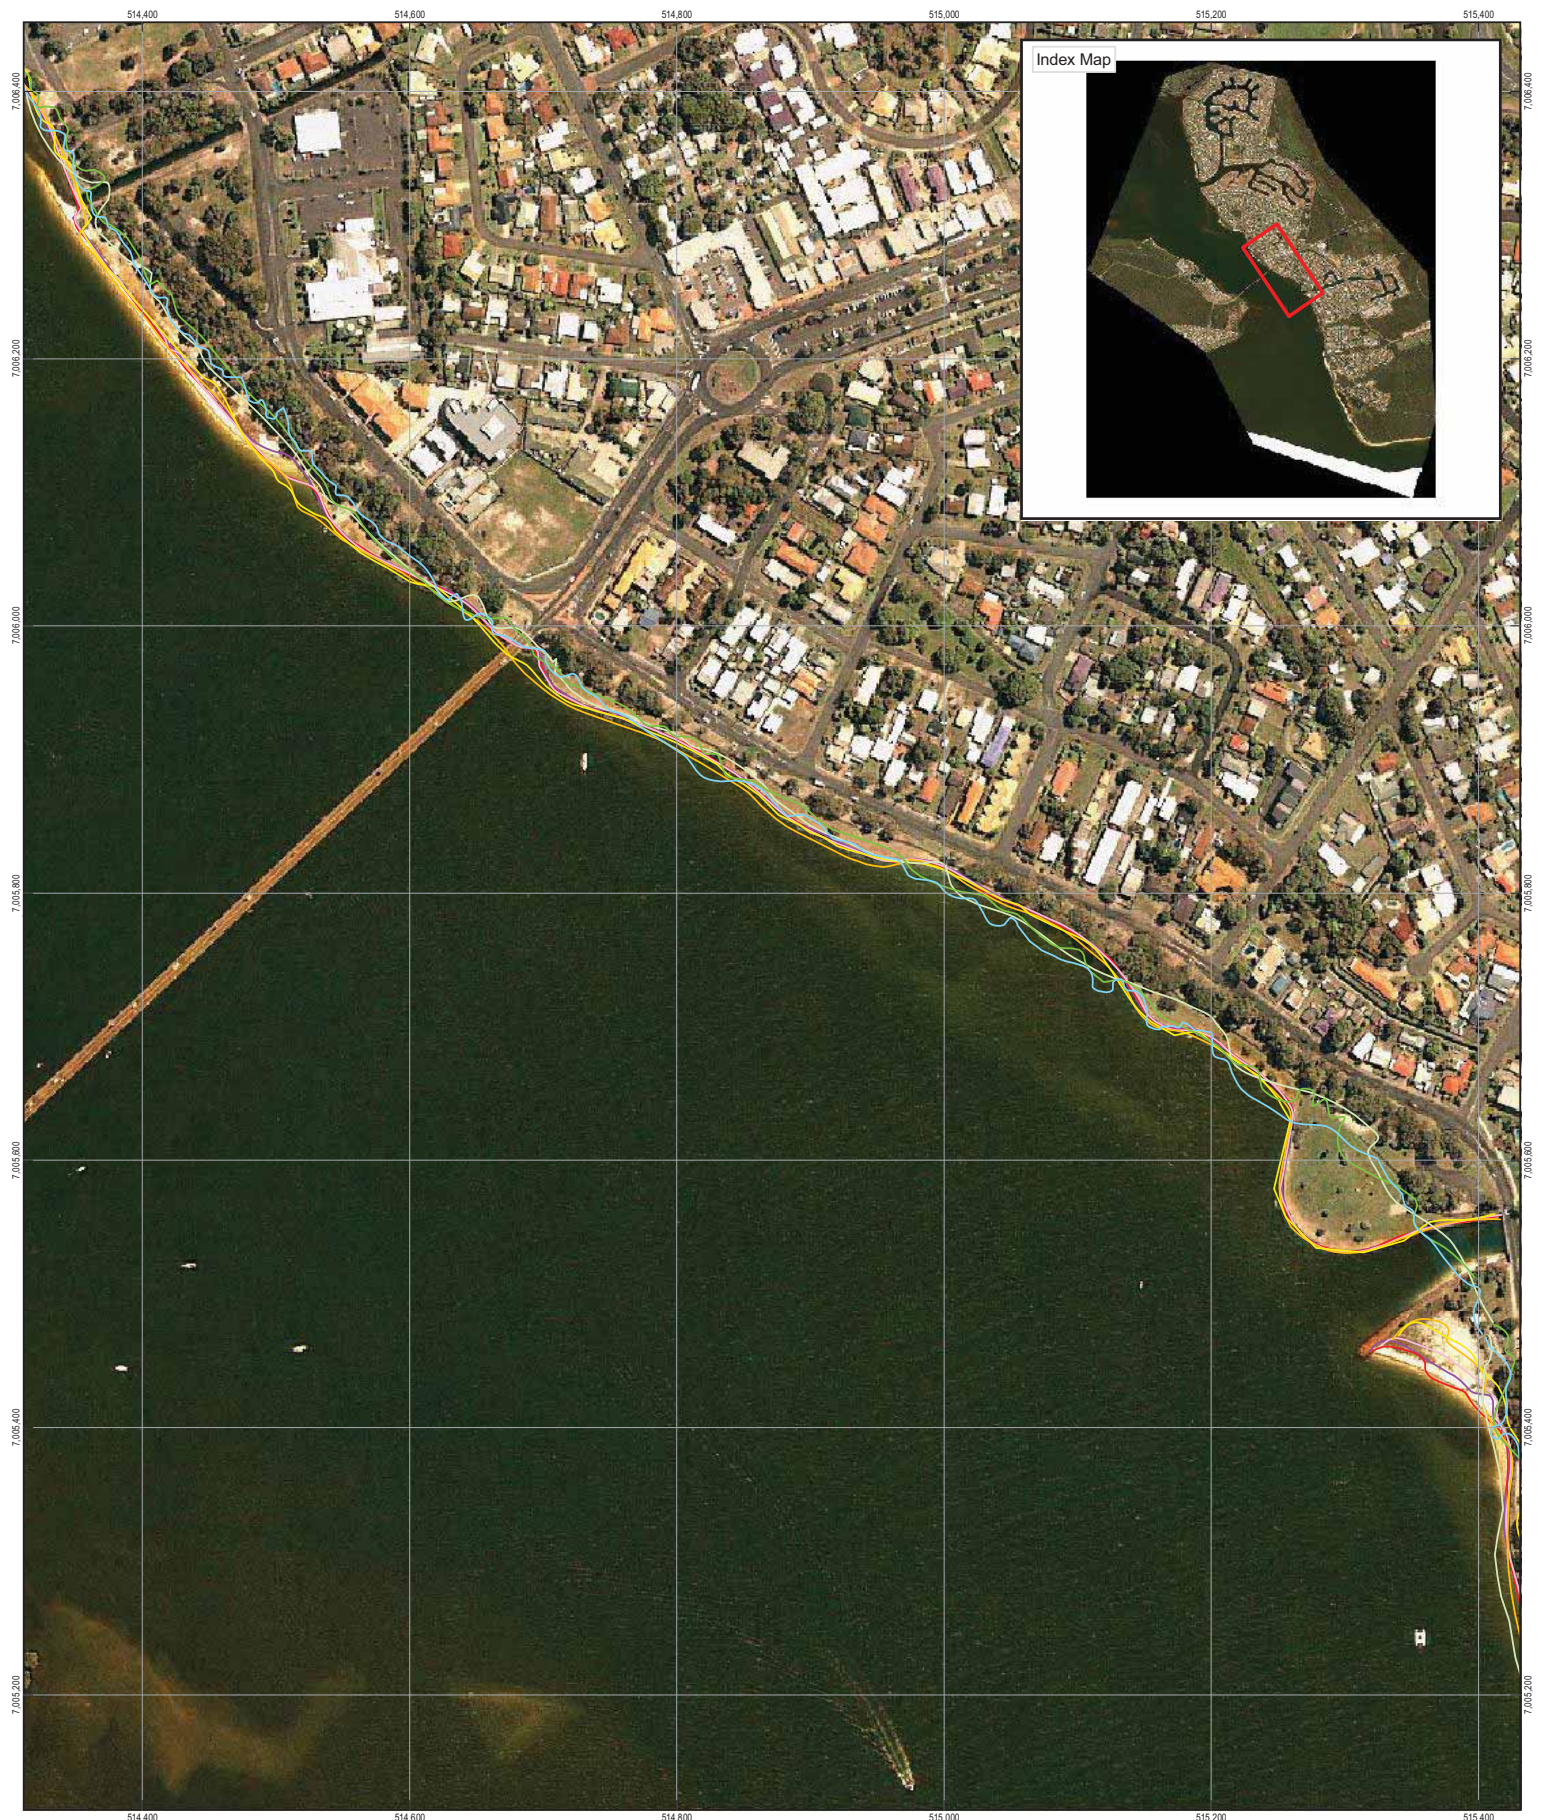
Figure 29

**Bongaree North to Bellara -
Vegetation Lines**

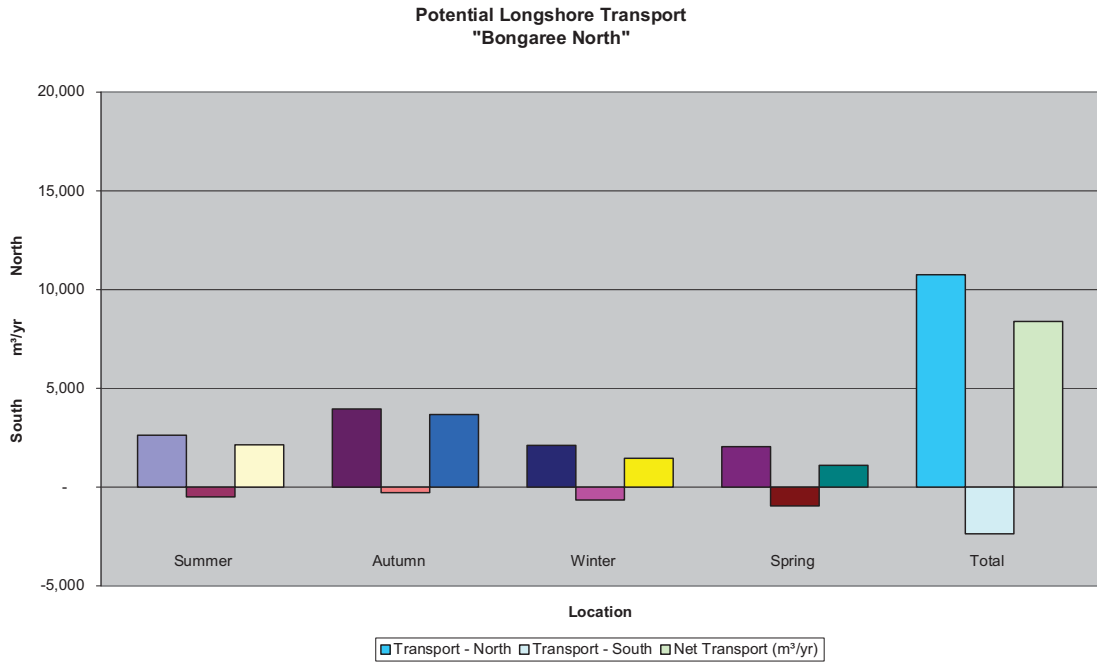
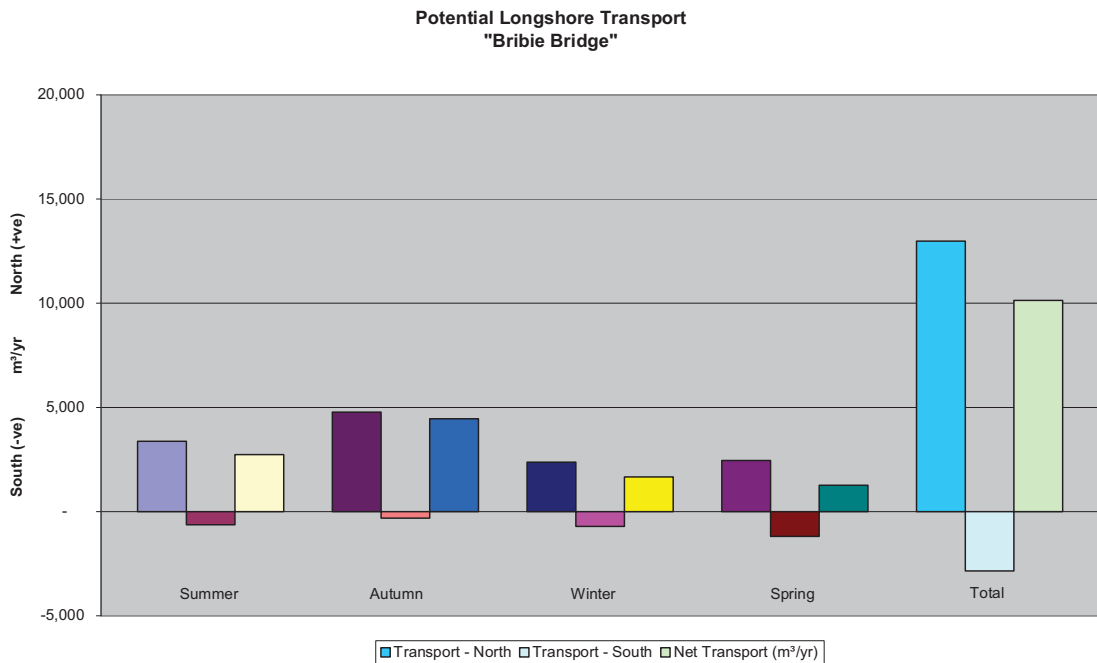
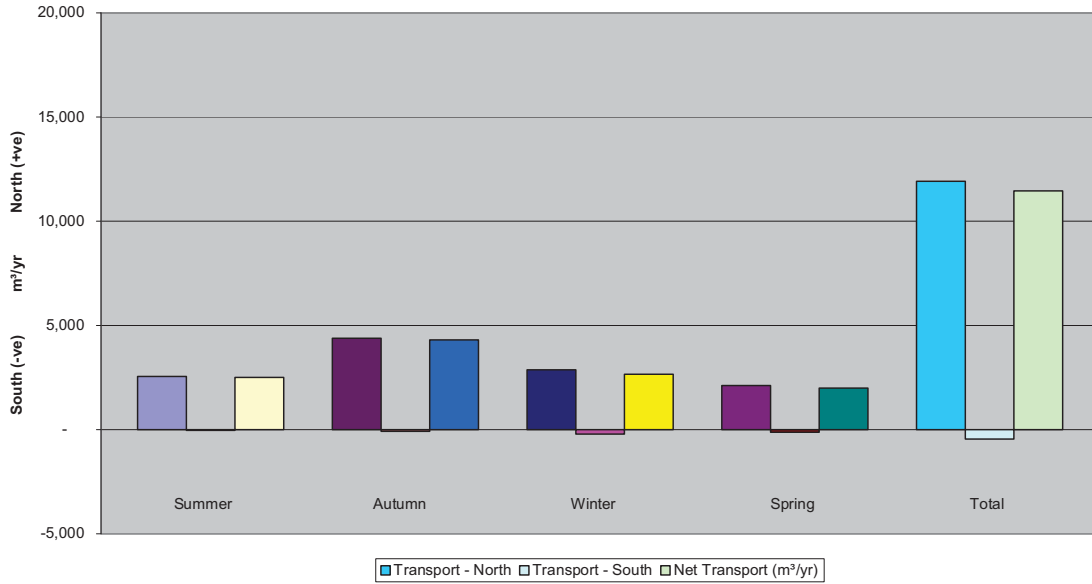
Figure 30 Bellara – Longshore Transport

For this section of the coast the following observations can be made (refer [Figure 30](#)):

- ▶ The predominant transport direction is strongly to the north;
- ▶ The potential longshore transport has decreased slightly compared to the section to the south due to further sheltering from the south-easterly waves;
- ▶ the northerly transport at Bribie Bridge is slightly greater than the transport to the north and south due to the orientation of the coastline in this area;
- ▶ The seasonal variation is similar to the annual results with higher potential transport rates occurring during Autumn; and
- ▶ At Bellara virtually all the transport is to the north due to a combination of the coastline alignment, and wave refraction effects.

Potential Longshore Transport
"Bellara"

This section presents details of the potential longshore transport for this particular section of the coastline with both the annual southerly, northerly, and net transport movements shown as well as the seasonal variations. Just as the annual calculations are based on the average wind climate over the period of record for the full 12 months, the seasonal calculations are based on the average wind climate over the period of record for that particular season.
