9. Sandstone Point to Turner's Camp

Moreton Bay Regional Council
Shoreline Erosion Management Plan

Sandstone Point to Turner's Camp -
Locality Plan

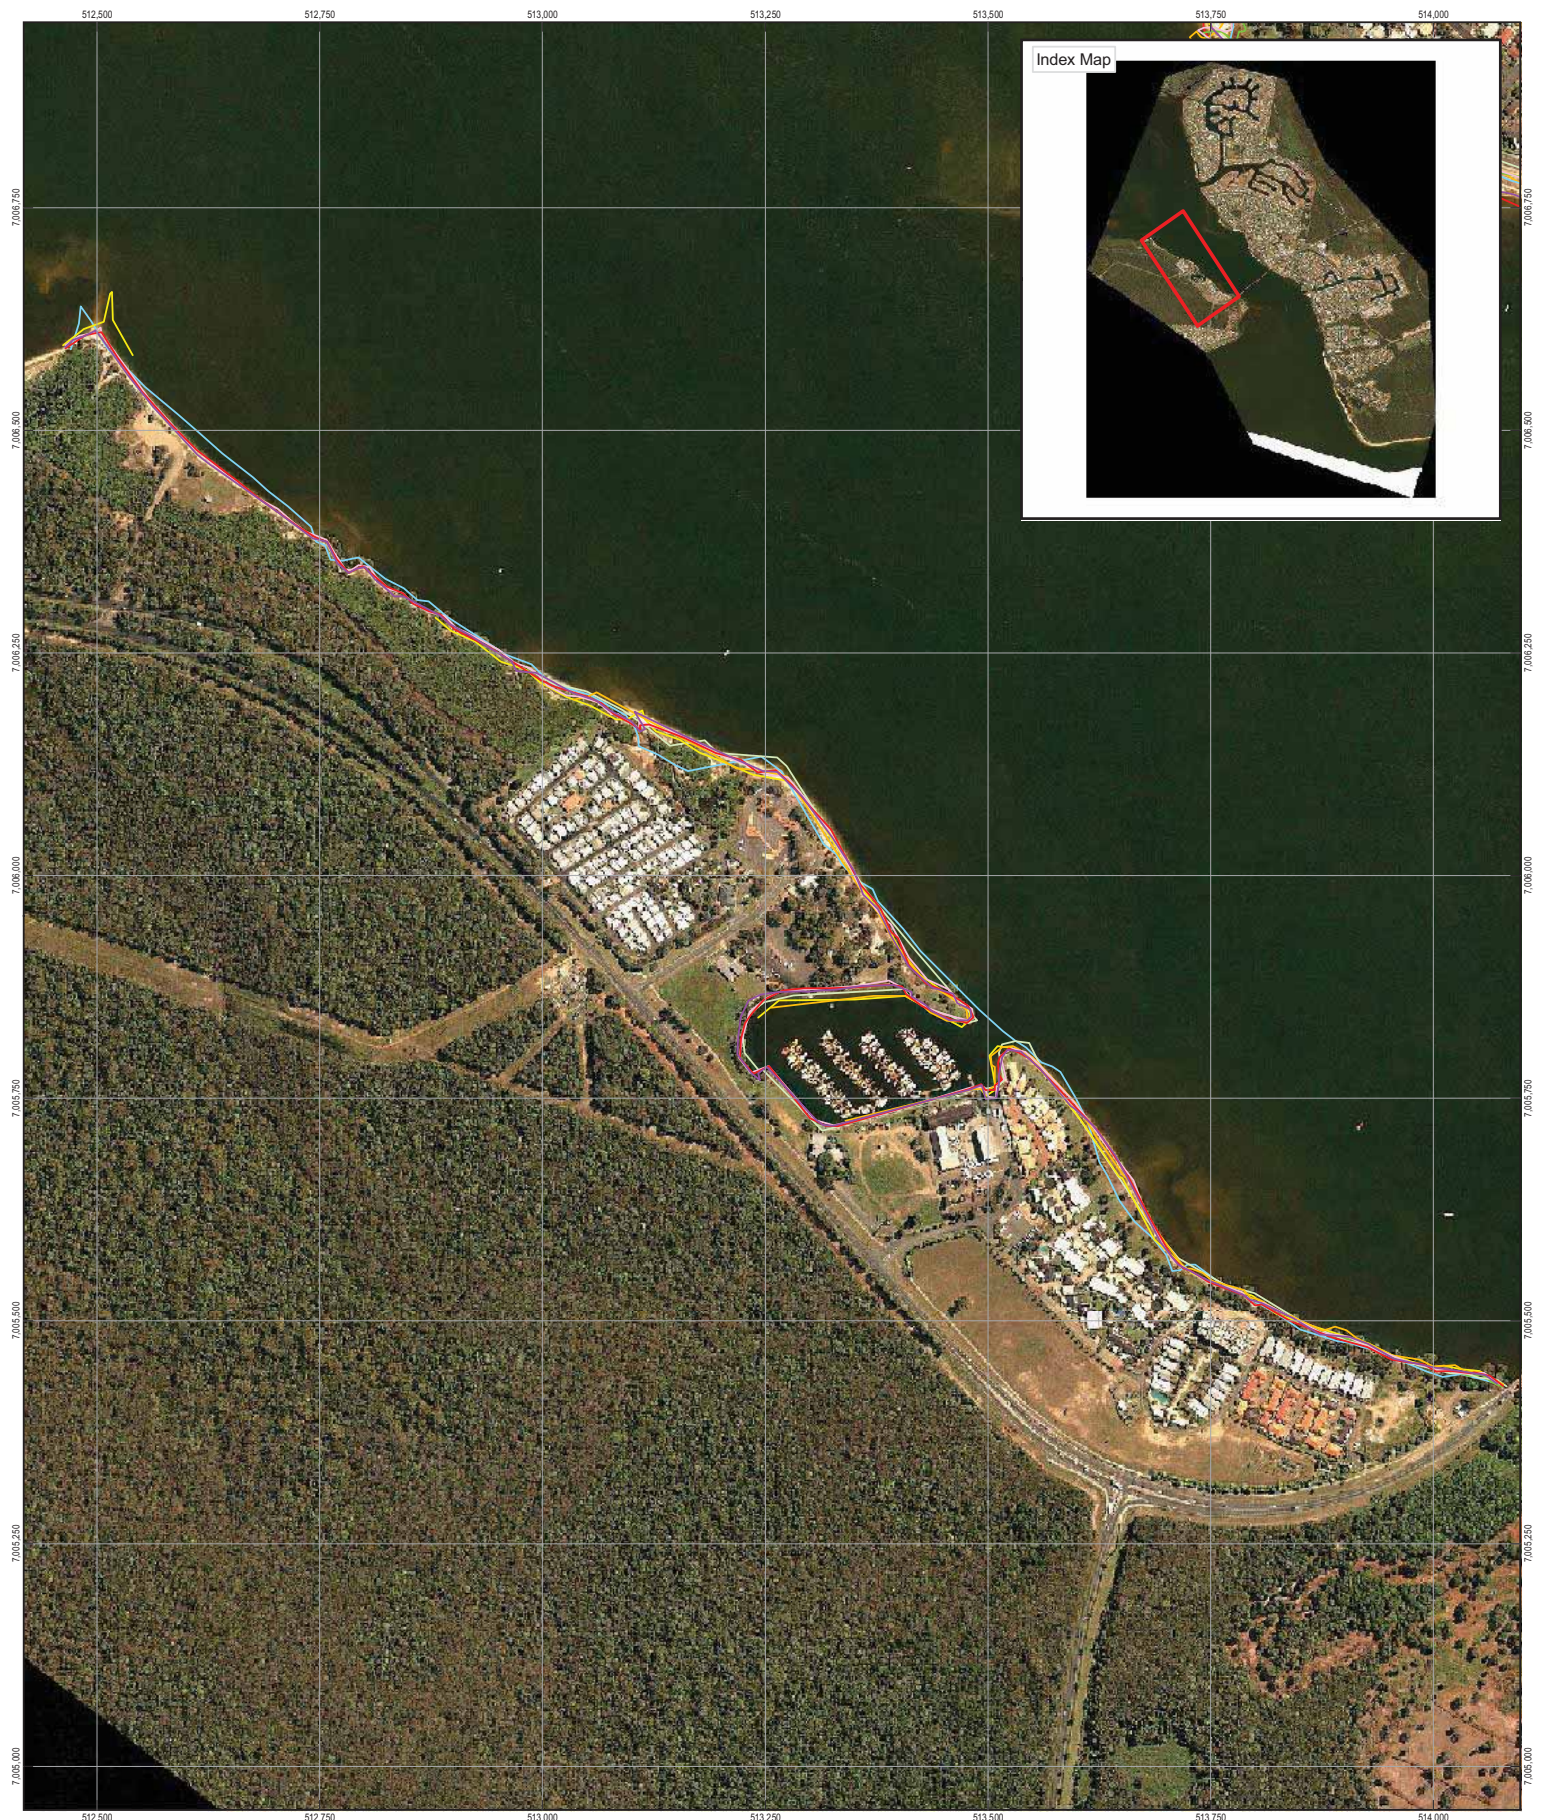
**Sandstone Point to Turner's Camp -
 Shorelines**

North of the boat ramp but still seaward of the caravan park, the shoreline has experienced some localised movements over time due to migration of a small coastal creek (refer Figure 44 Shorelines). The closest development is located approximately 30m landward of the back of the beach in this area and to date the shoreline has been able to respond to these changes naturally.

Overall, the shoreline between the marina and the bridge, and from the caravan park to Turners Camp has been relatively stable (refer to Figure 44 Shorelines and Figure 45 Vegetation Lines). The localised changes in the centre of the beach compartment (i.e. around the marina and the boat ramp) have been small and largely driven by human interference.

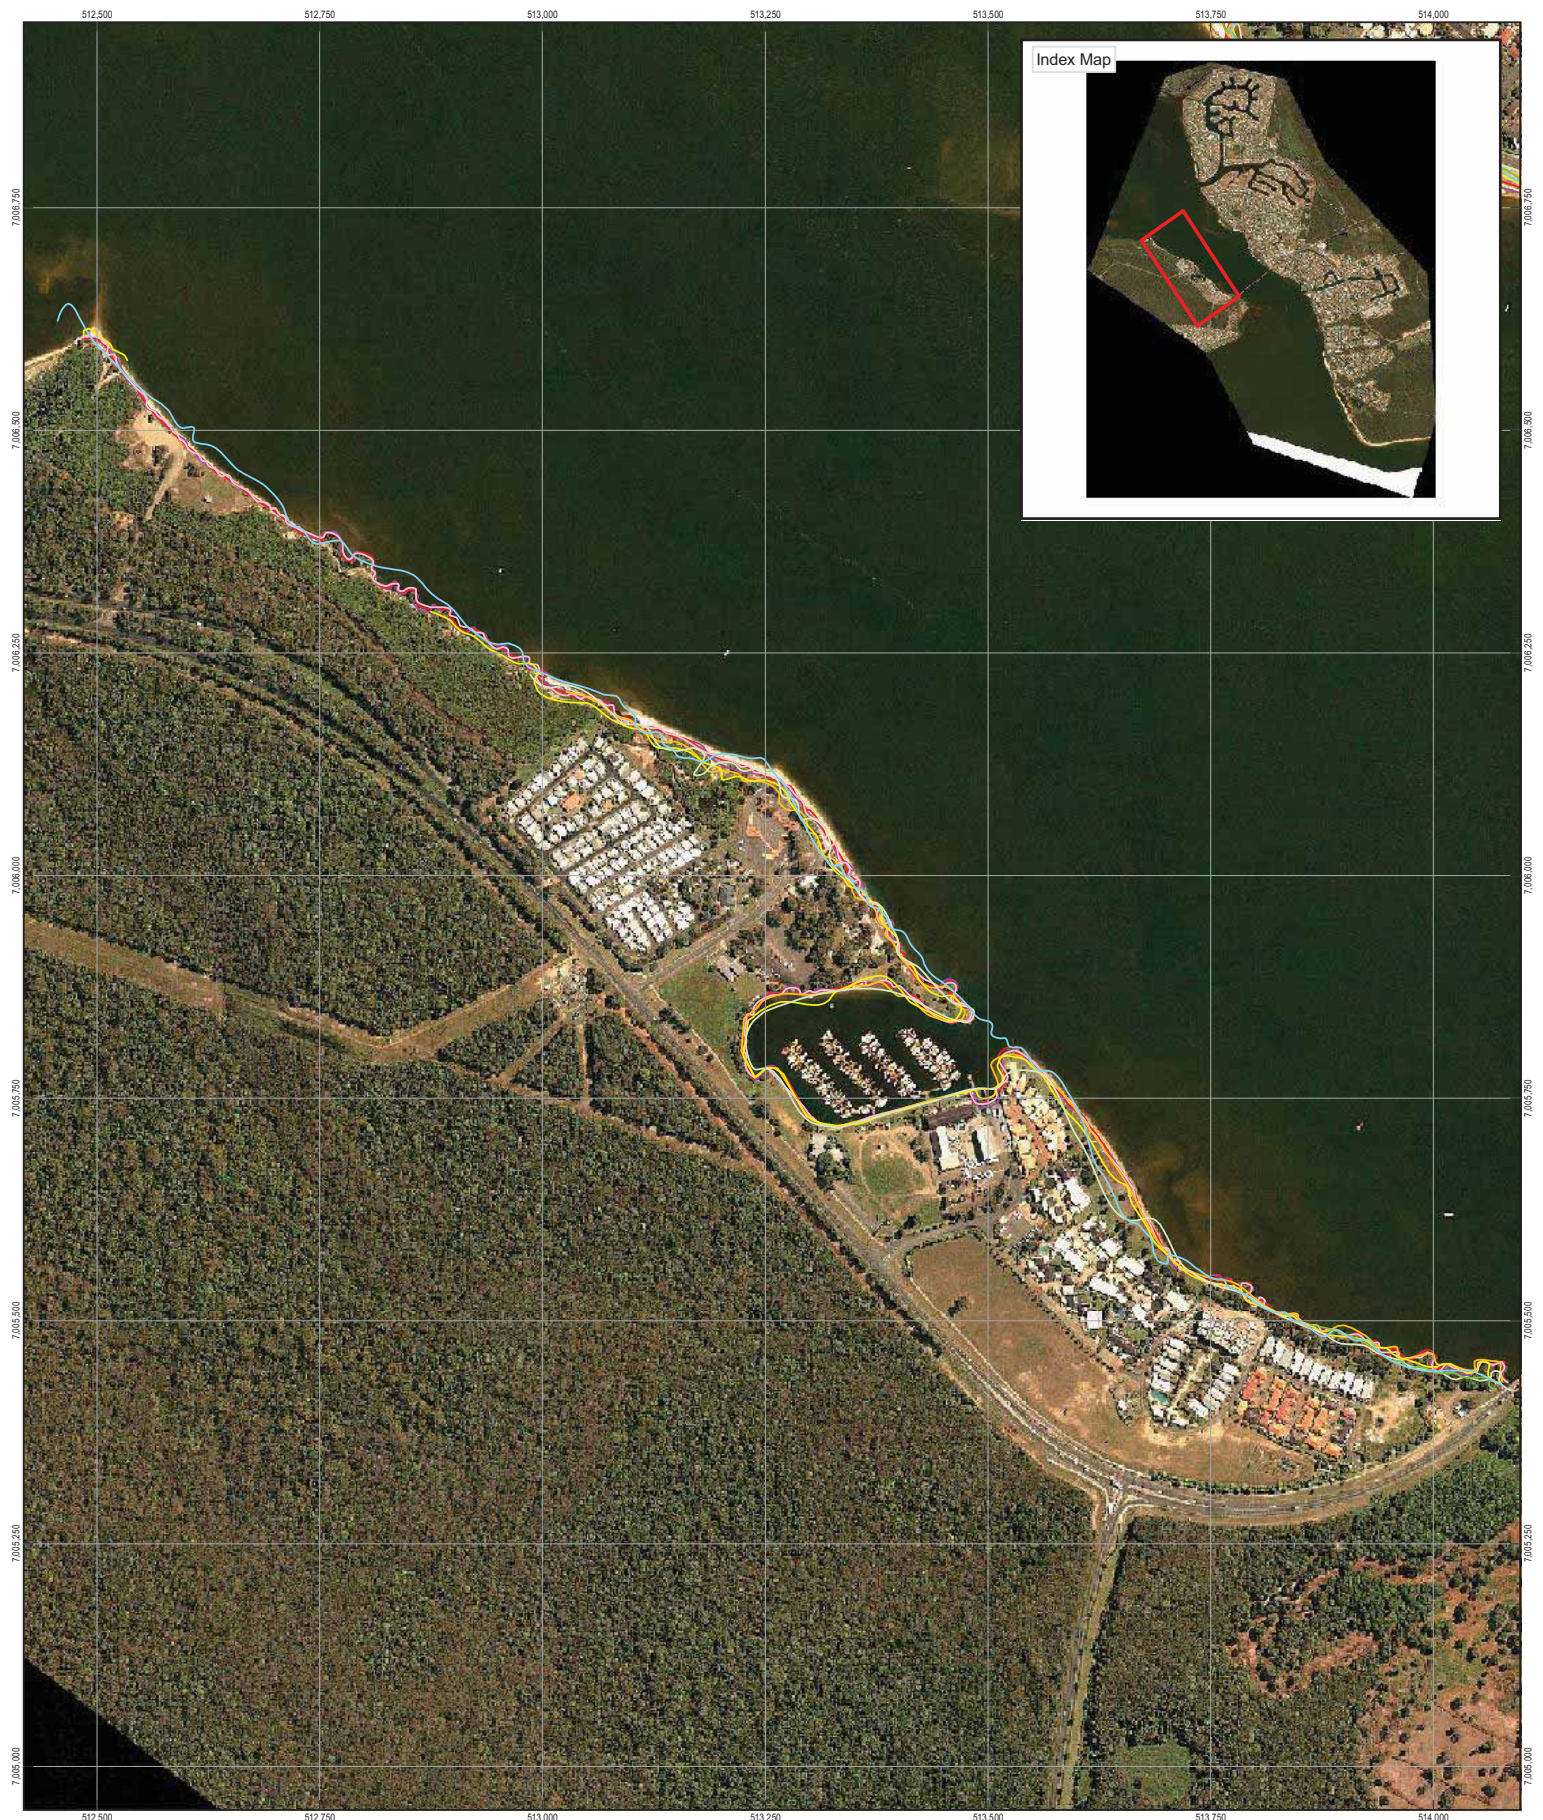
Figure 45

**Sandstone Point to Turner's Camp -
 Vegetation Lines**

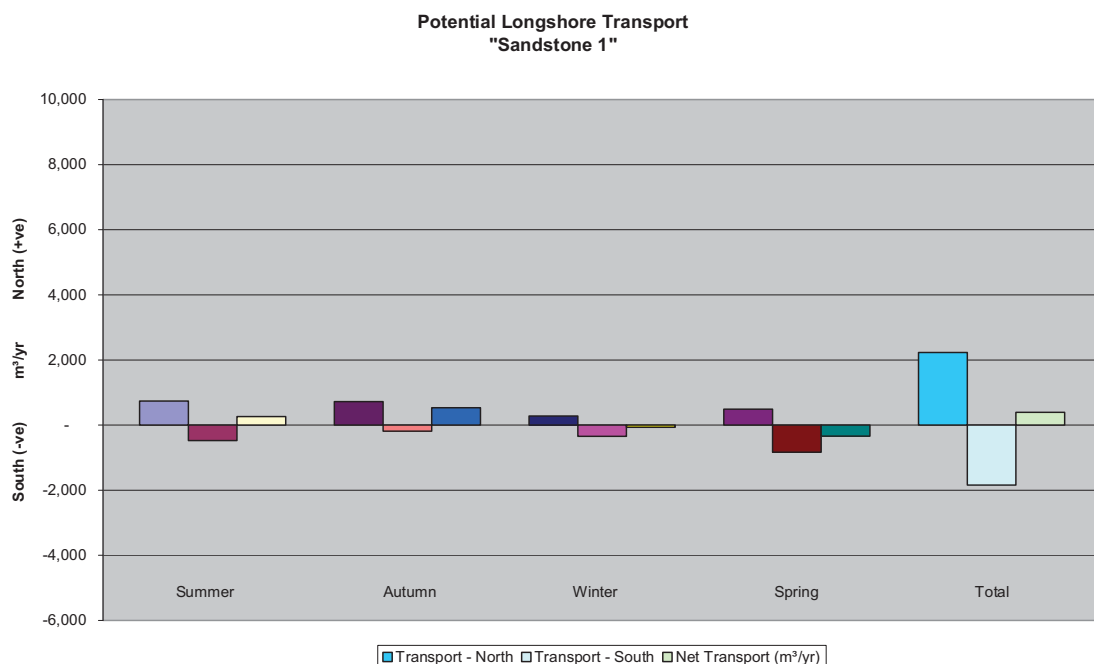
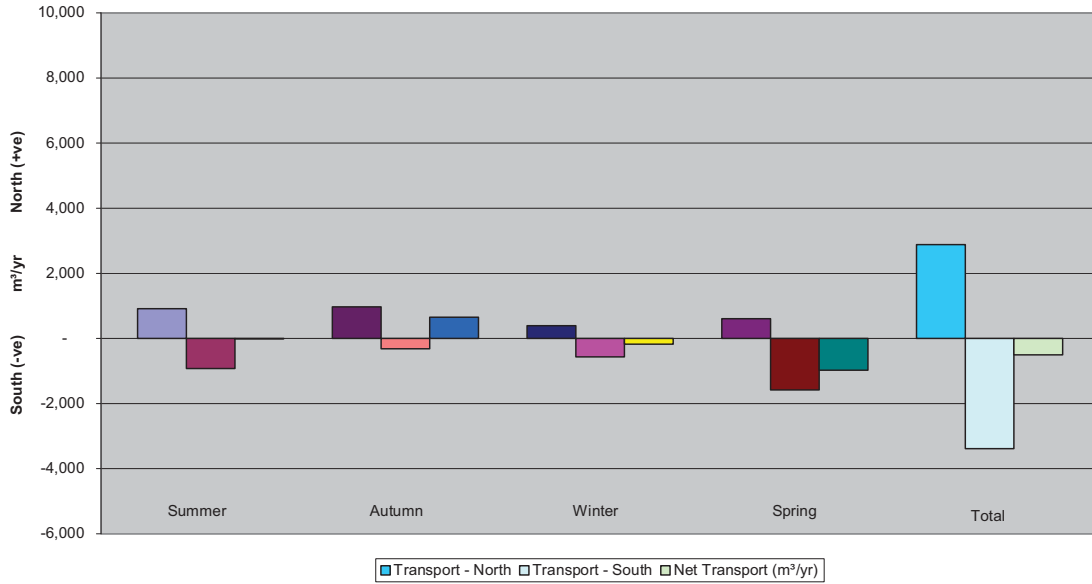
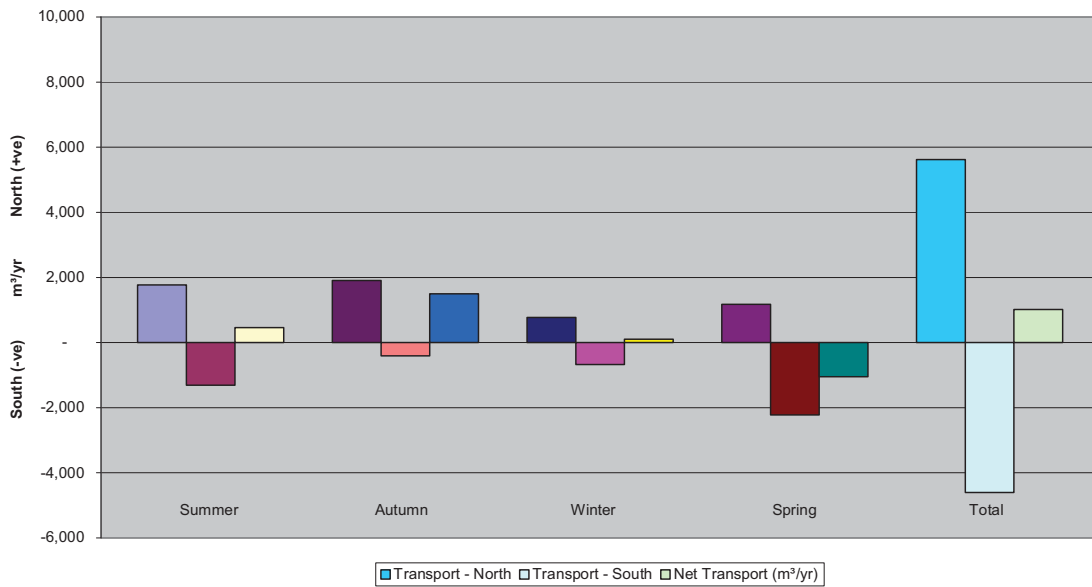
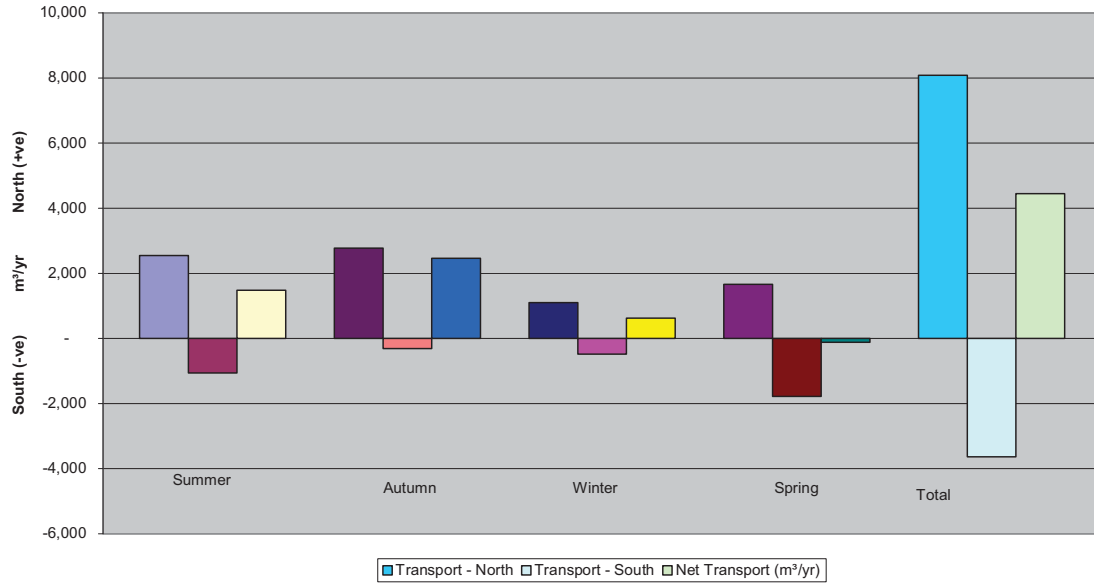
Figure 46 Sandstone Point to Turner’s Camp – Longshore Transport

Potential Longshore Transport
"Sandstone 2"

Potential Longshore Transport
"Boat Ramp"

Potential Longshore Transport
"Turners Camp"

For this section of the coast the following observations can be made (refer [Figure 46](#)):

- ▶ The section of coastline between the Bribie Bridge and the Spinnaker Sound marina is well protected from waves from all directions except from north-east across the Passage, and waves from this direction break parallel to the beach with little influence on longshore transport (which relies on waves breaking at an angle to the beach alignment);
- ▶ The net transport increases to the north from virtually zero at Bribie Bridge to around 5000 m³/yr at Turners Camp due to the increased exposure of this area to waves propagating up the Passage and refracting onto the beach and to local waves from the south-east; and
- ▶ This area shows the most variation across the seasons than other areas with both northerly and southerly net transport directions.
