3. South Point to Bongaree Jetty

Moreton Bay Regional Council
Shoreline Erosion Management Plan

**South Point to Bongaree Jetty -
Locality Plan**

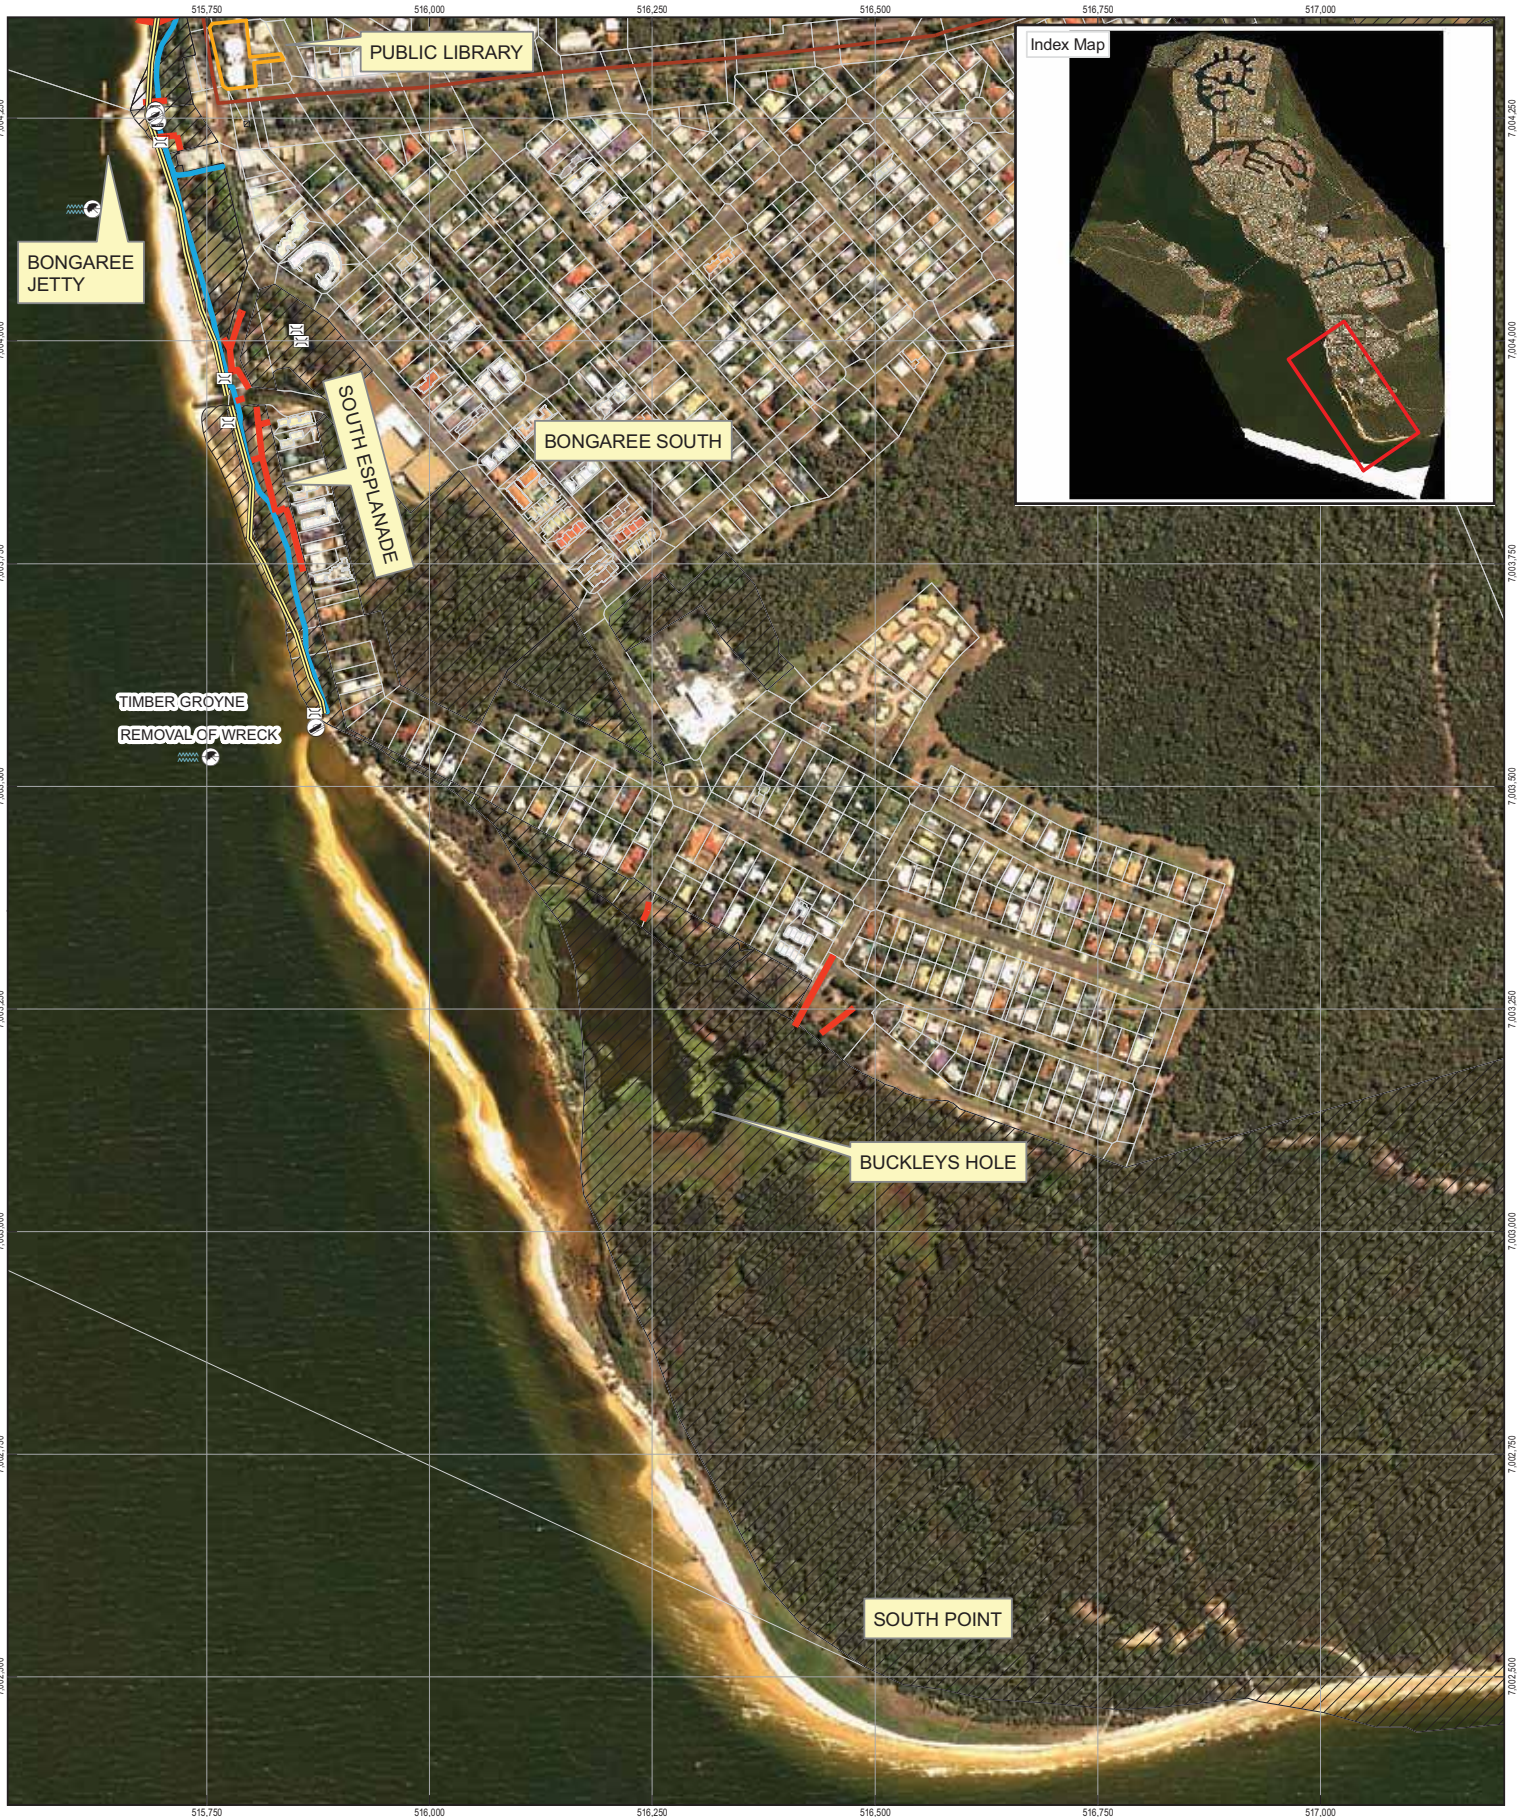
Figure 19

The South Point to Bongaree Jetty study area (refer to [Figure 19](#)) is at the south-western tip of Bribie Island (South Point) and consists of the beach adjacent to the Buckley's Hole Conservation Park as well as approximately one kilometre of shoreline between Buckley's Hole lagoon and the Bongaree Jetty. The extent of Buckley's Hole Conservation Park is of National Park tenure, with the remaining foreshore in this study area consisting of esplanade and road reserve. There is a small area of leasehold land at the commercial area adjacent Bongaree Jetty.

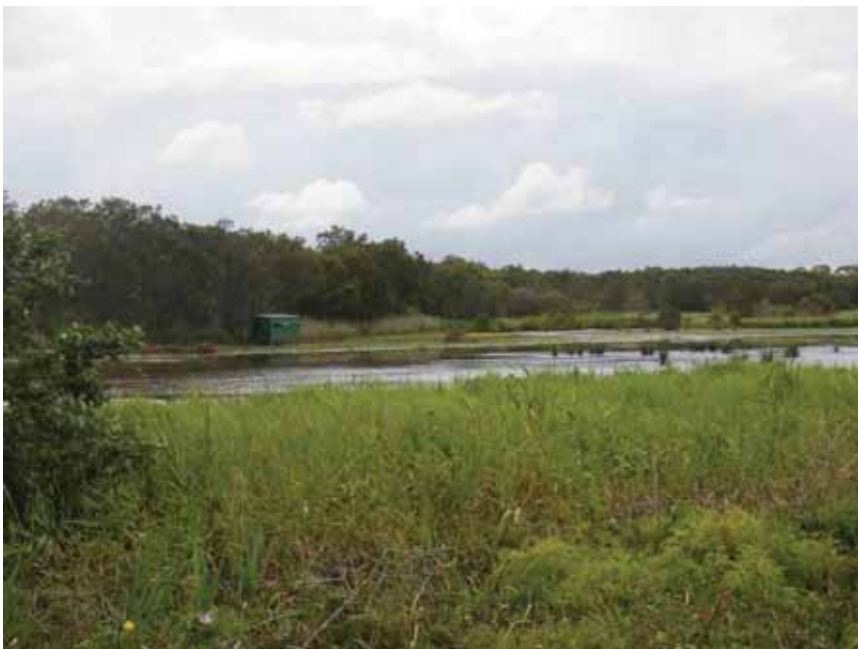
Photo Plate 3-2 Buckley's Hole shorebird habitat

The waterhole that makes up Buckley's Hole is regarded as an important shorebird and migratory bird habitat and nesting site (refer to [Photo Plate 3-2](#)). The freshwater lagoon of Buckley's Hole is known to be intermittently used by migratory shorebirds. Access is limited by vegetation around the lagoon and therefore disturbance is negligible (Milton *et al*, 2009).

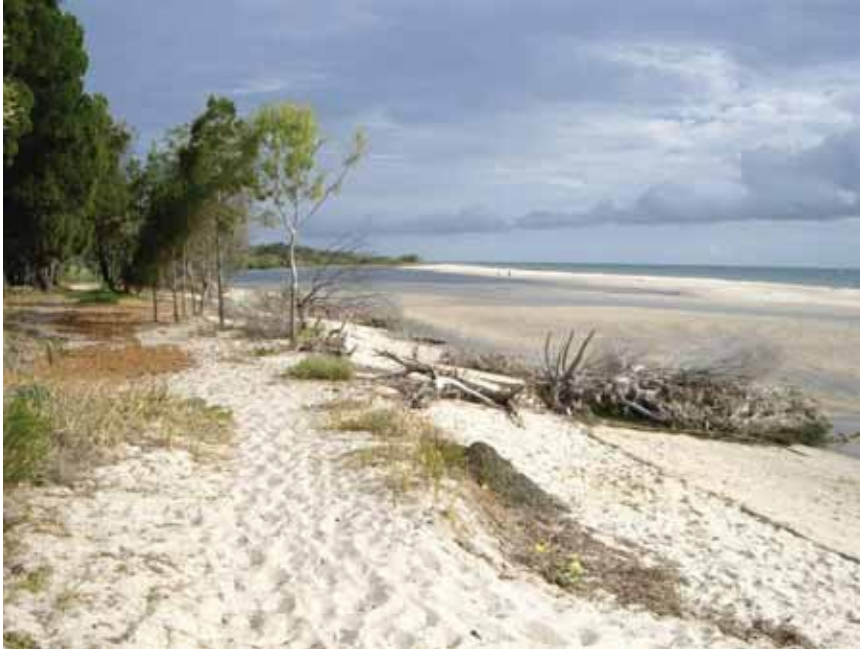
Photo Plate 3-3 Foreshore south of timber groyne with vegetation damage

The foreshore between Buckley's Hole and Bongaree Jetty (approximately 700 m) is reinforced by a sea wall, which is presently mostly covered by sand and foredune vegetation. The sea wall ends at Buckley's Hole where an old timber groyne is located at the mouth of a small channel between the high-water mark and the northern end of a long sand spit that forms a tidal estuary adjacent to the Conservation Park (refer to [Photo Plate 3-1](#) and [Photo Plate 3-4](#)). On the southern side of this groyne is an area of scattered pier or bridge timber logs that were reportedly placed by a former land owner many years ago as erosion protection works. A number of large sand bags have also been placed on the southern side of the timber groyne at some stage in the past presumably to stabilise the groyne when it was threatened by erosion. Several trees have recently been destabilised in the upper beach zone (refer to [Photo Plate 3-3](#)).

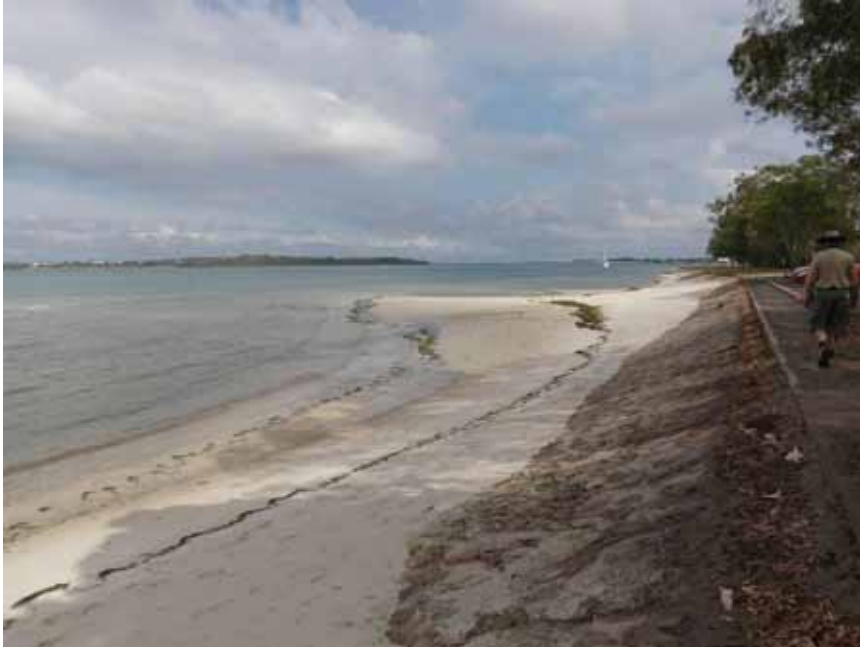
Photo Plate 3-5 Sea wall north from timber groyne

The South Esplanade runs adjacent the seawall, with car parking in the south and park areas and shops near Bongaree Jetty. The seawall changes at the jetty from a sloped rock and grouted concrete wall (south – refer to [Photo Plate 3-5](#)) to a stepped concrete wall (north – refer to [Photo Plate 3-6](#)). Historical photographs of these areas have been provided in Photo Plates 3-7 and 3-8. There is a 750 mm diameter stormwater pipe south of the jetty with an outlet at the

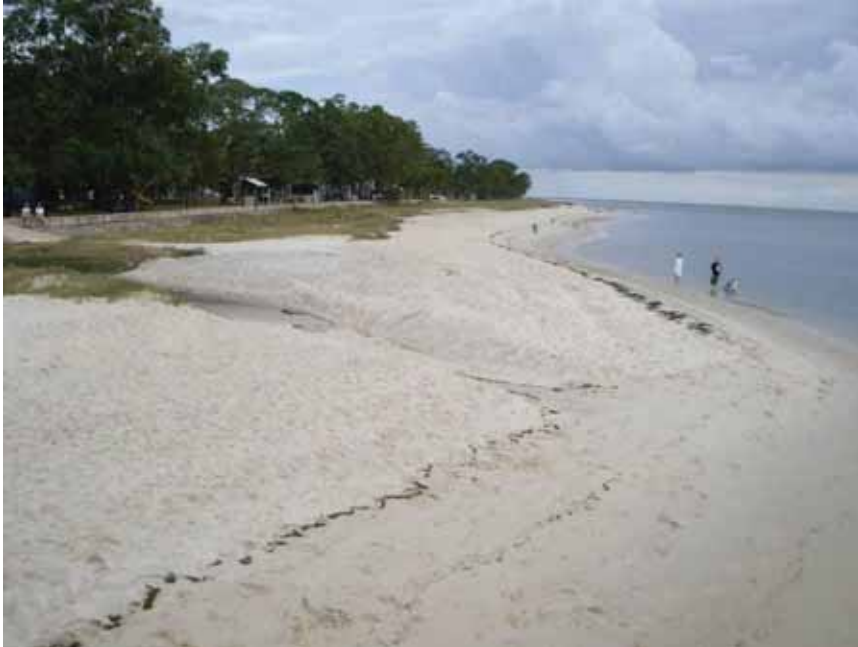
Photo Plate 3-9 Stormwater outlet south of Bongaree Jetty

top of the beach forming a channel through the sand (refer to [Photo Plate 3-9](#)). The sand build-up south of Bongaree Jetty is shown in Photo Plate 3-10..

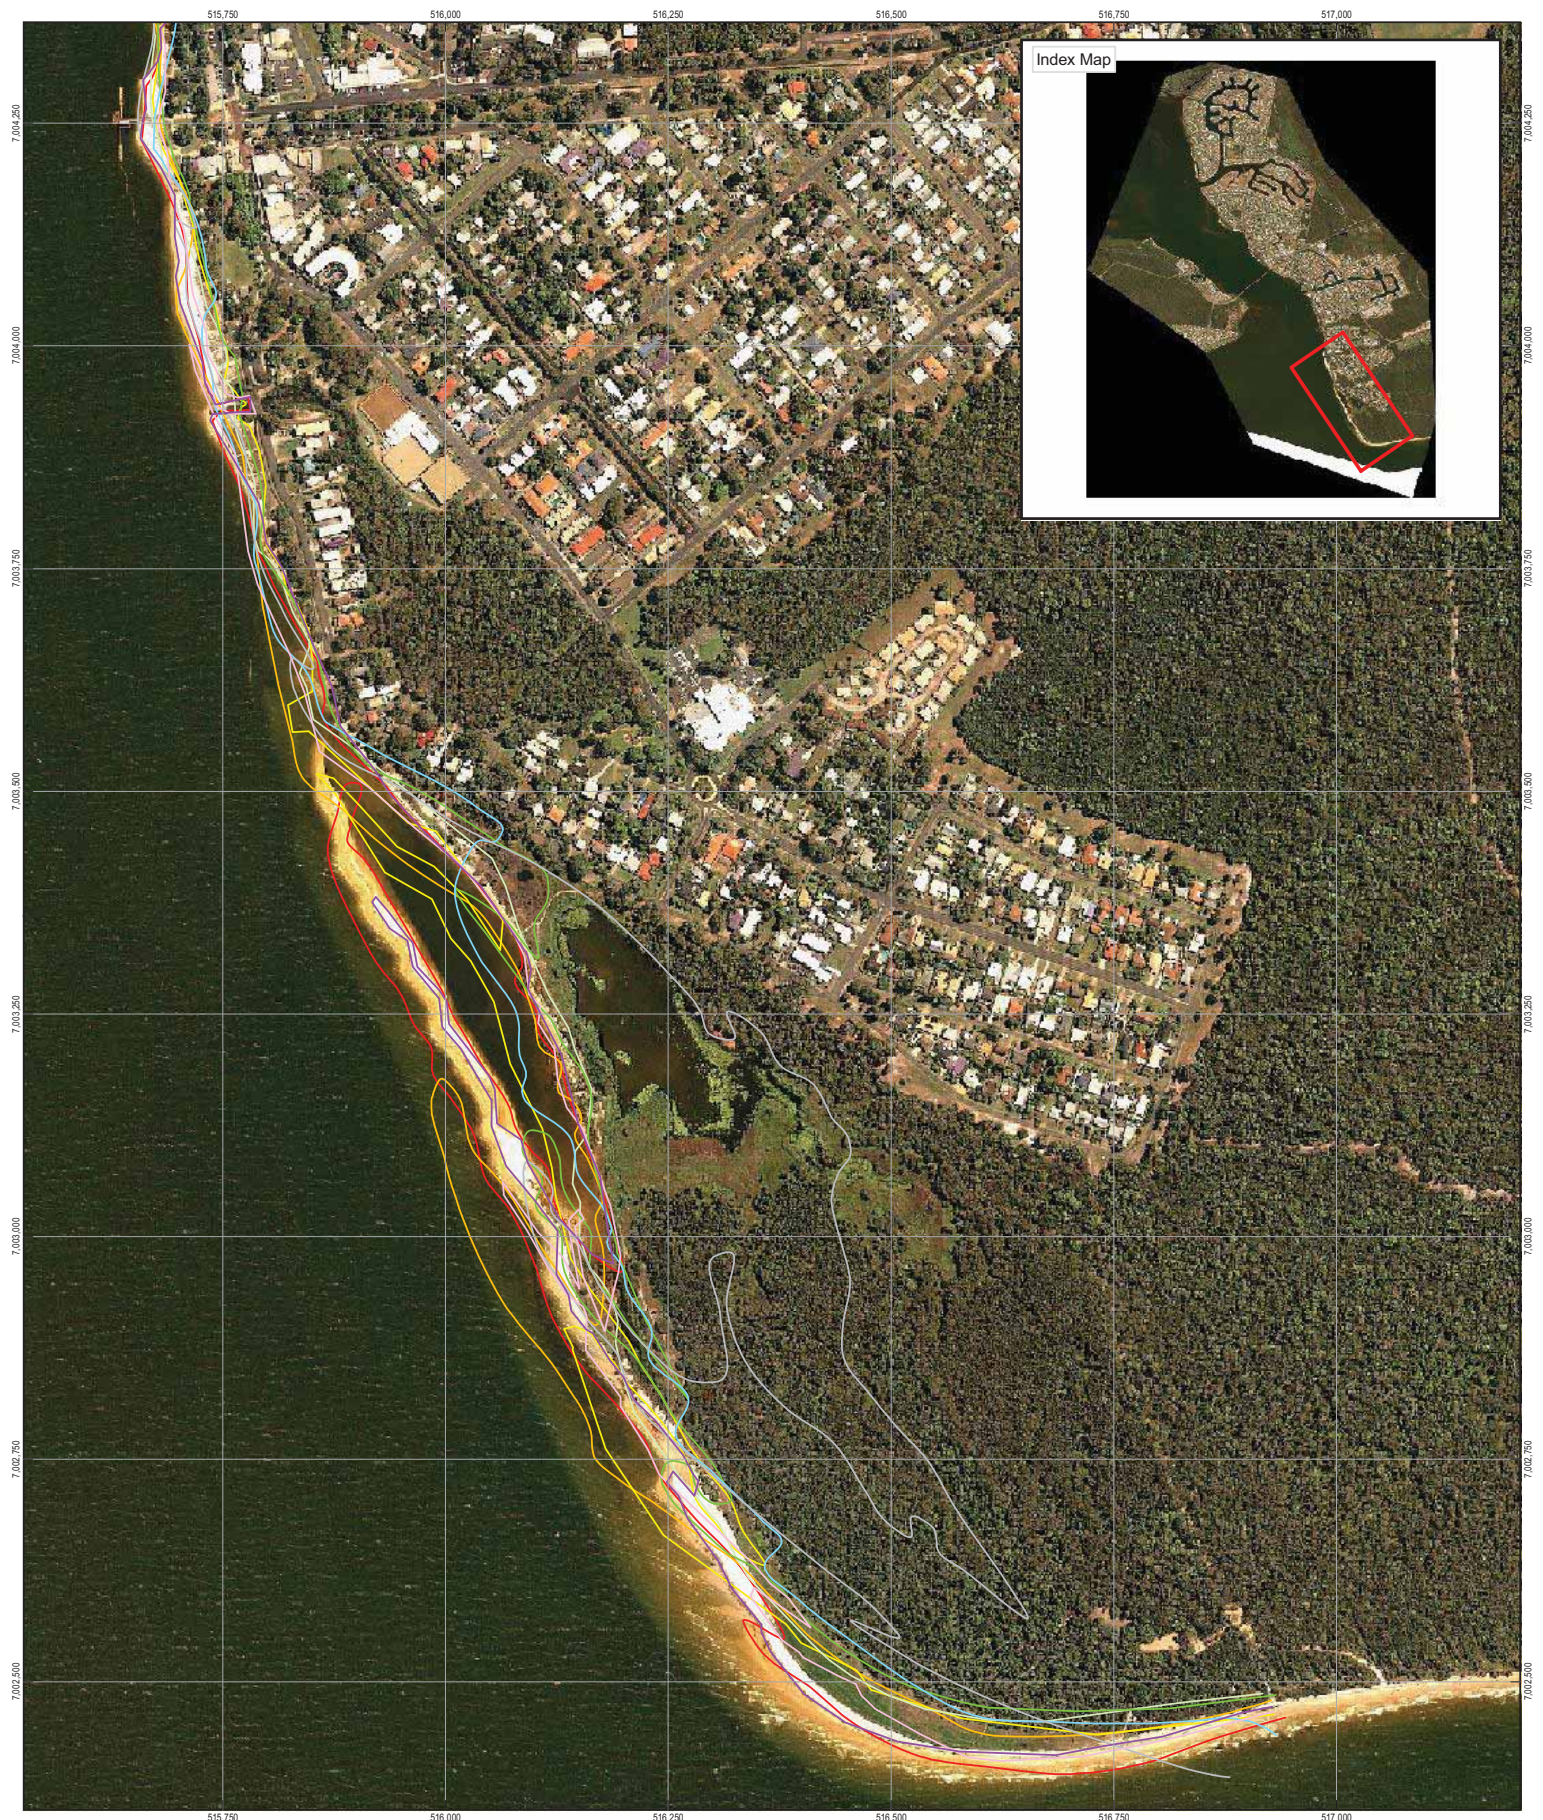
Figure 20

Analysis of historical aerial photography shows that significant accretion has been occurring in the vicinity of Buckley's Hole since the first photographs taken in 1942. The southernmost line of dwellings facing the south-west were constructed close to and along the general alignment of the shoreline in the 1950s. GIS imagery of the photographic analysis has been shown in [Figure 20](#) and [Figure 21](#).

**South Point to Bongaree Jetty -
 Shorelines**

The photographs show the pronounced formation of spits at varying locations and of differing sizes throughout the area. Spit growth is consistently towards the north. This indicates that sand is being transported via longshore transport along the southern coastline of Bribie Island from the east towards the west. When the sand reaches Pumicestone Passage, the wave and tidal conditions change significantly, and the sand falls out of suspension, resulting in a submerged spit. As this spit grows, it then starts to influence nearshore waves and currents, which gradually cause the spit to reorient to become shore parallel whilst migrating landwards. Eventually, the spit becomes exposed during the tidal cycle, when aeolian (wind) transport can occur. Gradually, the sand moves further up the beach and eventually becomes a new dune ridge.

The shoreline change in the area surrounding Buckley's Hole ranges from just a few metres at the northern end of the beach (southernmost end of South Esplanade) and the southern shoreline of Bribie Island, up to an accretion of approximately 275m in the centre of this coastal unit.

On the western-facing shoreline at the southern end of South Esplanade, immediately north of Buckley's Hole, the shoreline appears to have fluctuated in the order of approximately 30m. Since 1942, the shoreline has accreted and receded several times. This fluctuation is likely to be the result of "slugs" of sediment being transported northwards along the coastline. Recession at the site coincides with a significant period of sand accumulation at Buckley's Hole. It is therefore likely that Buckley's Hole was acting as a temporary sediment sink, and sediment bypassing of this area only resumed once the Buckley's Hole estuary had been closed. The shoreline is currently experiencing recession again, however the northward growth of the spit forming the western side of the new lagoon is now providing some protection from wave action to the shoreline at the southern end of South Esplanade.

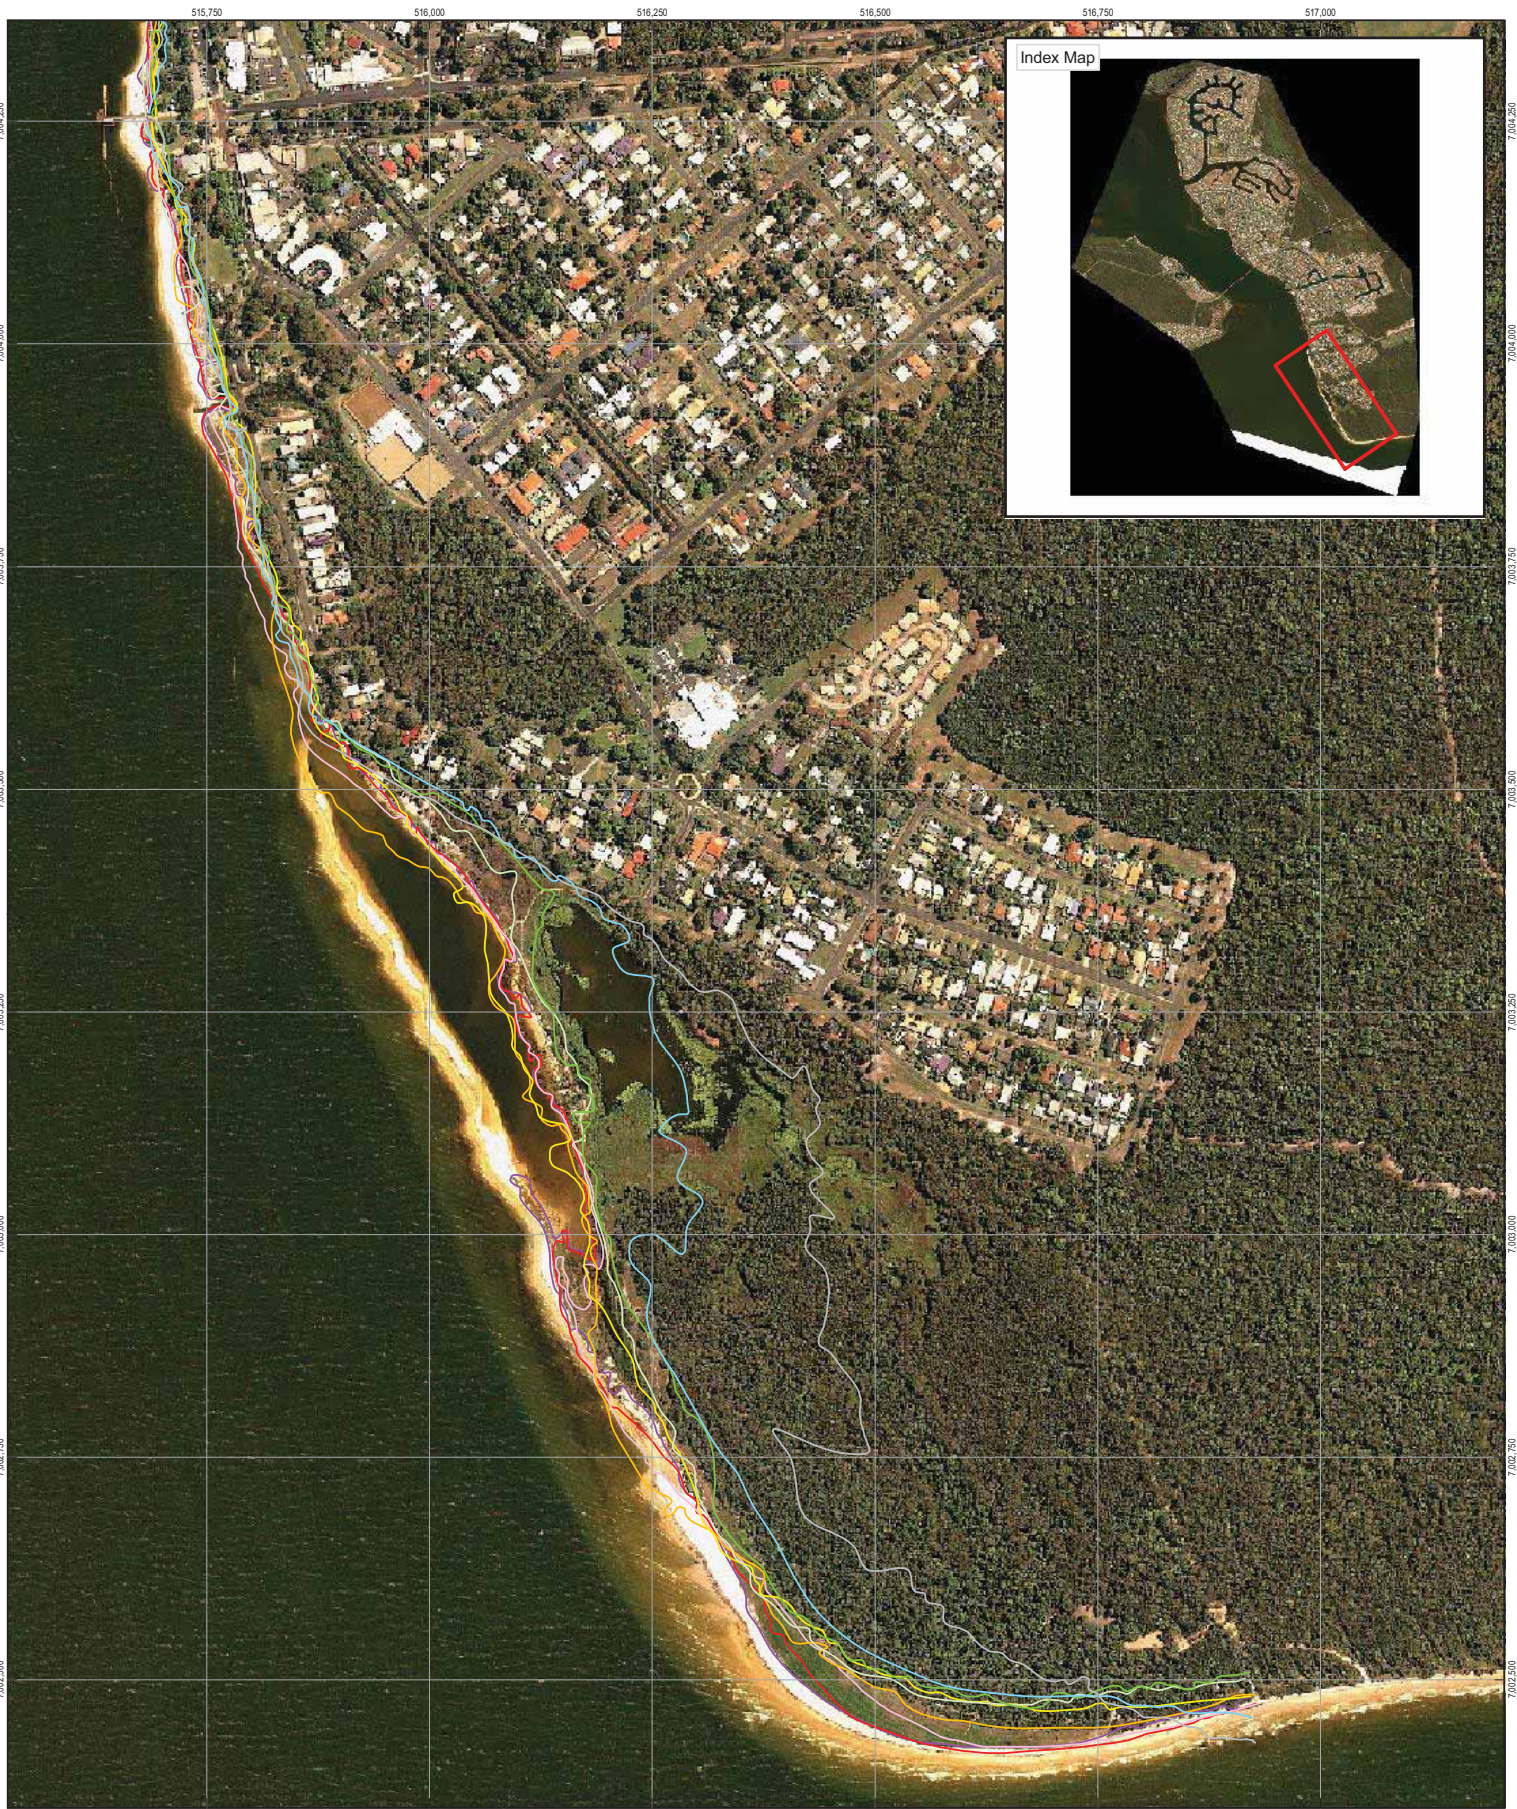
Figure 21

**South Point to Bongaree Jetty -
Vegetation Lines**

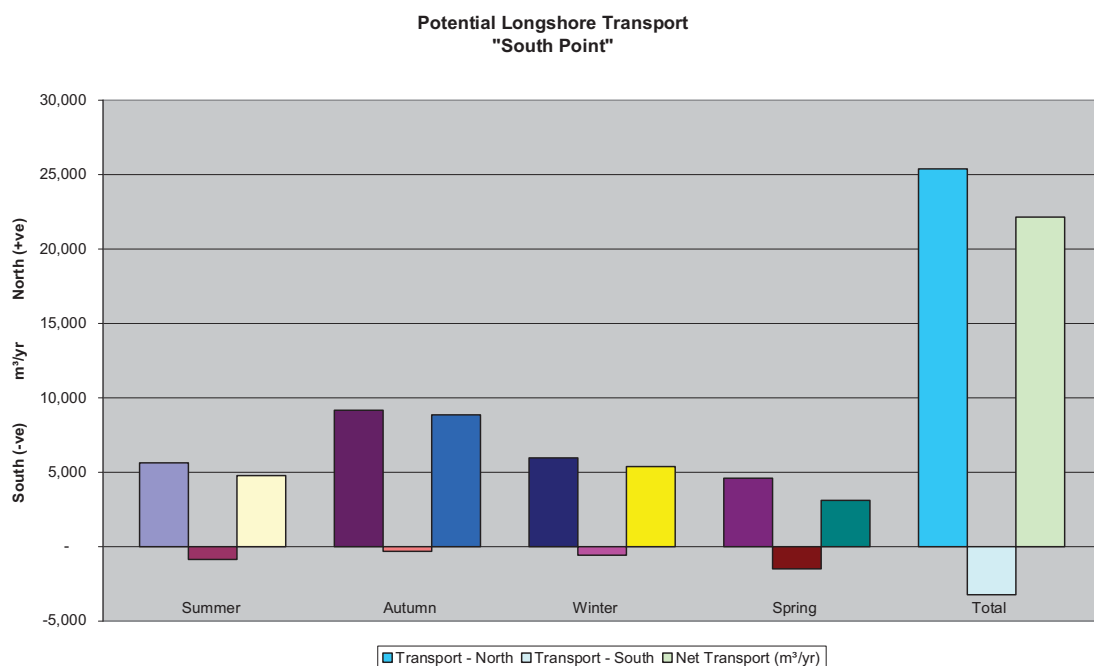
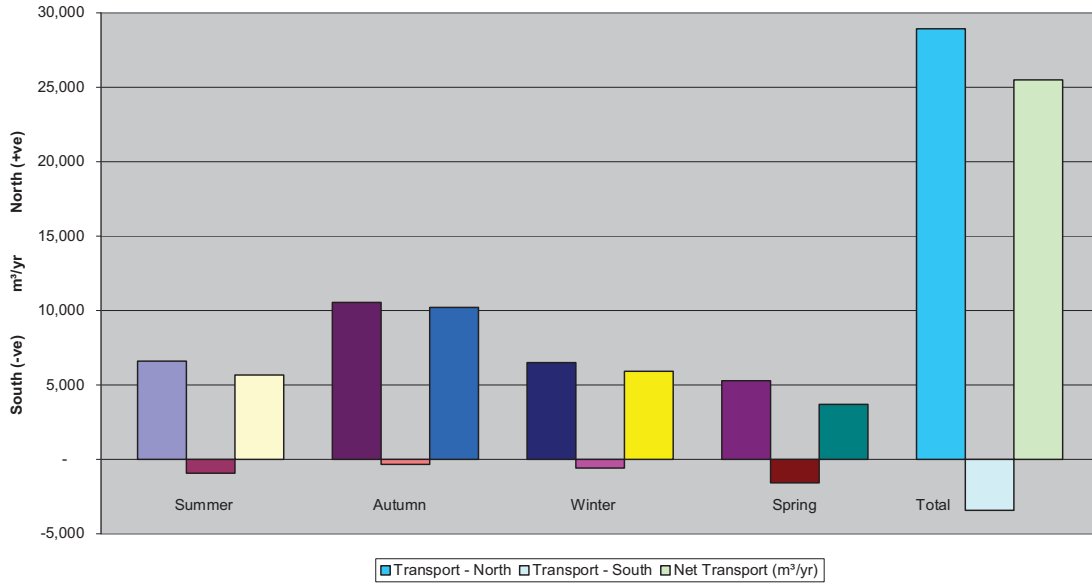
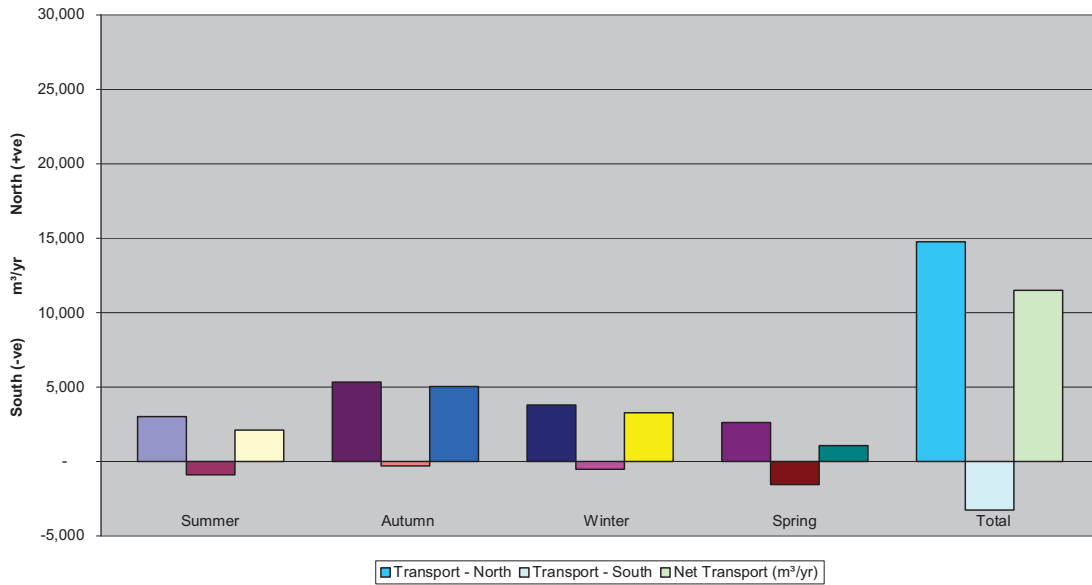
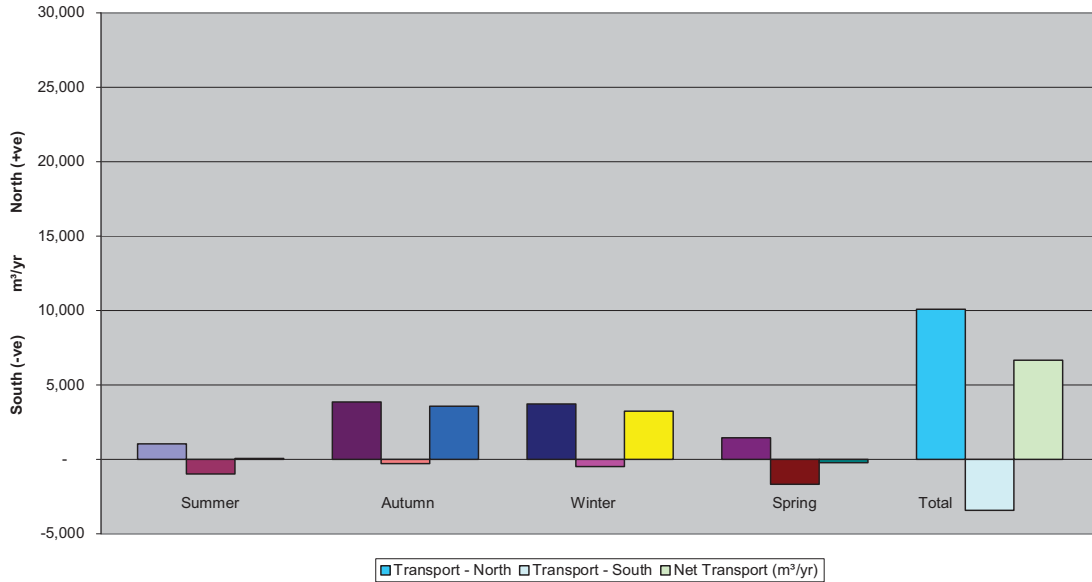
Figure 22 South Point to Bongaree Jetty – Longshore Transport

For this section of the coast the following observations can be made (refer [Figure 22](#)):

- ▶ The predominant transport direction is strongly to the north;
- ▶ The potential longshore transport at South Point and Buckley's Hole is higher than any other section of the SEMP area of interest, as it is the most exposed to the prevailing south-easterly winds;
- ▶ The Buckley's Hole transport is slightly larger than that for South Point because of the larger angle of the coastline to the waves; and
- ▶ The seasonal variation is similar to the annual results with higher potential transport rates occurring during Autumn.
