7 Donnybrook

7.1 Council Controlled Areas and Current Condition

Title: **Donnybrook Beach Unit - Council Controlled Shoreline Areas and Current Condition**

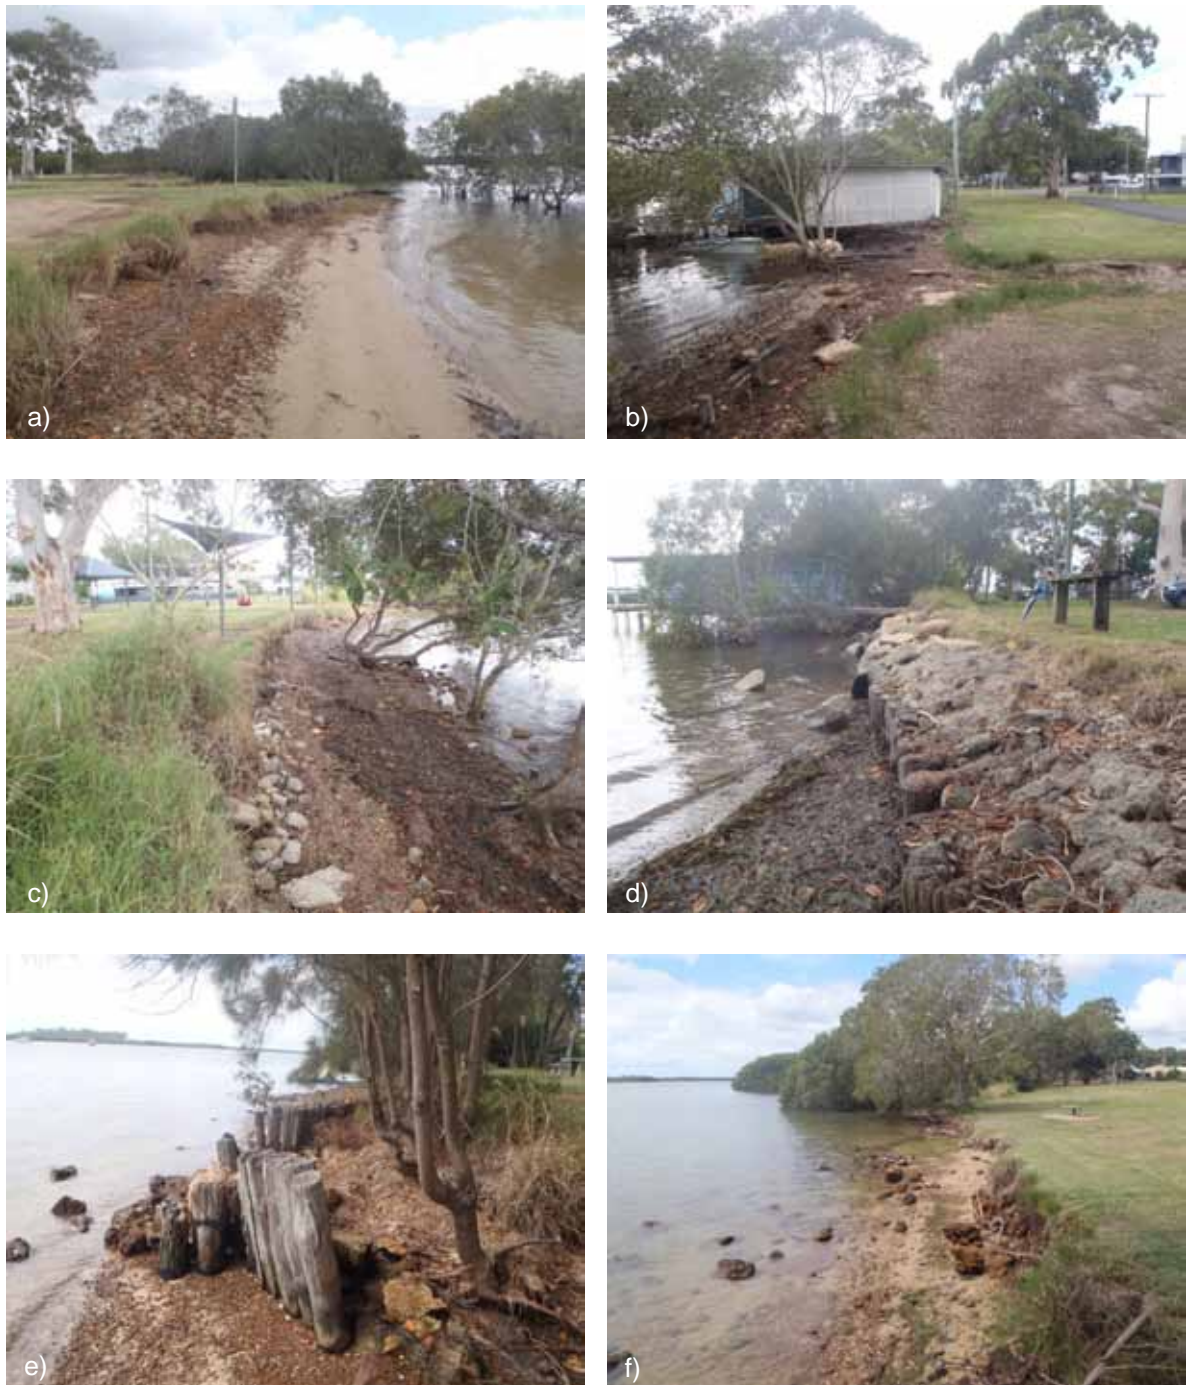
Examples of the shoreline condition throughout Donnybrook are shown in Figure 7-2. The shoreline is generally free of formalised structures however rock, timber and/or concrete have been used in the northern half of the study area to resist shoreline erosion at the Caravan Park foreshore (refer Figure 7-2d and Figure 7-2e). The original placement of these materials many years ago was unlikely to have been part of an approved shoreline management strategy.

North of the Caravan Park the foreshore buffer narrows to within 10m of the road (Esplanade North, refer Figure 7-2a). Mangroves provide shelter at most locations and there does not appear to be an immediate erosion threat to the sealed road or other assets. A previous storm tide assessment suggests this area may be inundated during design storm events (Cardno Lawson Treloar, 2009).

Both structures are aging and are likely to require significant repair to remain safe and usable. The poor condition of Esplanade North jetty was evident during a site visit in early 2014 with the immediate area littered with old boating equipment and debris (refer Figure 7-2b).

Figure 7-2 Example Shoreline Condition throughout Donnybrook Study Area: a) Sandy Shore with Erosion Scarp; b) Boat Shed; c) Loose Rock and Mangrove; d) Deteriorating Rock, Concrete and Timber; e) Deteriorating Rock and Timber; f) Loose Rock and Erosion Scarp

Removal of previous timber, rock and concrete erosion control measures is recommended throughout the areas adjacent to the boat ramp and Caravan Park. These materials are not likely to be performing as intended and better erosion control outcomes could be achieved through shoreline realignment, foreshore landscaping and revegetation activities.

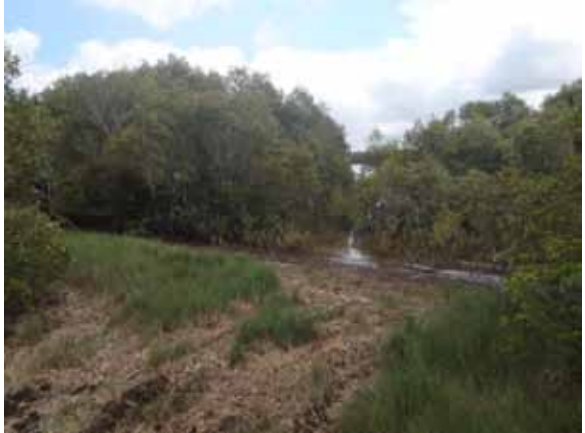
Shoreline Section Number	Existing Condition	Proposed Management Strategy
<p>1. The Esplanade North – approx. 210m</p>

<ul style="list-style-type: none"> • Grassy foreshore with dense mangrove community • Shorebird habitat 	<ul style="list-style-type: none"> • Maintain status quo
<p>2. The Esplanade North-Caravan Park – approx. 300m</p>

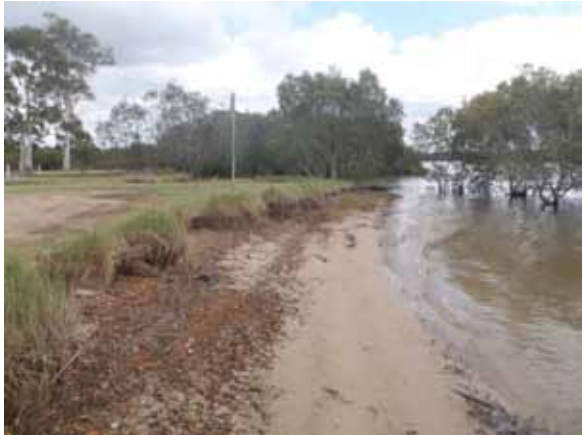
<ul style="list-style-type: none"> • Erosion scarp and loosely placed rock rubble • Rock, concrete and timber in sections south of jetty 	<ul style="list-style-type: none"> • Relocate playground equipment • Revegetation and foreshore landscaping, construction of foreshore pathway and shoreline stabilisation with native vegetation • If threat to permanent infrastructure becomes unacceptable, plan for enhanced management action through formalised seawall

- Section 2 (The Esplanade North and Caravan Park): \$150,000; and
- Section 3 (Grant Lane-The Esplanade South): \$100,000.

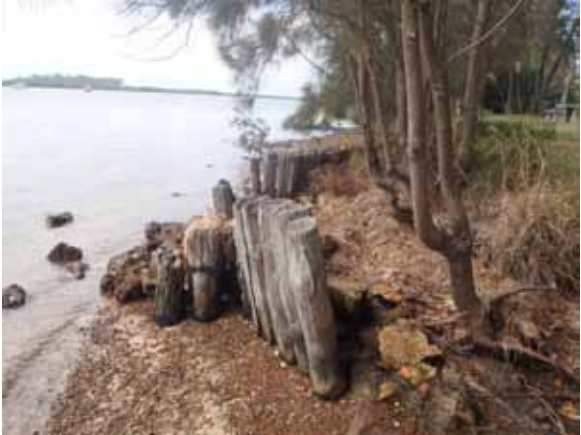
Shoreline Section Number	Existing Condition	Proposed Management Strategy
<p>3. Grant Ln-The Esplanade South – approx. 320m</p>

<ul style="list-style-type: none"> • Erosion scarp and loosely placed rock rubble • Rock, concrete and timber in sections south of boat ramp 	<ul style="list-style-type: none"> • Foreshore landscaping, construction of foreshore pathway and shoreline stabilisation with native vegetation
<p>4. The Esplanade South – approx. 740m</p>

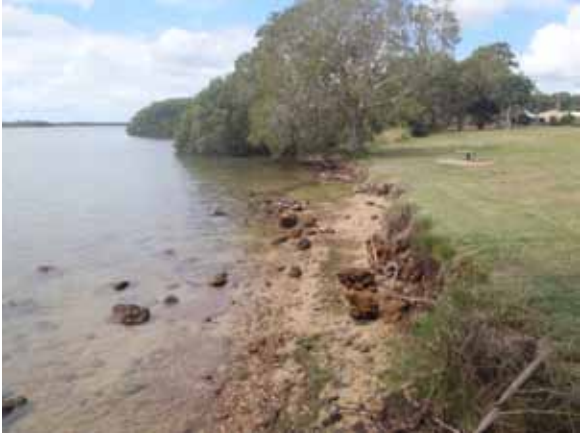
<ul style="list-style-type: none"> • Erosion scarp and loosely placed rock rubble • Wide grassy foreshore • Dense mangrove toward south • No significant assets within erosion prone area 	<ul style="list-style-type: none"> • Sort loose rock at shoreline • Revegetation and ongoing foreshore and vegetation management
