Northern Moreton Bay Shoreline Erosion Management Plan

Stage 2 Final Report

Prepared for: Moreton Bay Regional Council

Prepared by: BMT WBM Pty Ltd (Member of the BMT group of companies)

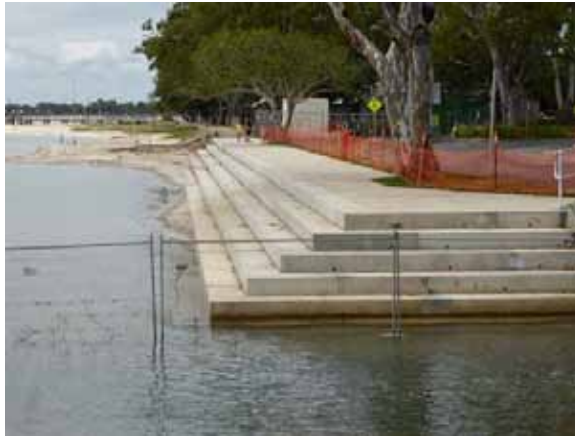
Figure 1-2 Precast Concrete Stepped Seawall at Bongaree (Auzcon, 2014)

- Bongaree precast concrete stepped seawall;
 - Albert and Myrtle Park (Beachmere) tightly packed rock revetment seawall; and
 - Beachmere Activity Centre loosely placed rock revetment seawall.

Examples of the above seawall types are shown in Figure 1-2 and Figure 1-3. The cost estimates are provided for planning purposes only and may not be representative of the actual costs incurred if and when the promoted strategy is implemented.

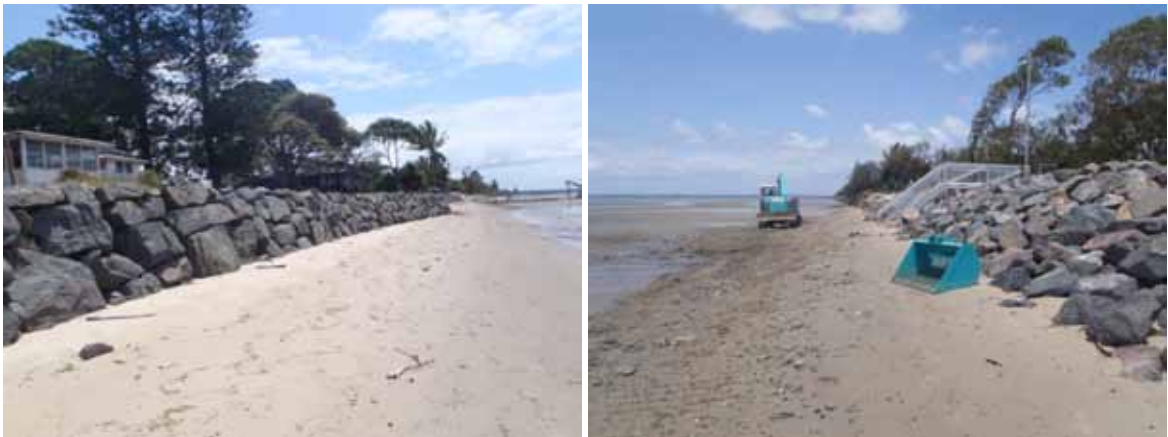
Figure 1-3 Rock Revetment Seawalls at Beachmere: Tightly Packed (left) and Loosely Placed (right)
