## 5 Sandstone Point

### 5.1 Council Controlled Areas and Current Condition

Title:  
**Sandstone Point Beach Unit - Council Controlled Shoreline Area and Current Condition**

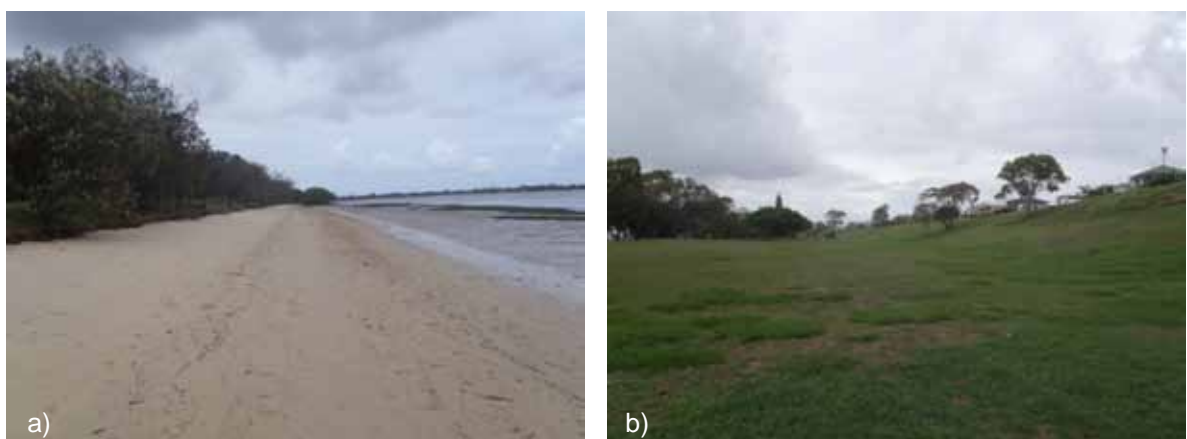
**Figure 5-1 Example Shoreline Condition throughout Sandstone Point Study Area: a) Sandy Beach with Coastal Vegetation; b) Grassy Foreshore with Elevated Residential Lots Setback from Shoreline**

The main public access to the shoreline is via Oxley Place which offers car parking, picnic facilities and playground equipment. The grassy foreshore and narrow sandy beach (refer Figure 5-1a) add significant social and recreational value to the area. The sandy shoreline is lined with well-established vegetation and the threat of erosion to natural and Council controlled assets appears low. Privately owned lots are positioned above the grassy foreshore and are not exposed to coastal processes (refer Figure 5-1c).

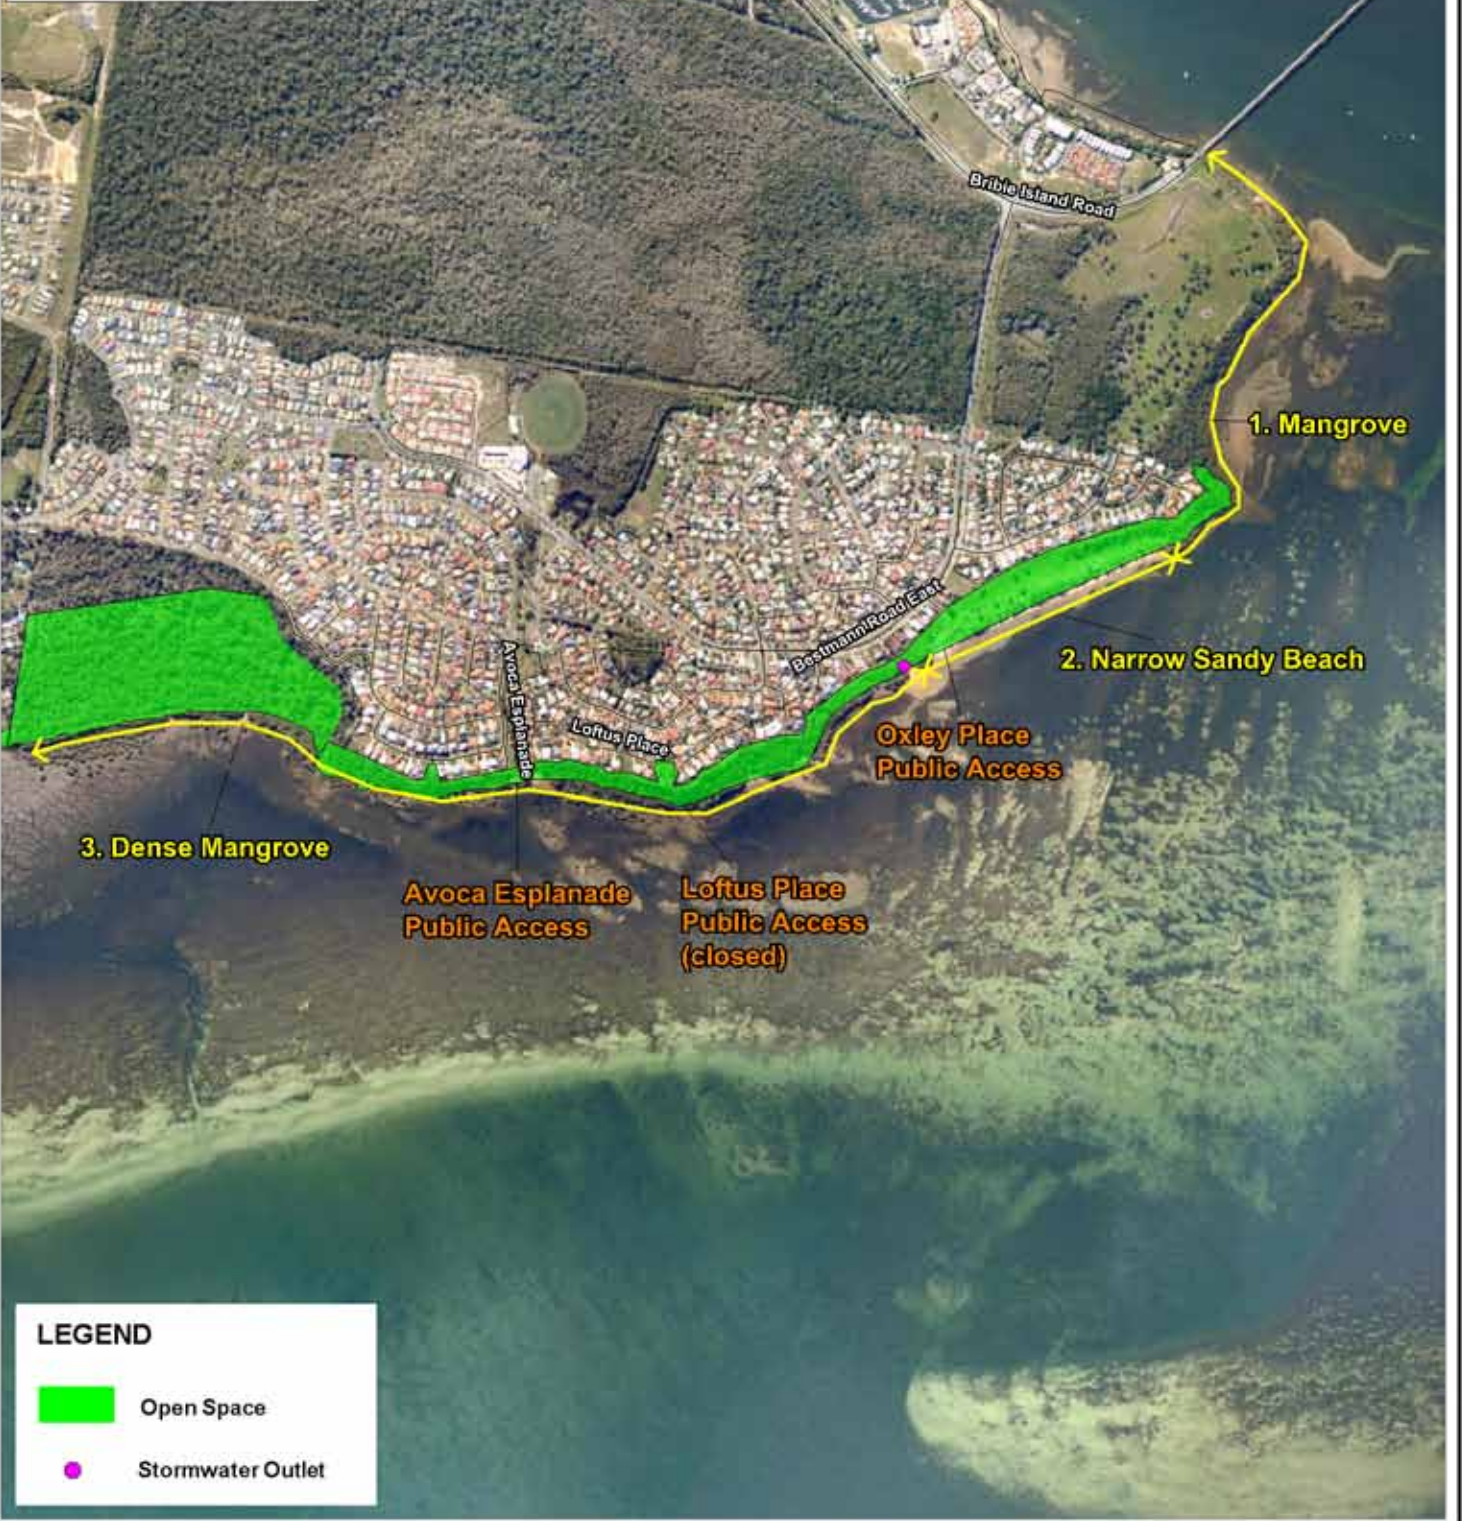
Figure:  
**5-2**

Council controlled land and shoreline types within the Sandstone Point study area are indicated in Figure 5-2. The beach unit is within a declared Conservation Park Zone with significant seagrass beds located offshore and identified shorebird habitat within the intertidal areas (refer Appendix A). The majority of the shoreline is characterised as open space with management of the public areas outlined in the Sandstone Point Foreshore Parkland Land Management Plan (MBRC, 2009). Public access to the shoreline is restricted in most areas due to dense mangrove, natural topography and/or privately owned land. One main access point to a 600m stretch of foreshore exists, with additional access available via narrow easements between privately owned lots. Most of the Sandstone Point community is elevated at +10mAHD and therefore the erosion and inundation threat to private land due to coastal processes is considered negligible.

The proposed management strategy for the Sandstone Point shoreline sections defined in Figure 5-2 are summarised in Table 5-2. An enhanced management strategy is not considered necessary at this time; however, a number of passive actions are promoted to ensure social and environmental values are maintained.

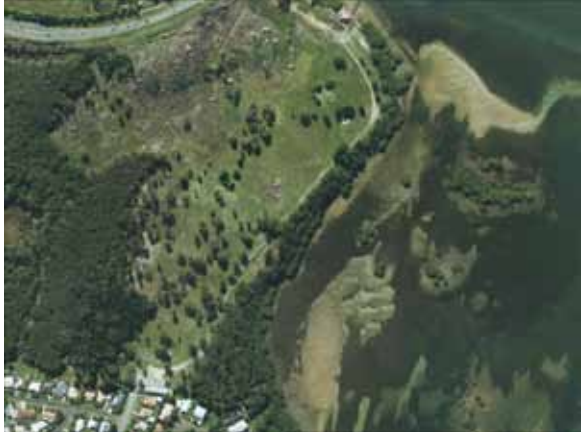
Shoreline Section Number	Existing Condition	Proposed Management Strategy
<p>1. East of Bestmann Rd – approx. 1200m (Lot 6 SP187342)</p>

<ul style="list-style-type: none"> <li>• Mangrove shoreline forming private lot boundary</li> <li>• Tidal flat offshore</li> <li>• No Council controlled land at shoreline</li> </ul>	<ul style="list-style-type: none"> <li>• Provide landholder(s) with information regarding appropriate erosion buffer and erosion control strategies</li> <li>• Ensure appropriate coastal and shoreline management buffer is considered where development is proposed</li> </ul>
<p>2. Clark Tce – approx. 630m</p>

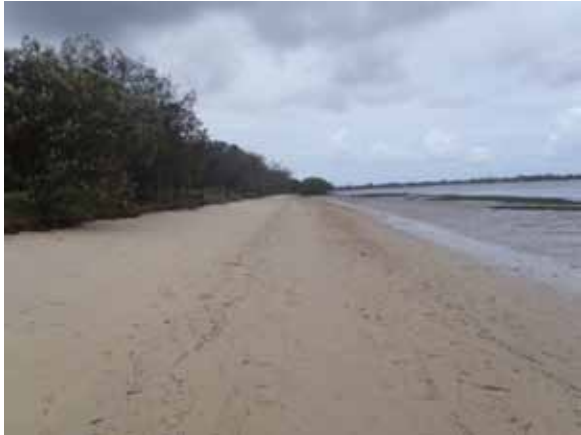
<ul style="list-style-type: none"> <li>• Sandy beach with tidal flat offshore</li> <li>• Mangrove and grassy foreshore provide erosion buffer</li> <li>• No significant assets in erosion prone area</li> </ul>	<ul style="list-style-type: none"> <li>• Enhance foreshore vegetation condition, potentially incorporating pedestrian management options to improve vegetation (and shoreline) resilience</li> </ul>
