# MAINTENANCE PLAN KAKADU BEACH PARKLAND AND CONSTRUCTED HIGH TIDE ROOST FACILITY – BRIBIE ISLAND

2017

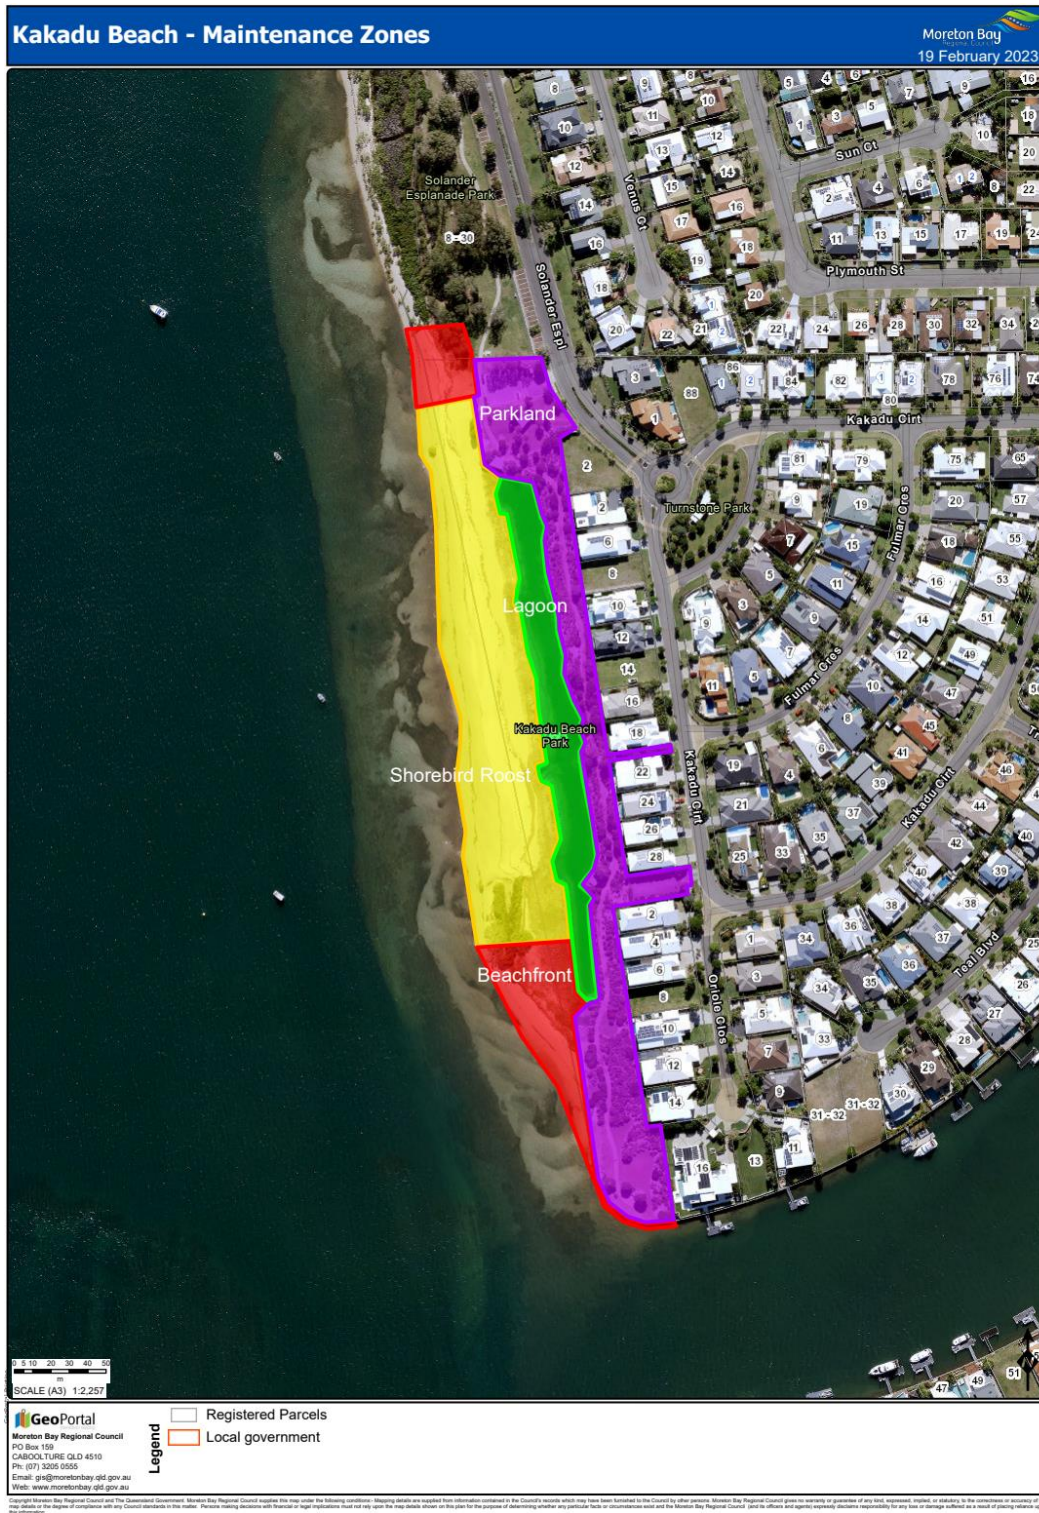
Figure 5: Kakadu Shorebird Roost Maintenance Zones

There are four different maintenance zones covered by this maintenance manual, each designed for a specific purpose. These zones, known as 'Parkland', 'Beachfront', 'Lagoon' and 'Shorebird Roost Site', are shown in Figure 5. A brief description of each maintenance zone and its purpose is provided below.

The 'Parkland' is shown as the area outlined in purple in Figure 5. The parkland provides an area for public recreation and contains landscaped gardens and lawns, pathways and seating and facilities for bird watching including interpretive exhibits and bird viewing hides. Most vegetation in the landscaped gardens is intentionally kept short (except for established trees). The planting and regeneration of preferred roosting and nesting trees (such as Eucalypts and Casuarina) of raptors is avoided to reduce the risk of attracting them to the site which could compromise the safety of the shorebirds. However; there is an acceptance that raptors such as Sea Eagles, Brahminy Kite and Osprey are within the region and cannot be completely excluded from the area. The landscaped gardens also help to provide a barrier to deter domestic animals from entering the shorebird roost site and lagoon area.

The 'Beachfront' is shown as the two areas outlined in orange in Figure 5. These areas provide the public with access to the beachfront to the left and right hand side of the shorebird roost site. Signage has been erected in these areas to warn the public, including the boating public, not to enter the shorebird roost site. Fencing at either end of the roost site and an outcrop of mangroves on northern end of the southern section of beachfront deters humans and domestic animals from entering the site.

The 'Lagoon' is outlined in green in Figure 5. This lagoon sits between the parkland and the shorebird roost site and provides an effective barrier to prevent humans, domestic animals and feral animals from entering the shorebird roost site. The shallow edge of the lagoon on the side adjacent to the shorebird roost site also has the potential to be used by shorebirds. The vegetation on this side of the lagoon includes rushes and *Ishaemum tritiecum* that are to be retained to provide stability to the bank. However; if the extent of vegetation growth is identified as an impediment to access to the lagoon by shorebirds, corridors for accessibility will be identified for vegetation thinning.

The 'Shorebird Roost Site' is shown as the area outlined in yellow in Figure 5. The shorebird roost site provides shorebirds with an area to roost at high tide and is one of the few high tide roost sites in Pumicestone Passage. To feel secure, shorebirds need an area with relatively sparse, short vegetation. The exception is the small cluster of established vegetation at the south of the roost that acts a natural barrier to prevent public from entering. These include; *Hibiscus tiliaceus* and *Avicennia marina*. Regenerating trees, mangroves and propagules in the permit area is therefore removed from the roost site and vegetation is kept very low. The public are prevented from entering the shorebird roost site to minimise the disturbance. Maintenance is limited to periods of low tide and care is taken between September and March when migratory species are resident at the site.

The Kakadu Beach Constructed High Tide Migratory Shorebird Roost Facility forms part of Kakadu Beach Park maintenance that is comprised of four distinctive zones including; a parkland area, beachfront, lagoon and shorebird roost identified in Figure 5. The shorebird roost zone requires a maintenance program to keep the sandy beach suitable for roosting shorebirds. Management actions include; removal of litter and debris washed up on the shoreline, weed control, removal of propagules and newly established or minor vegetation to ensure suitable habitat for migratory shore birds whilst reducing impacts to the tidal area and dunal system.

Restricted access signage  (When maintenance inspection identifies action required)	Refix, repair, relocate and replace signage as required.	Low tide	Natural Area Team
Lagoon mangrove control	Remove mangrove propagules and germinates colonising the lagoon area as identified in the green polygon in Figure 5.	Low tide, at time of each beach grooming	Natural Area Team

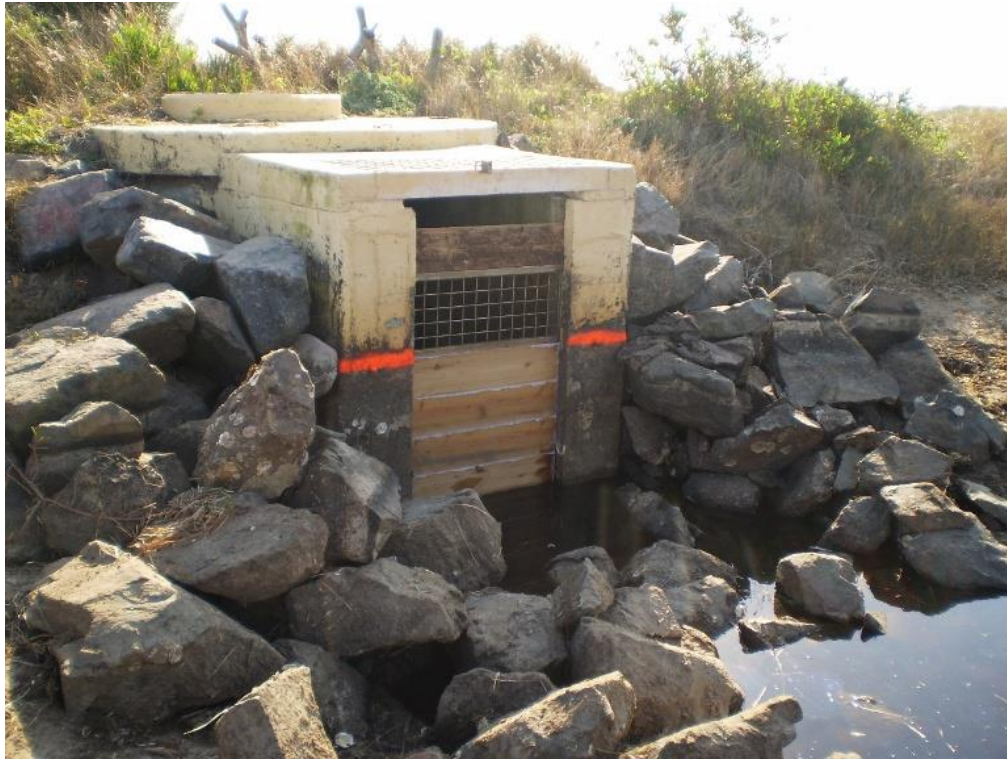
**Photo 2 Weir grills and orange paint setting the RL for the weir boards.**

ACTIVITY	TASK	DURATION	RESPONSIBILITY
Lagoon western shoreline vegetation.  (When maintenance inspection identifies action required)	Maintain low growing native ground covers (including; rushes and native grasses) along the western shoreline including over the revetment wall to perform the role of a vegetated sand dune separating the lagoon from the cleared high tide roost. Monitor the extent of vegetation growth as an impediment to access to the lagoon by shorebirds. If vegetation growth is preventing access; corridors for accessibility will be identified for vegetation thinning. The dune vegetation will provide habitat and prevent westerly winds from filling the lagoon with windblown sand.	Low tide	Natural Area Team
	Ensure vegetation growth/colonisation does not impede sight lines for children and adults from the two bird hides.	As required	Natural Area Team
Lagoon inlet/outlet weir/s	Inspect the inlet/outlet weirs to ensure there are no blockages/leaks to maintain a permanent lagoon water level of RL 0.83 m AHD (Mean High Water Spring) with an absolute minimum water level of RL 0.53 m.	6 times a year within 2 hours of low tide	Natural Area Team

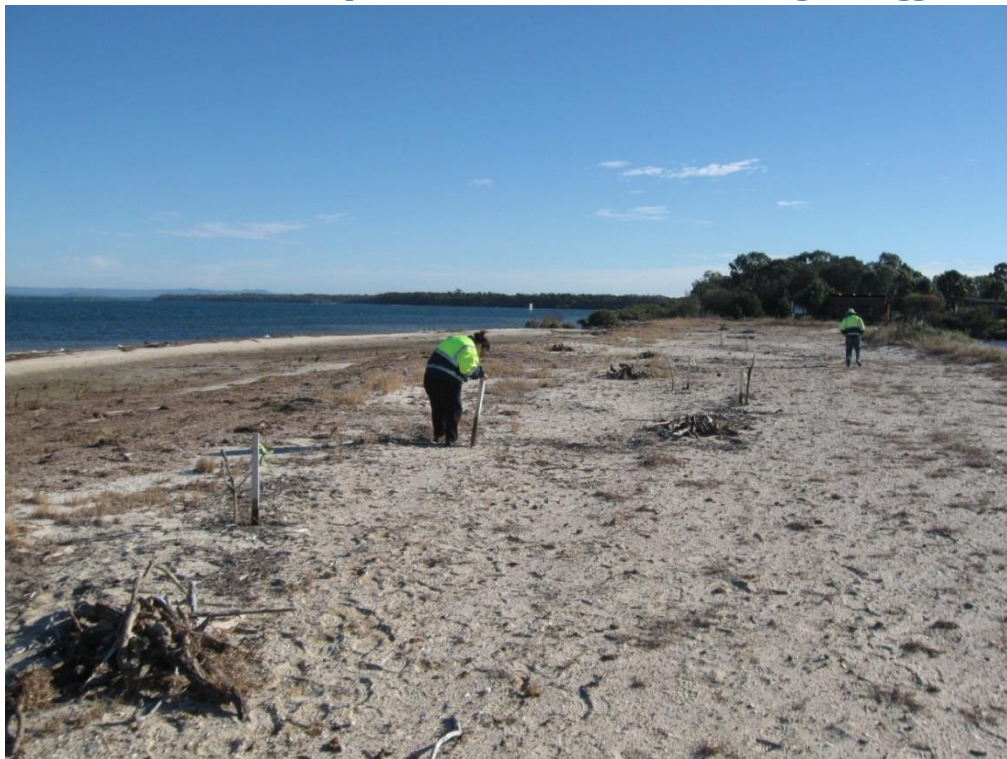
**Photo 3 Prestart inspection to locate and mark nesting bird eggs**

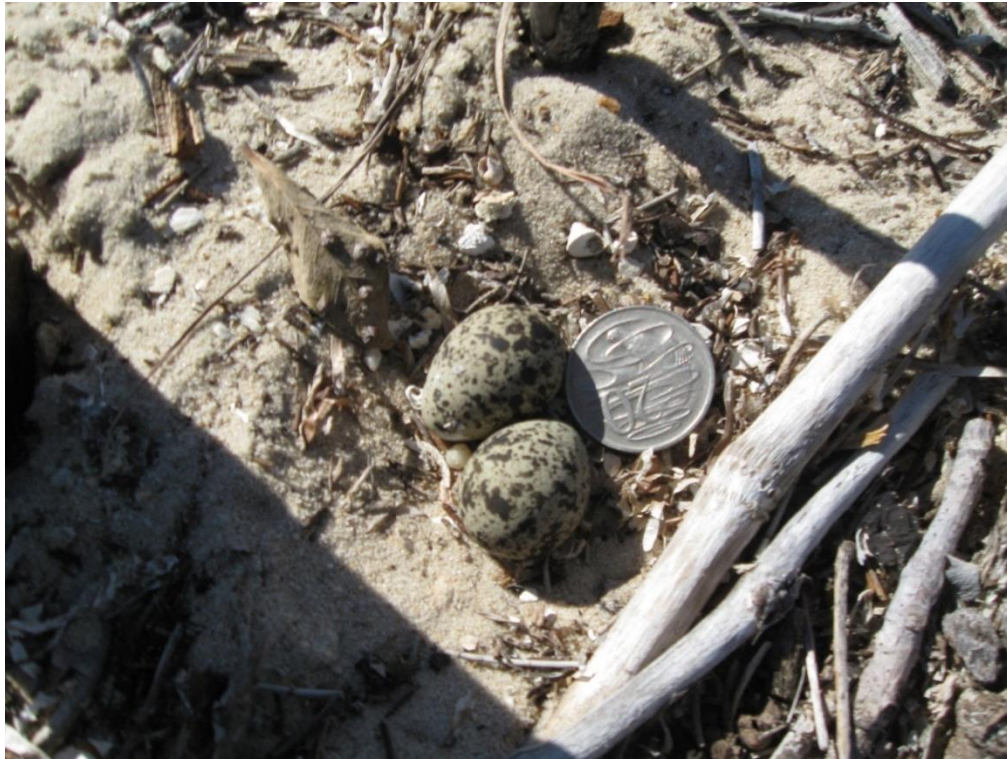
**Photo 4 Identification of well camouflaged bird eggs.**

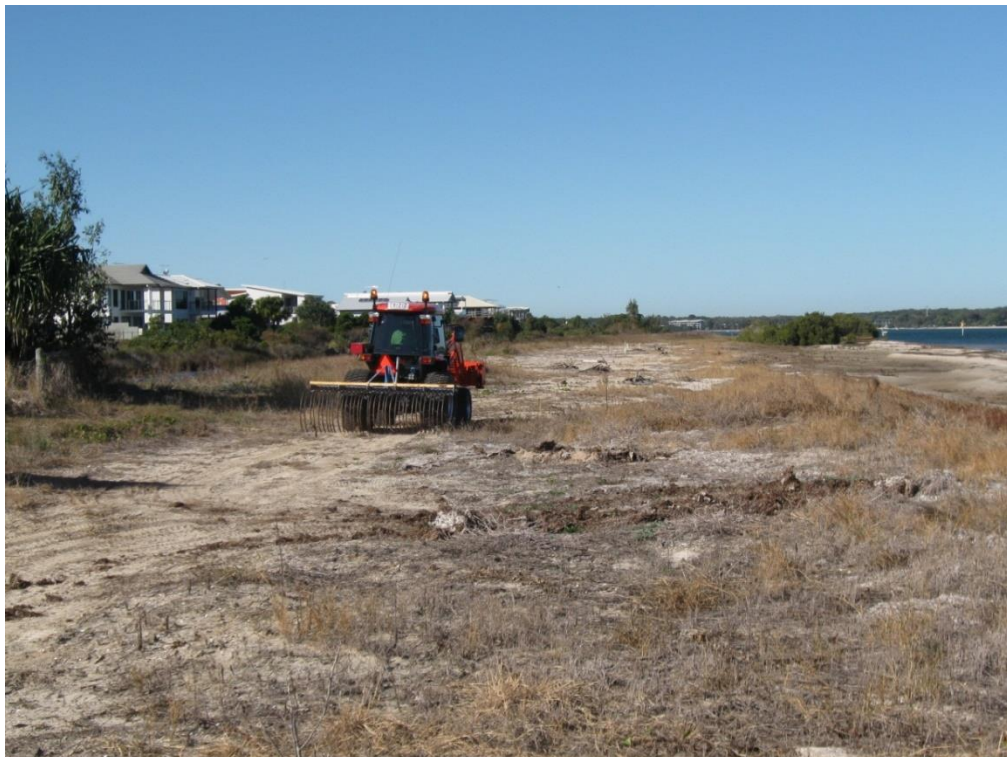
**Photo 5 High tide roost well overdue for grooming.**

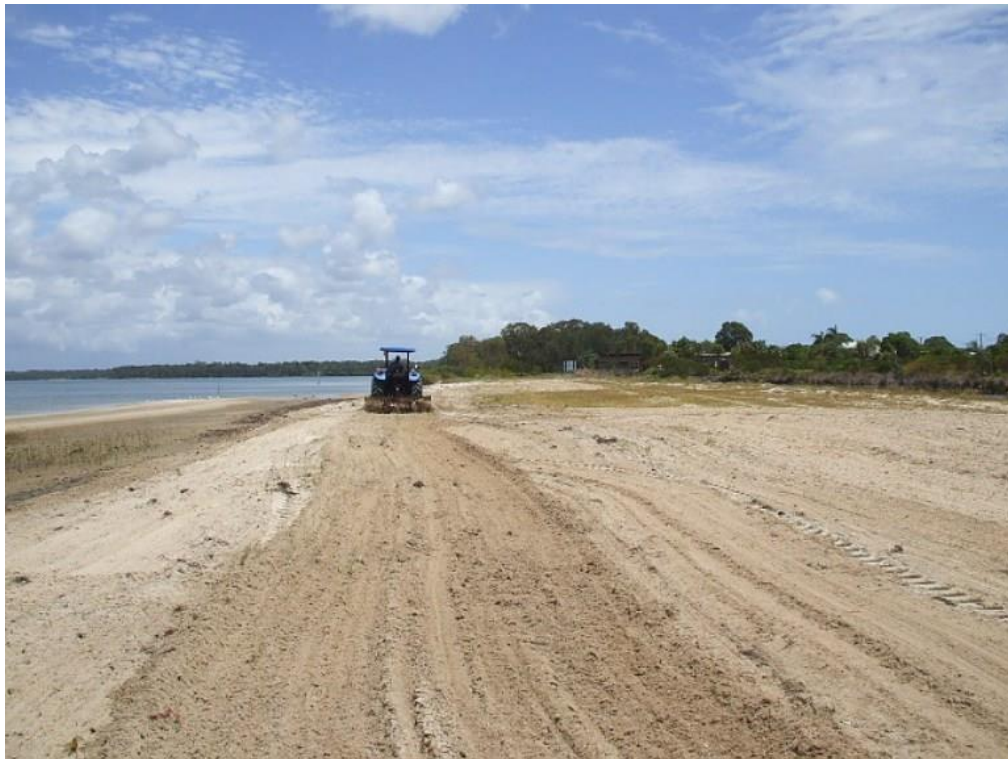
**Photo 6 High tide roost being groomed of vegetation**

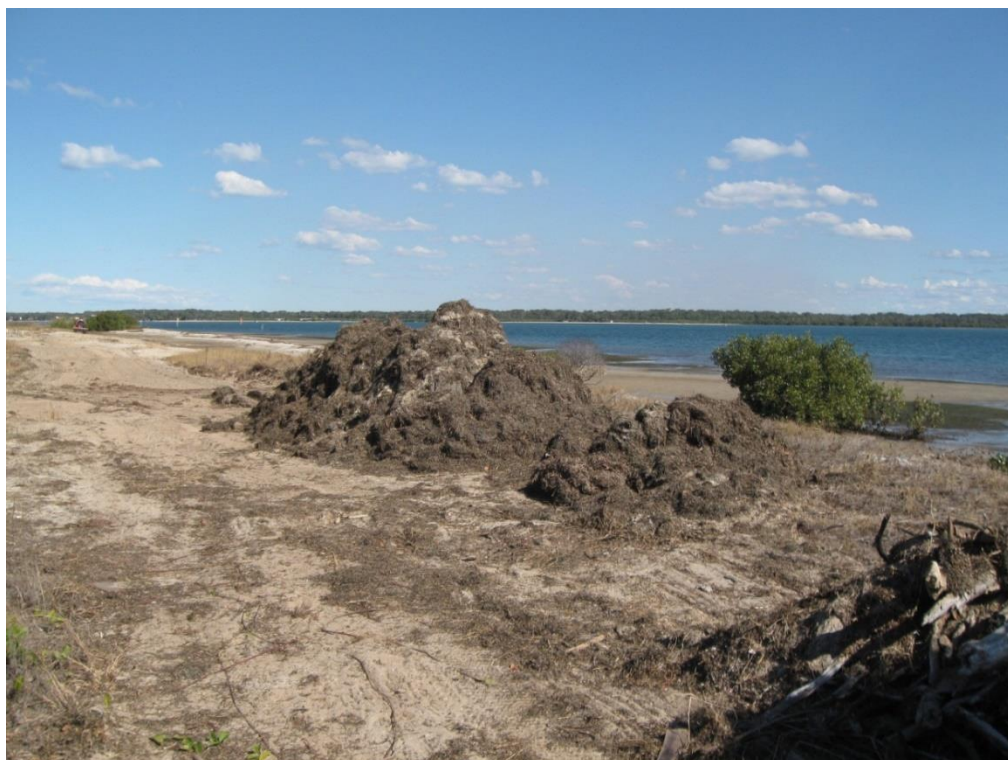
**Photo 7 Organic debris raked to each end once man-made litter has been manually removed from site.**

Strip the tidal foreshore area using a stick rake to drag all flotsam and vegetation to either end for on-site decomposition (refer to Appendix 4 Photos). Maintain the buffer of <i>Sesuvium portulacastrum</i> , <i>Carpobrotus glaucescens</i> or native species similar in growth habit within the tidal zone, that does not impede shorebird use and provides stability to the foreshore.	April, early August, December or as required at low tide	Natural Area Team
Mangrove control  (When maintenance inspection identifies action required)	Control and remove newly regenerated mangroves and propagules within the shorebird roost (marked as the yellow area in Figure 5). This will largely be comprised of manual removal.	Low tide	Natural Area Team
