Northern Moreton Bay Shoreline Erosion Management Plan

Summary Report

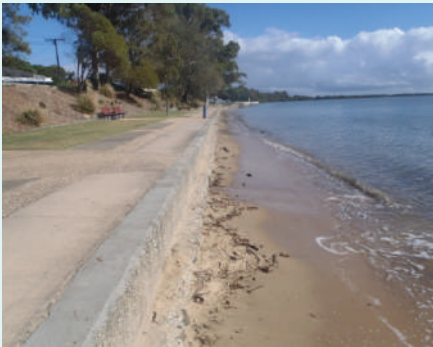
Stepped seawall

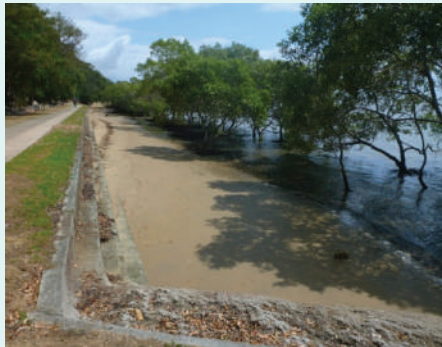
Stepped seawall with mangrove buffer

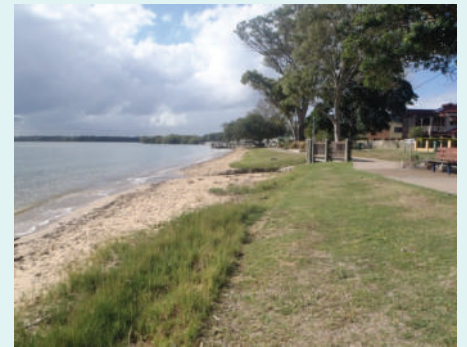
Vegetated shoreline

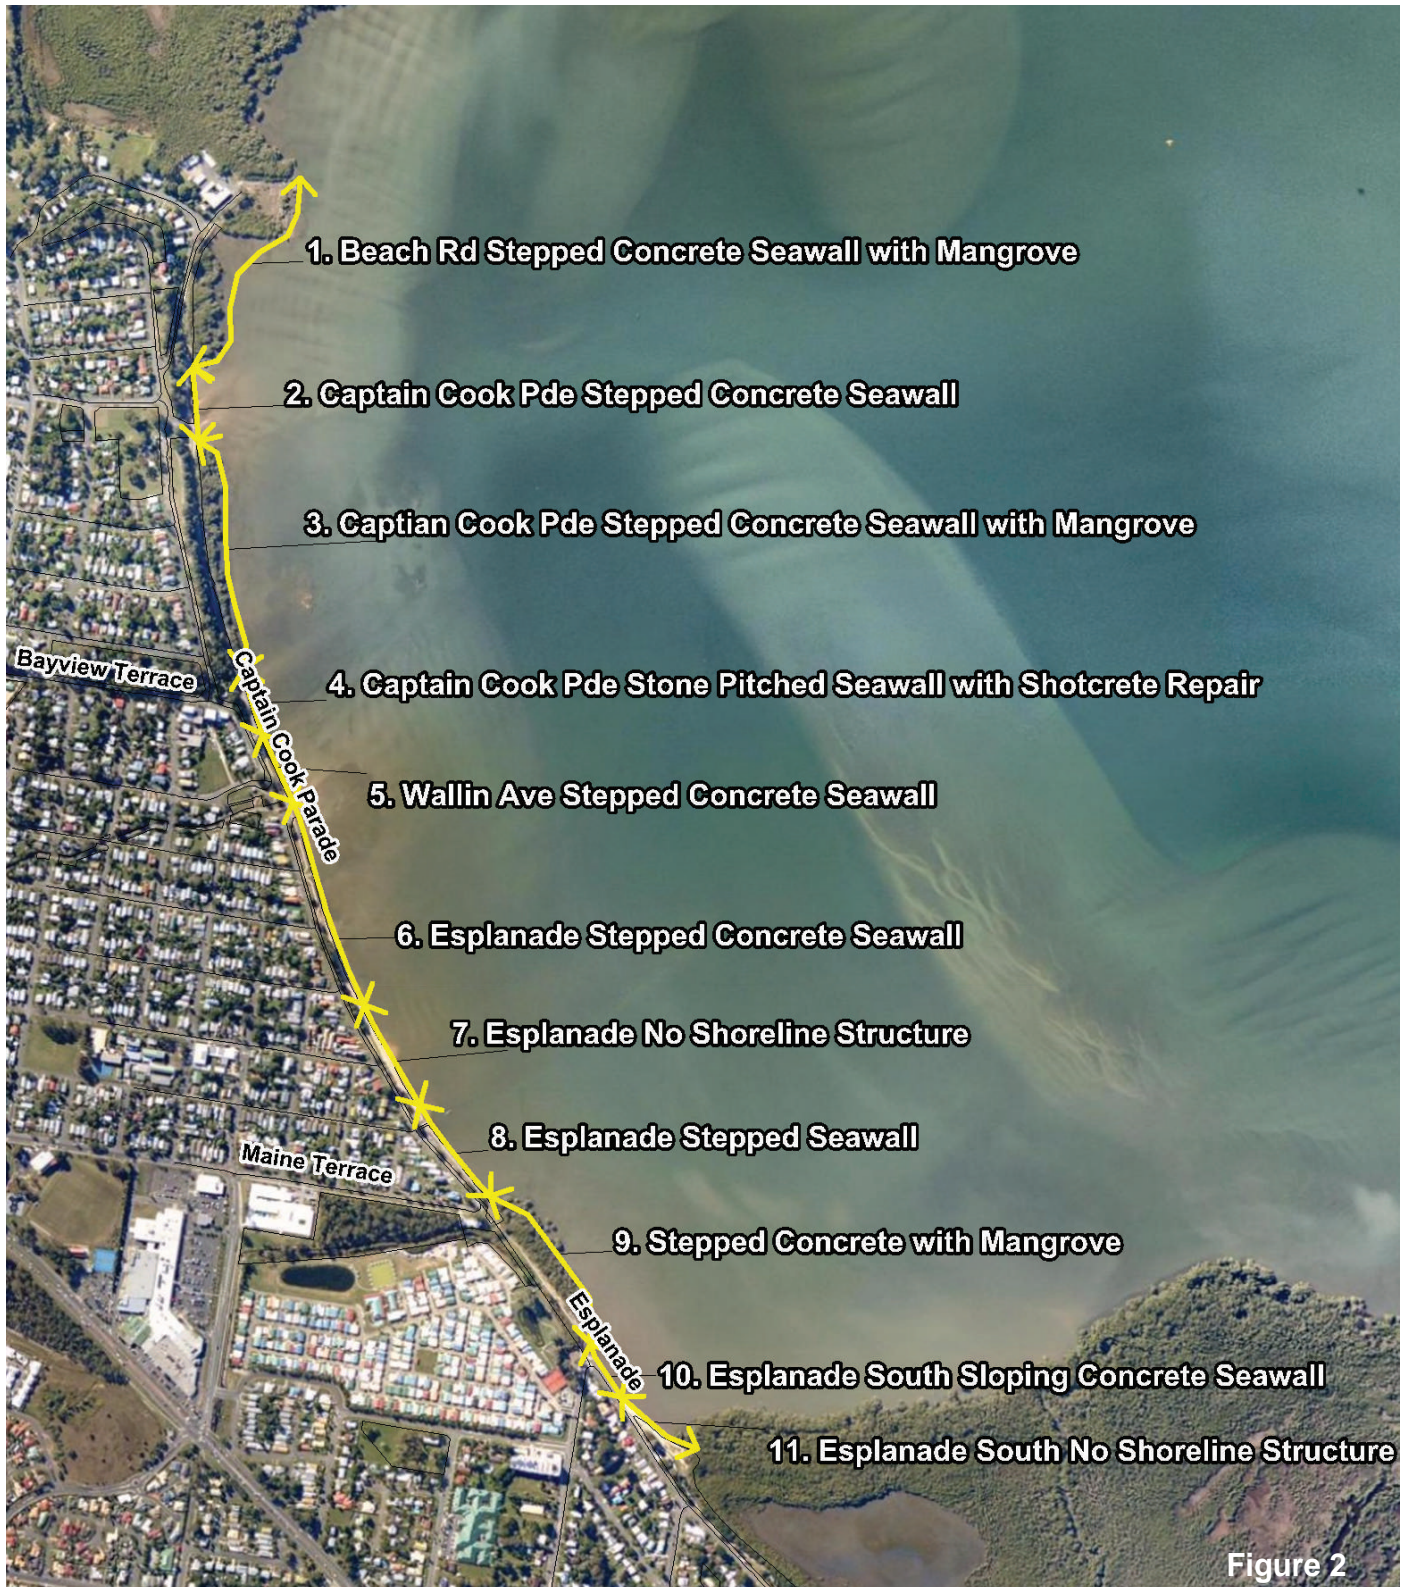
Figure 2

Shoreline types within the Deception Bay study area are indicated in Figure 2. The beach unit is characterised by open public areas protected by seawalls. The area has significant social and recreational value associated with coastal pathways, landscaped foreshore areas, picnic facilities and Council controlled boat ramps. Environmental values are also evident, with small mangrove communities within the beach unit and the offshore areas a declared Habitat Protection Zone. Established mangrove habitats are

The existing management strategy throughout the Deception Bay study area is maintaining a valuable open public space. Most shoreline structures are in good condition and do not require significant upgrade at this time. Preservation of mangroves

- Maintain status quo including ongoing foreshore and vegetation management
- Inspect seawall and foreshore condition following severe storm events
- Perform maintenance as required

- Upgrade Section 4 seawall and setback/realign with existing stepped seawall to the north
- Explore options to intercept and reuse sand that accumulates at the Wallin Ave storm water outlet

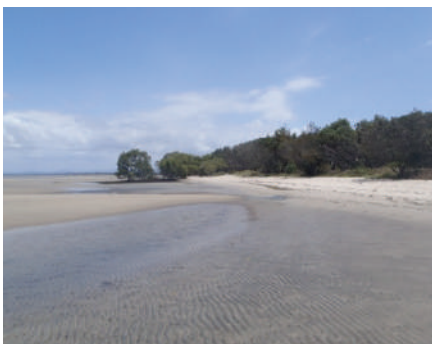
Tidal flats and vegetated Shoreline (Section 2)

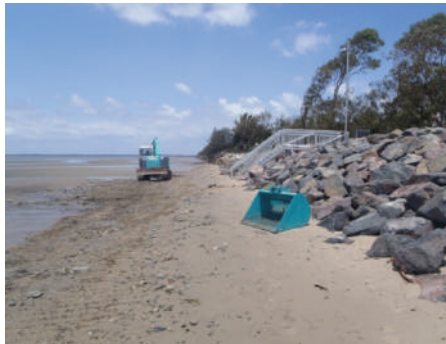
Due to ongoing erosion pressure and maintenance issues associated with existing structures in poor condition, Council has recently upgraded seawalls at the Beachmere Activity Centre and Albert and Myrtle Lehman Park. Conditional approval for seawall rehabilitation works at southern extent of Biggs Ave has also been gained.

Rock seawall construction at Beachmere Activity Centre

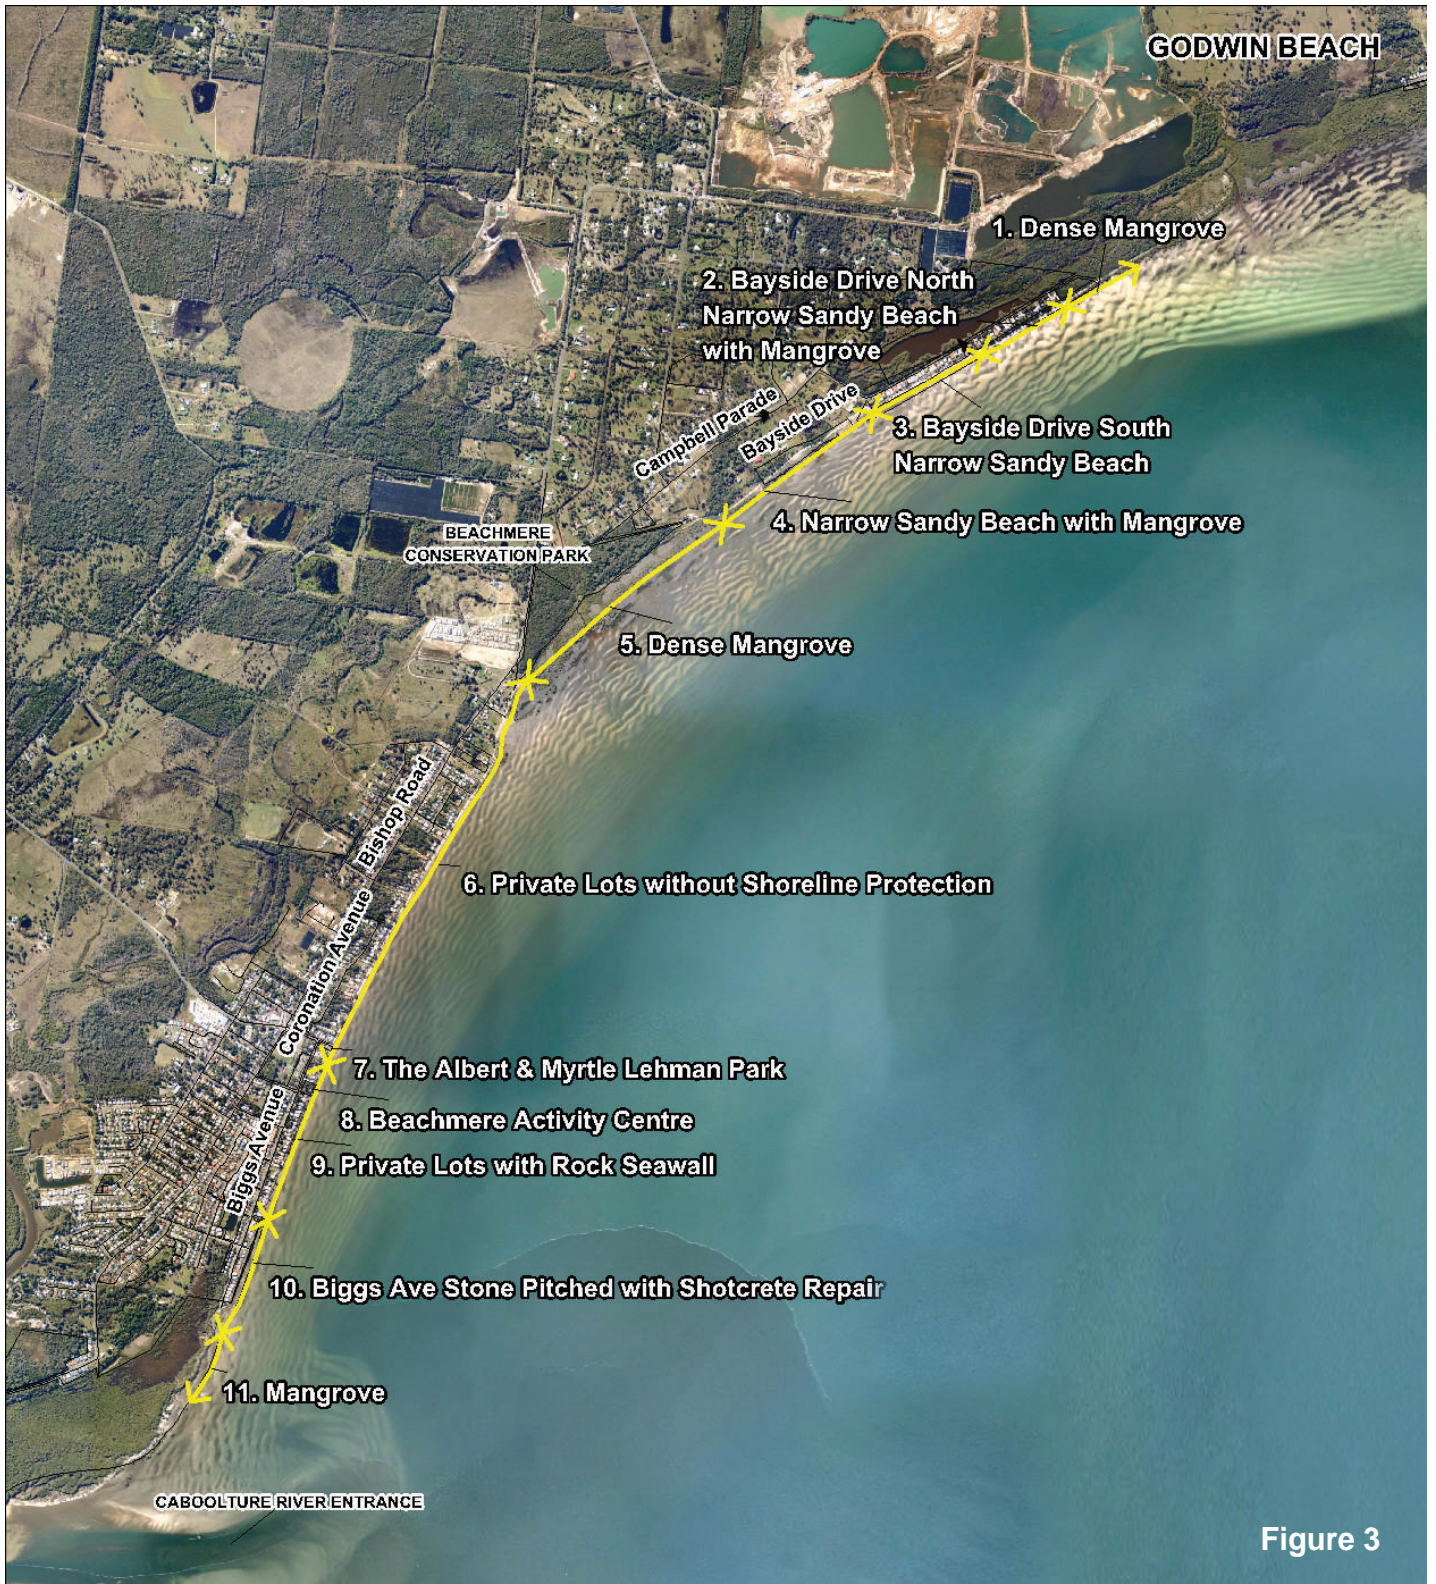
Figure 3

Council controlled land and shoreline types within the Beachmere study area are indicated in Figure 3. South of the Beachmere Conservation Park, private lots extend to the shoreline with public access generally restricted to the seaward end of road reserves. Small pockets of additional Council controlled shoreline are located at the Beachmere Activity Centre and the Albert and Myrtle Lehman Park. Road reserve and wide tidal flats along the shoreline to the north of the Beachmere Conservation Park buffers the adjacent private lots from direct exposure to coastal processes. The

- Upgrade Section 10 seawall with a rock seawall design that better dissipates wave energy during severe storm conditions
- Community awareness program providing information on the maintenance of dune and shoreline vegetation on private land

- Distribute information to land owners regarding appropriate shoreline erosion management on private land, including the preferred conceptual design and alignment of shoreline structures

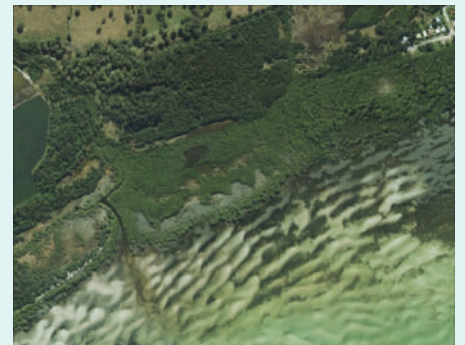
Dense mangrove community (Section 2)

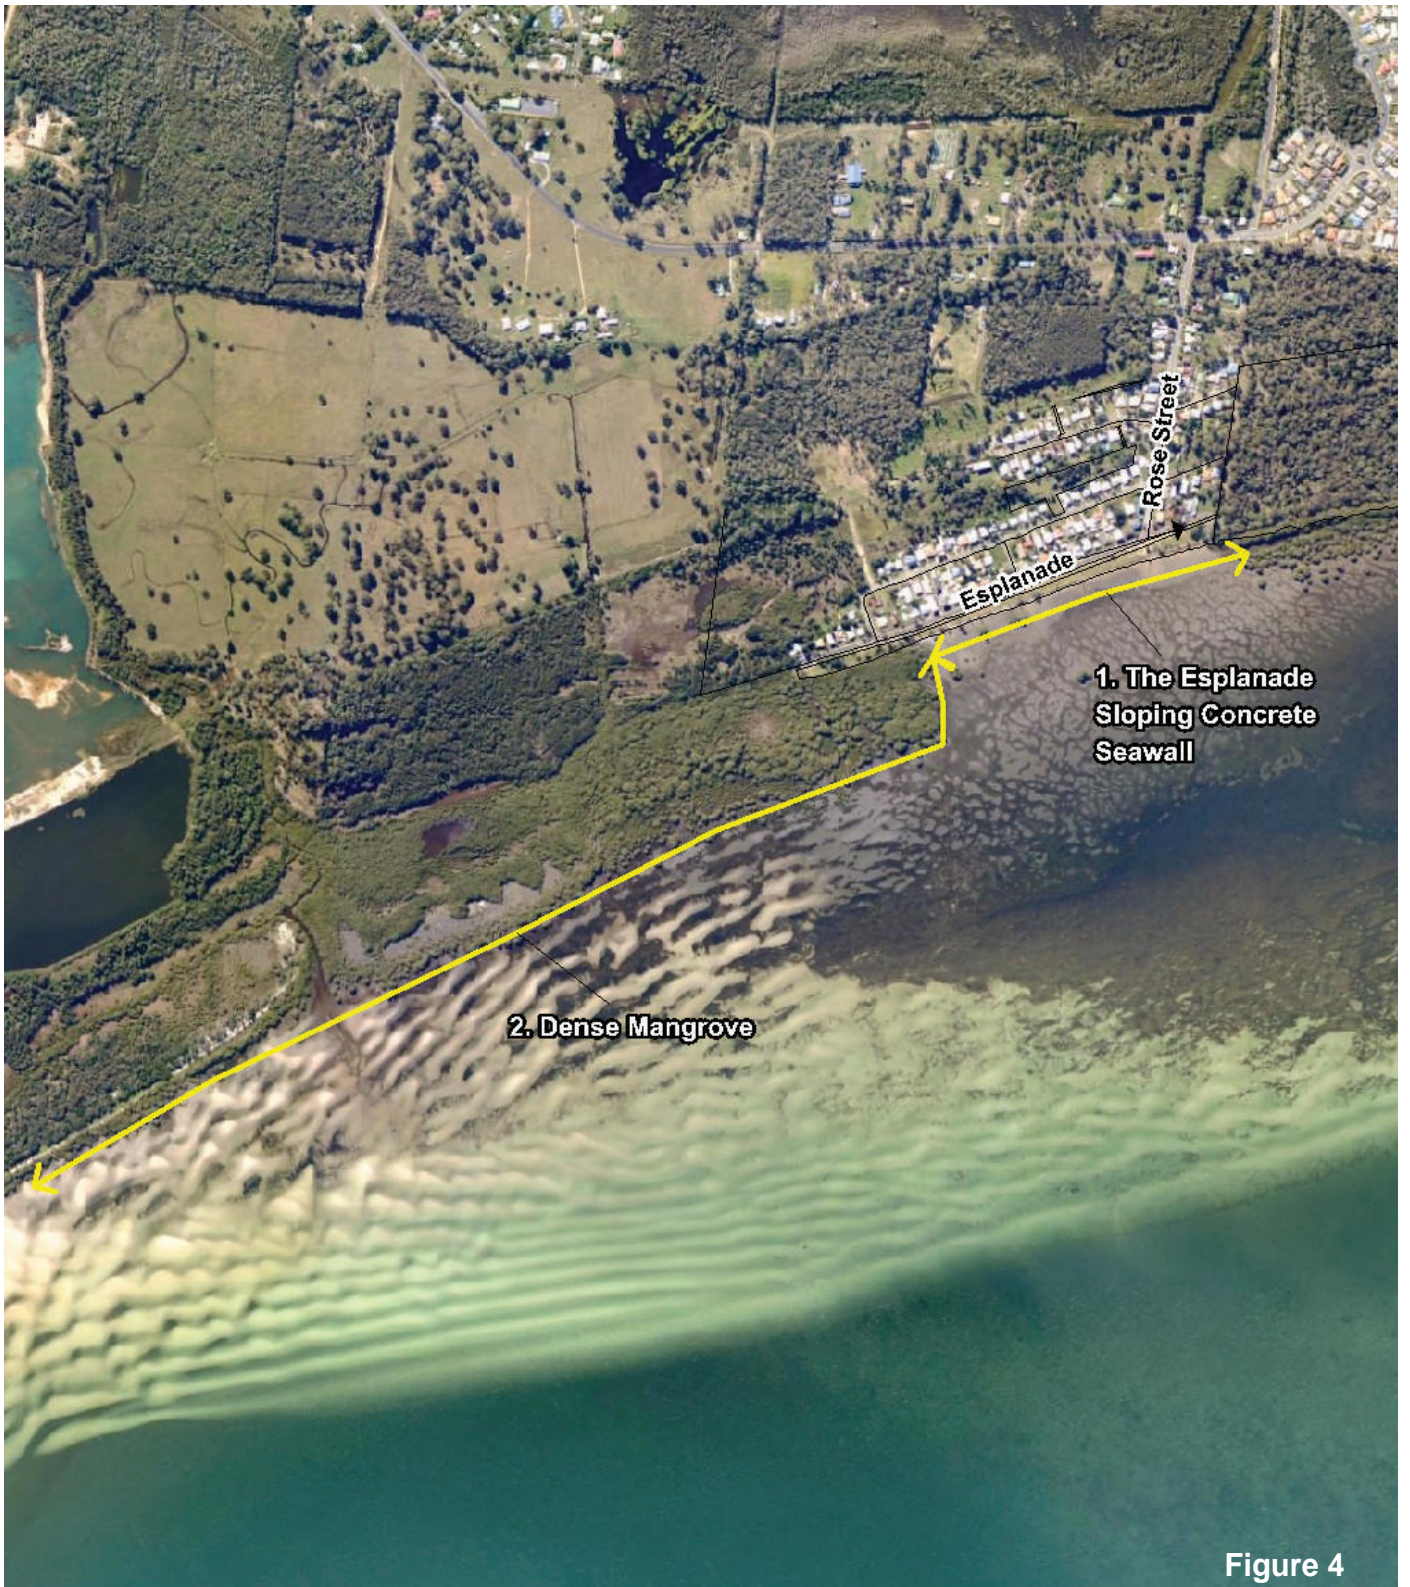
Figure 4

Council controlled land and shoreline types within the Godwin Beach study area are indicated in Figure 4. The beach unit is within a declared Conservation Park Zone and the waters offshore are part of a National Marine Park Zone with significant seagrass beds. A small section of Council controlled road reserve is located at the southern extent of the study area (north of the Bayside Drive community). At present, there is limited access to this location and no significant built assets.

beach unit. The foreshore area stretching along The Esplanade is protected by a sloped concrete seawall with signs of previous repair works. A number of stormwater outlets that extend across the beach are having a minor “groyne-like” effect with sand accumulation on their up drift (northern) side. A small pocket of identified shorebird habitat is located within the intertidal zone toward the western end of the foreshore.

The sloping seawall that protects the Godwin Beach community foreshore is in a fair condition. While no major

- Structural integrity assessment of Section 1 sloping concrete seawall and drainage infrastructure

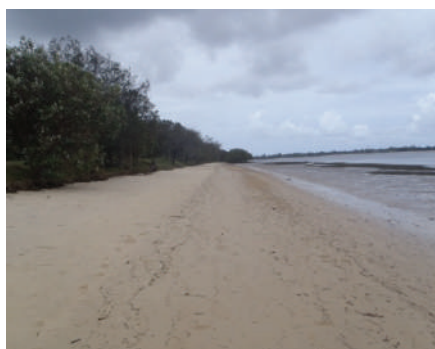
Sandy Beach with foreshore vegetation (Section 2)

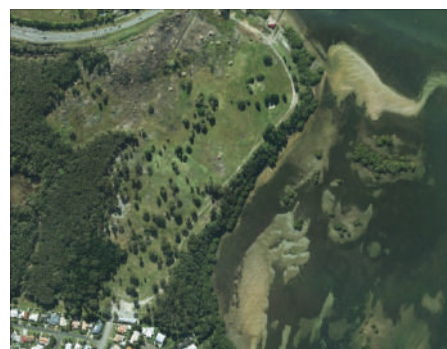
Undeveloped private lot (Section 1)

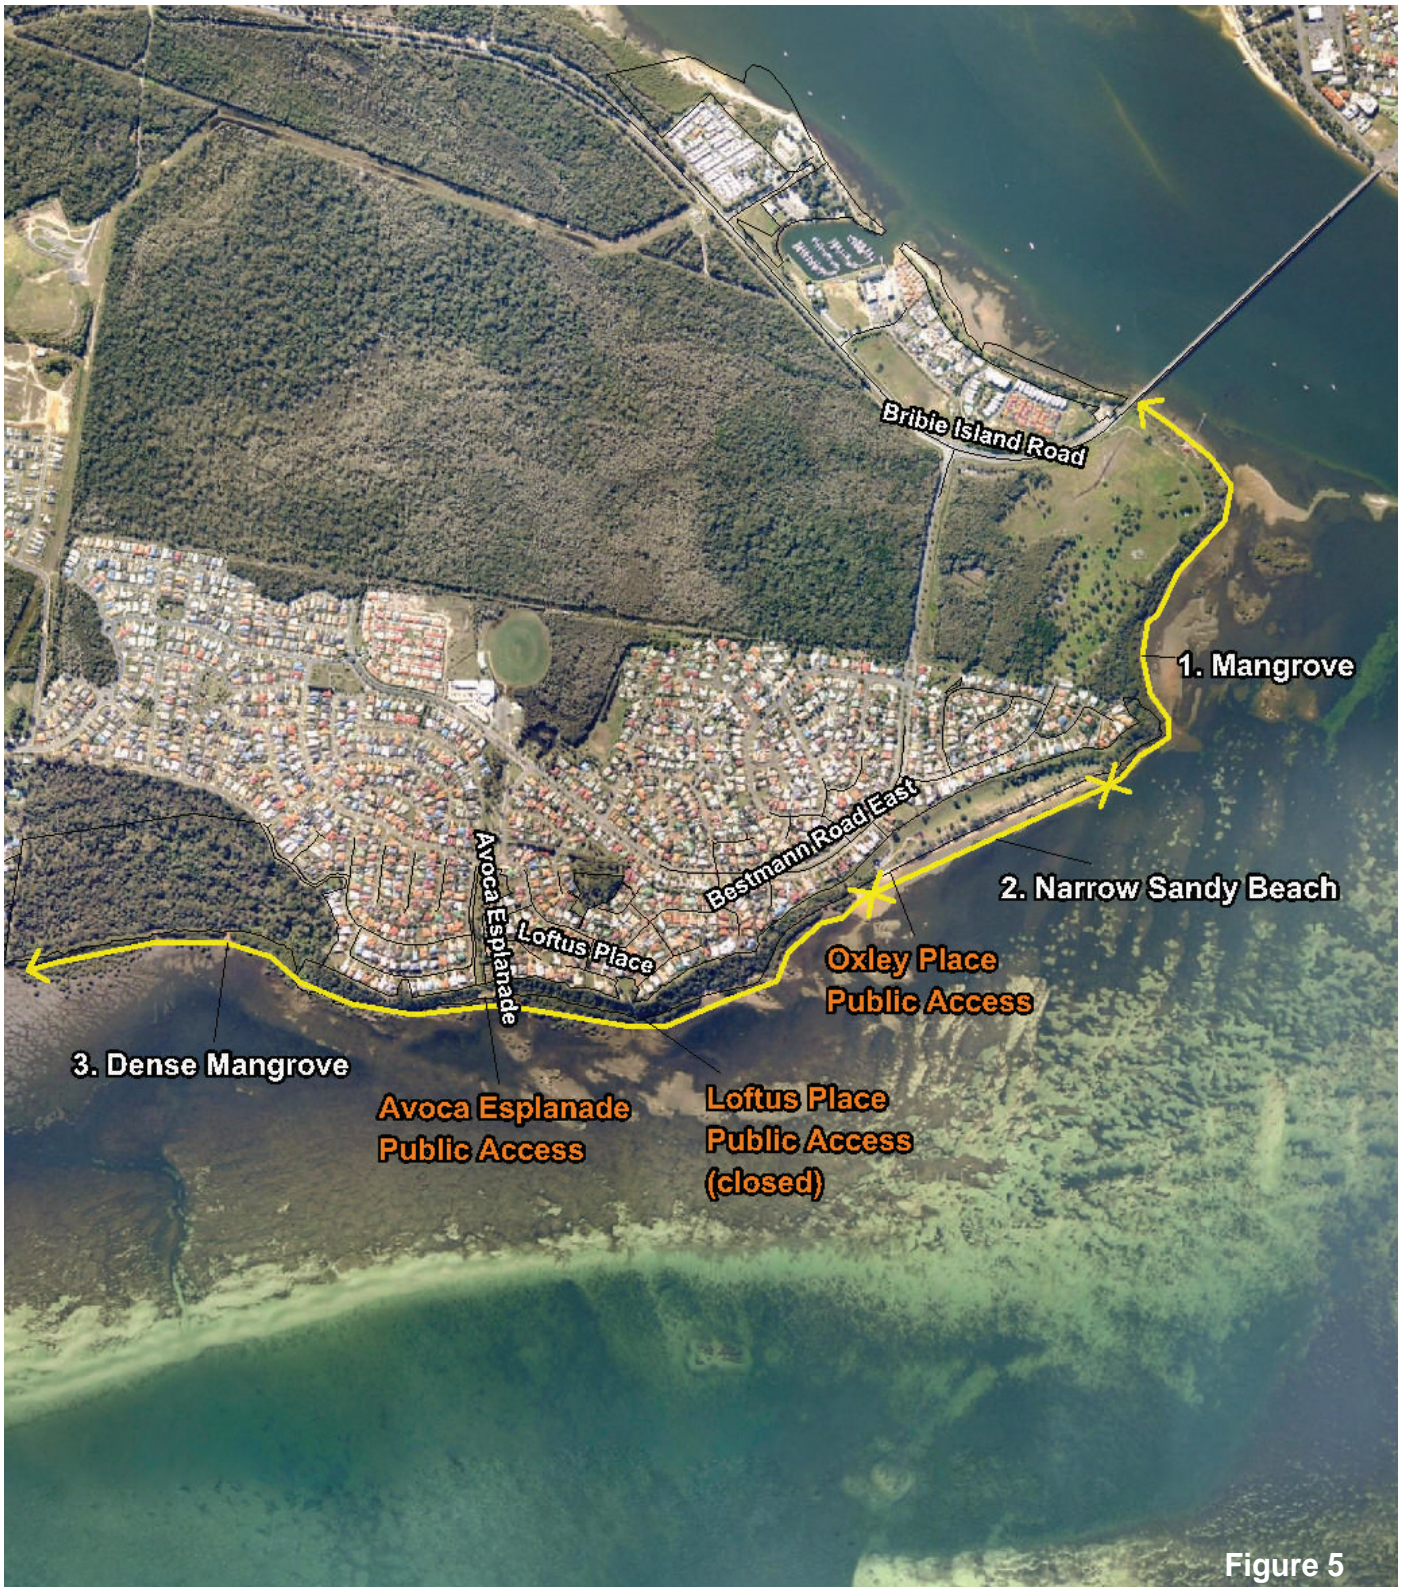
Figure 5

Council controlled land and shoreline types within the Sandstone Point study area are indicated in Figure 5. The beach unit is within a declared Conservation Park Zone with significant seagrass beds located offshore and identified shorebird habitat within the intertidal areas. The majority of the shoreline is characterised as open space with management of the public areas outlined in the Sandstone Point Foreshore Parkland Land Management. Public access to the shoreline is restricted in most areas due to dense mangrove, natural topography and/or privately owned

Access to the coastal trail with an identified safety hazard associated with a potential landslip should be formally closed. Site inspection of the Avoca Esplanade access point suggests this trail may still be used by some community members.

- Formally close access to coastal trail where a safety hazard exists

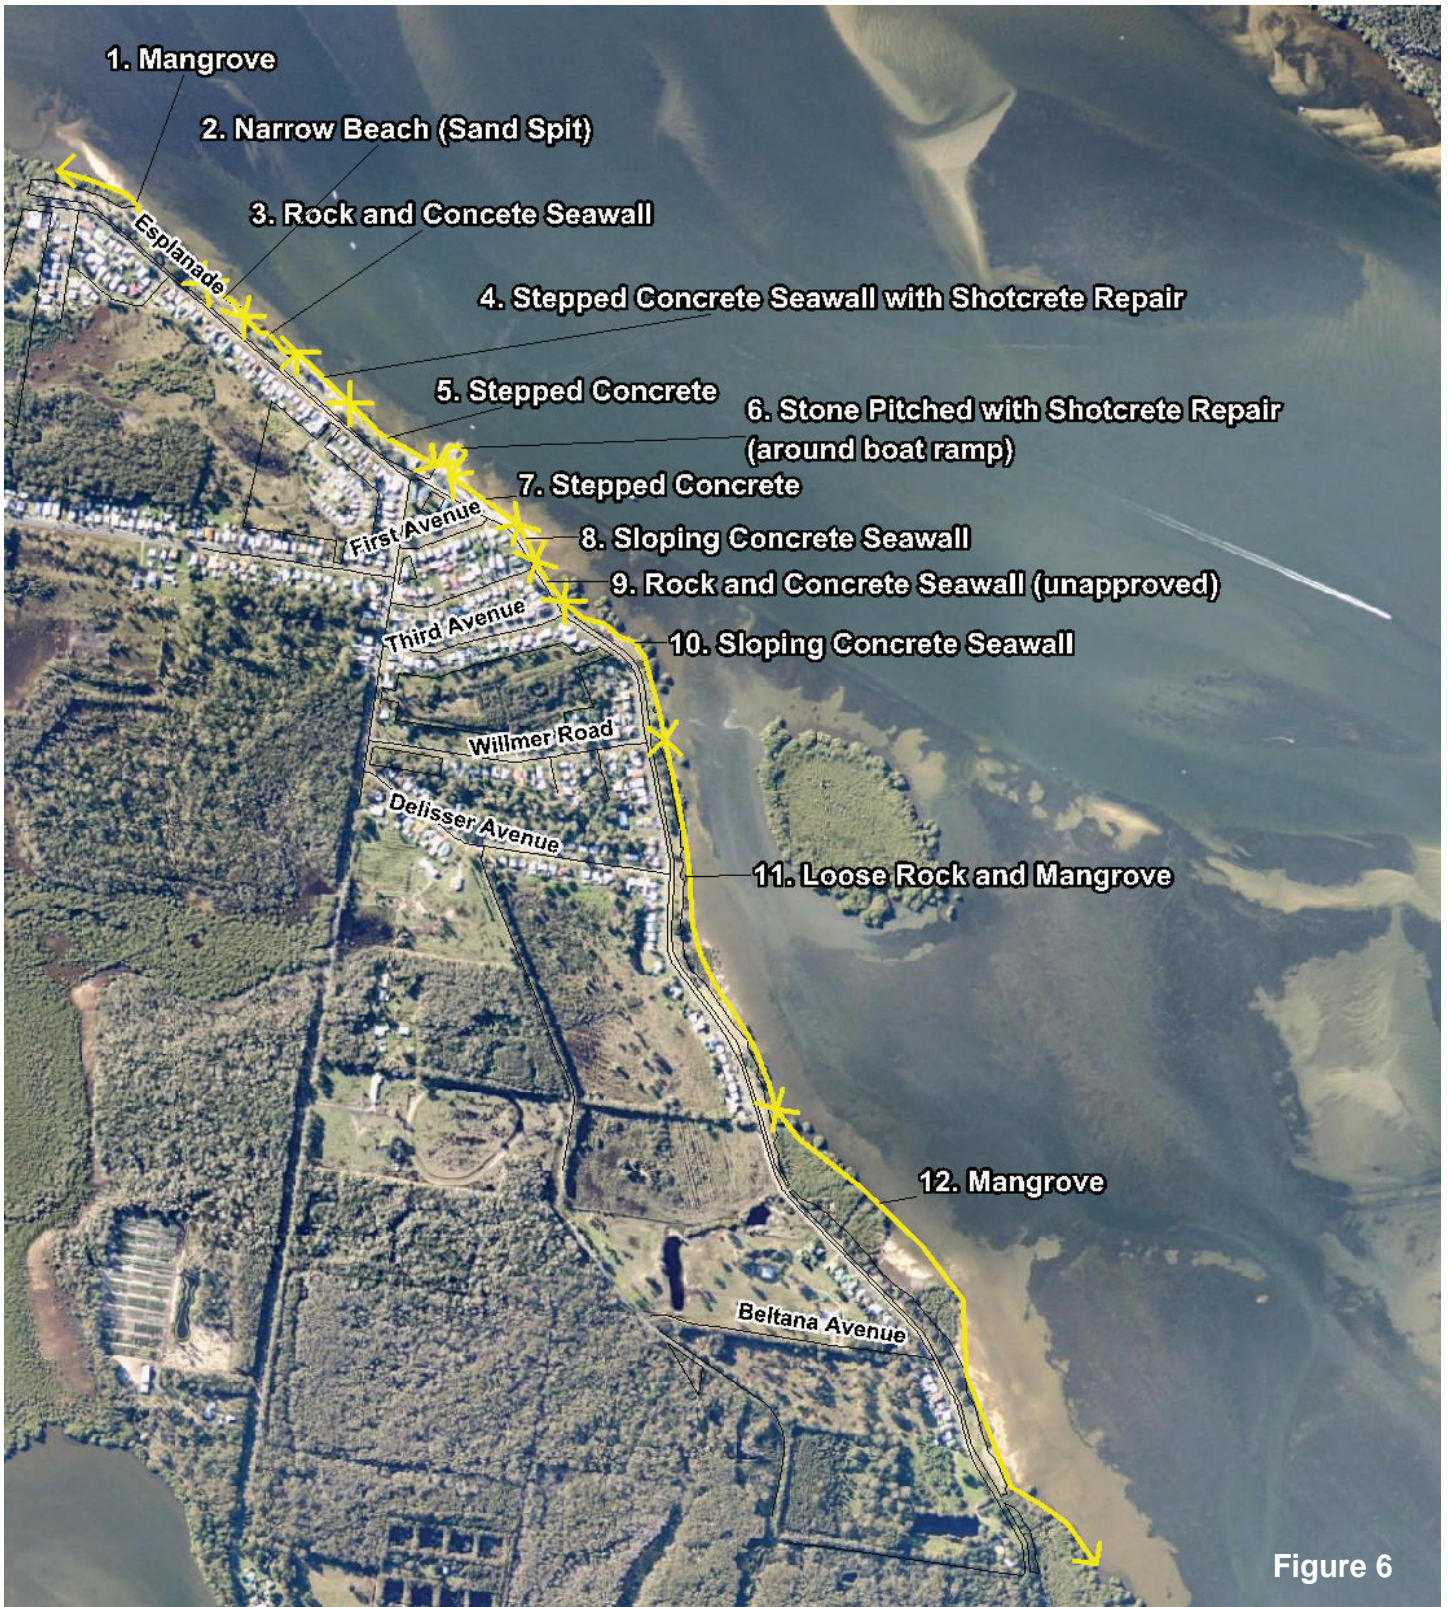
Figure 6

Council controlled land and shoreline types within the Toorbul study area are indicated in Figure 6. A range of seawalls of varying design and condition exist along The Esplanade shoreline. The majority of the foreshore is open space and includes facilities to support recreational and social values including car parking, boat ramps, public toilets, picnic facilities and pathways. A small section of road reserve (car and boat trailer parking) forms the shoreline boundary to the immediate south of the public boat ramp. The beach unit is within a declared Conservation Park Zone and Fish Habitat Area. Three distinct shorebird habitat areas have been identified within the Toorbul study area.

Council has identified a need to upgrade a section of seawall where significant damage occurred during ex-TC Oswald, January 2013. The seawall at this location was originally built by local residents in the 1970s and is therefore an unapproved structure. The proposed upgraded structure opposite Second Avenue will follow a straight alignment and is intended to protect the adjacent footpath and road. A development application for the proposed structure was submitted in early 2014

Seawalls to the north of the main public boat ramp have either undergone recent repair or are in a relatively poor condition. There is also a general concern that the geometries of the structures present safety hazards. It is anticipated that

Seawalls in the vicinity of the public boat ramp show some signs of weathering but are generally in a fair condition. While the structures appear structurally sound, they should continue to be monitored and inspected following severe storm conditions.

The sloping concrete seawall south of the Second Avenue is in a poor condition in some locations. Large cracks and subsequent slumping of the structure present a trip hazard and suggest a significant loss of sediment from behind the rigid structure. While the immediate risk to assets appears low, planning to upgrade this structure should commence.

- Rehabilitation and vegetation of shorelines without existing structures
- Structural assessment of all existing structures to inform repair and/or upgrade prioritisation
- Commence planning for significant seawall upgrade works within a 10 year timeframe

- Upgrade and realign Section 9 unapproved seawall

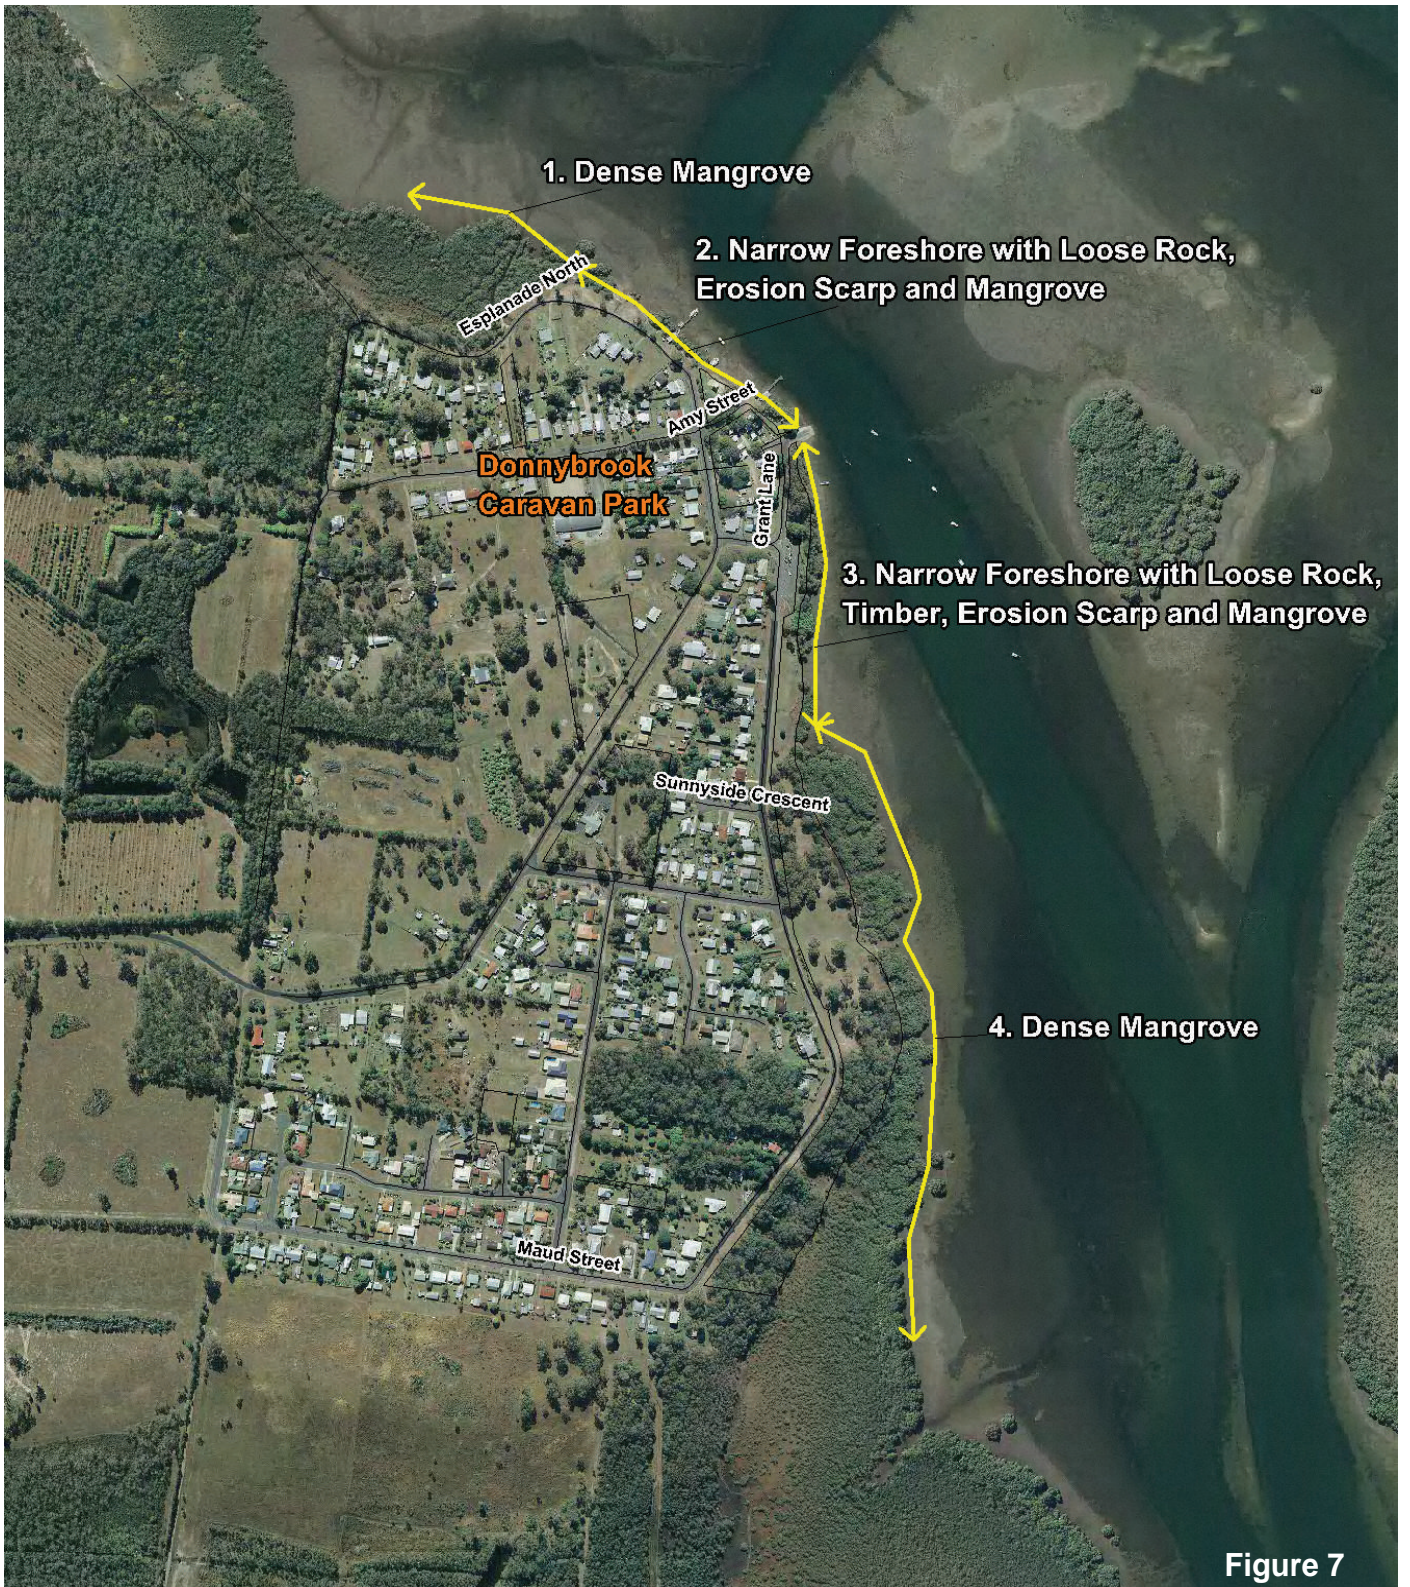
Figure 7

Council controlled land and shoreline types within the Donnybrook study area are indicated in Figure 7. The study area is characterised by open public space with grassy foreshore and small erosion scarp in most locations. The area primarily supports recreational boating and fishing and includes a Council-owned Caravan Park. The foreshore includes playground equipment and picnic facilities. A small shorebird habitat is located at the northern extent of the study area.

Dense mangrove communities exist south of the public boat ramp and provide some buffer to shoreline erosion. Additional shoreline stabilisation with vegetation is recommended along the Esplanade South shoreline and could be undertaken in conjunction with foreshore works recommended as part of the Open Space Master Plan for Donnybrook.

There are two small jetties within the study area understood to be privately owned. Both structures are aging and will require ongoing maintenance and repair to remain safe and usable.

- Removal of inappropriate materials used for shoreline erosion control
- Rehabilitation and vegetation of shorelines without existing structures
- Shoreline re-profiling and stabilisation to be carried out in conjunction with foreshore works recommended as part of the Open Space Master Plan for Donnybrook

- Relocation of playground equipment to a location outside of the erosion prone area
