5 South Pine River Geomorphic Processes

An understanding of the geomorphic processes which drive change within the tidal reaches of the South Pine River is essential for the development of an effective management strategy.

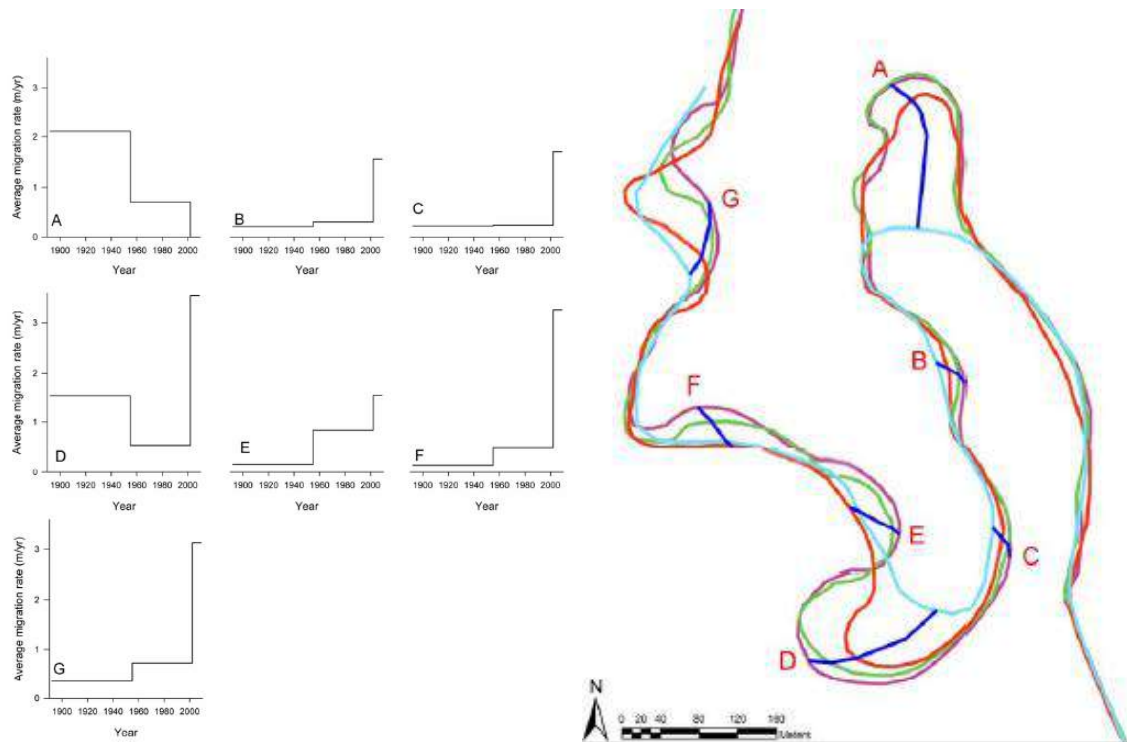
Figure 5-2 Saxton et al (2010) Historic Channel Migration Rate Results

- Historic aerial photography to assess historic migration rates; and
- Hydraulic modelling of the channel to identify sites of high erosion potential.
- The study found:
 - Migration rates have increased over the past 118 years, most likely causes are:
 - Changes in upstream catchment condition as a result of clearing;
 - Gravel extraction;
 - Removal of riparian bank vegetation; and the
 - Increased frequency of bankfull discharge events.
- Channel migration rates have increased significantly since 2002 in sections downstream of the old meander loop (Section C) with a potential maximum shift in orthogonal length of 10-30m over the next 50 years, shown in Figure 5-2.

Longest orthogonals (dark blue) identified for shifts between channel centrelines dating to 1892 (light blue), 1955 (red), 2002 (green) and 2009 (purple).

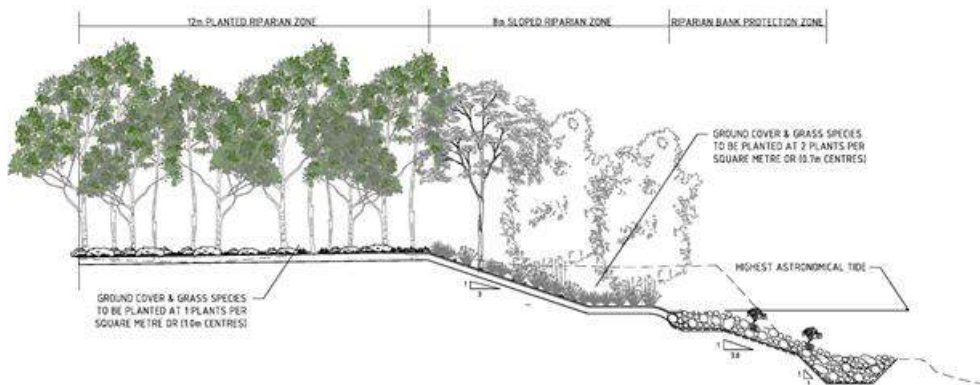
Figure 5-3 Aurecon (2010) Recommended Mitigation (Cross-section)

- Fretting and undercutting caused by clay dispersion is a contributing factor to the progressive collapse of the riverbank.
- Slope stability modelling showed that the existing bank profile has factors of safety lower than the normally accepted values.

- A re-shaped bank profile with a slope of 1V:3H was recommended to provide adequate short and long term factors of safety.
- It was also recommended that the re-shaped bank profile be taken down to the river bed level.

- Revegetation of the upper bank and establishment of a riparian corridor;
- Bank battering/terracing;
- Jute matting on the upper bank;
- Geofabric layer on the lower bank;
- Rock riprap protection at the toe of the bank; and
- Revegetation on the lower bank.

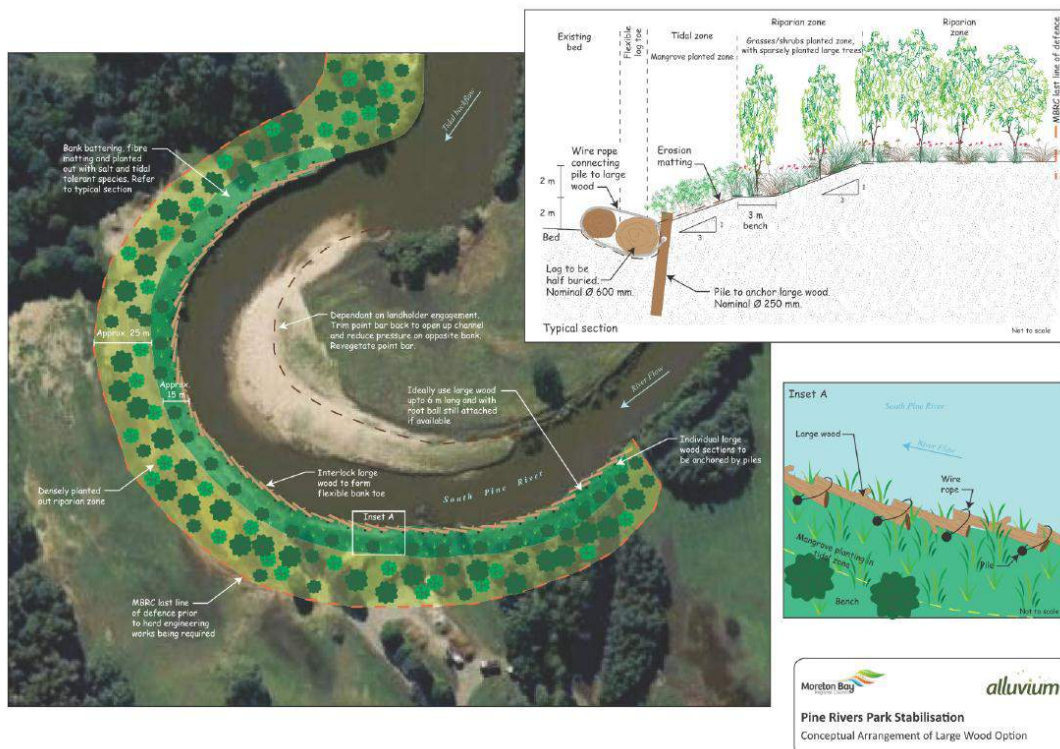
Figure 5-6 Alluvium Consulting (2011) Recommended Mitigation

The Alluvium Consulting study found that Meander D eroded at a rate of between 1-1.5m/year between 2009 and 2011. This rate is consistent with the accelerated average migration rate of the river bend documented by Saxton et al (2010) for the post 2002 period.

- Implementation of an ongoing monitoring program measure the rate of bank retreat.
- Consideration of soft engineering bank stabilisation measures to mitigate current accelerated migration of Section D, shown in Figure 5-6.
 - Armouring of the bank toe using large wood and mangrove planting within the range of tidal water level fluctuations;
 - Battering of the bank to reduce the slope to 1V:3H and erosion matting; and
 - Revegetation of the bank above the large wood toe protection bank and greater riparian zone.
- Hard engineering works aligned with the MBRC's limits of acceptable channel migration (40m setback from the 2011 top of bank location).

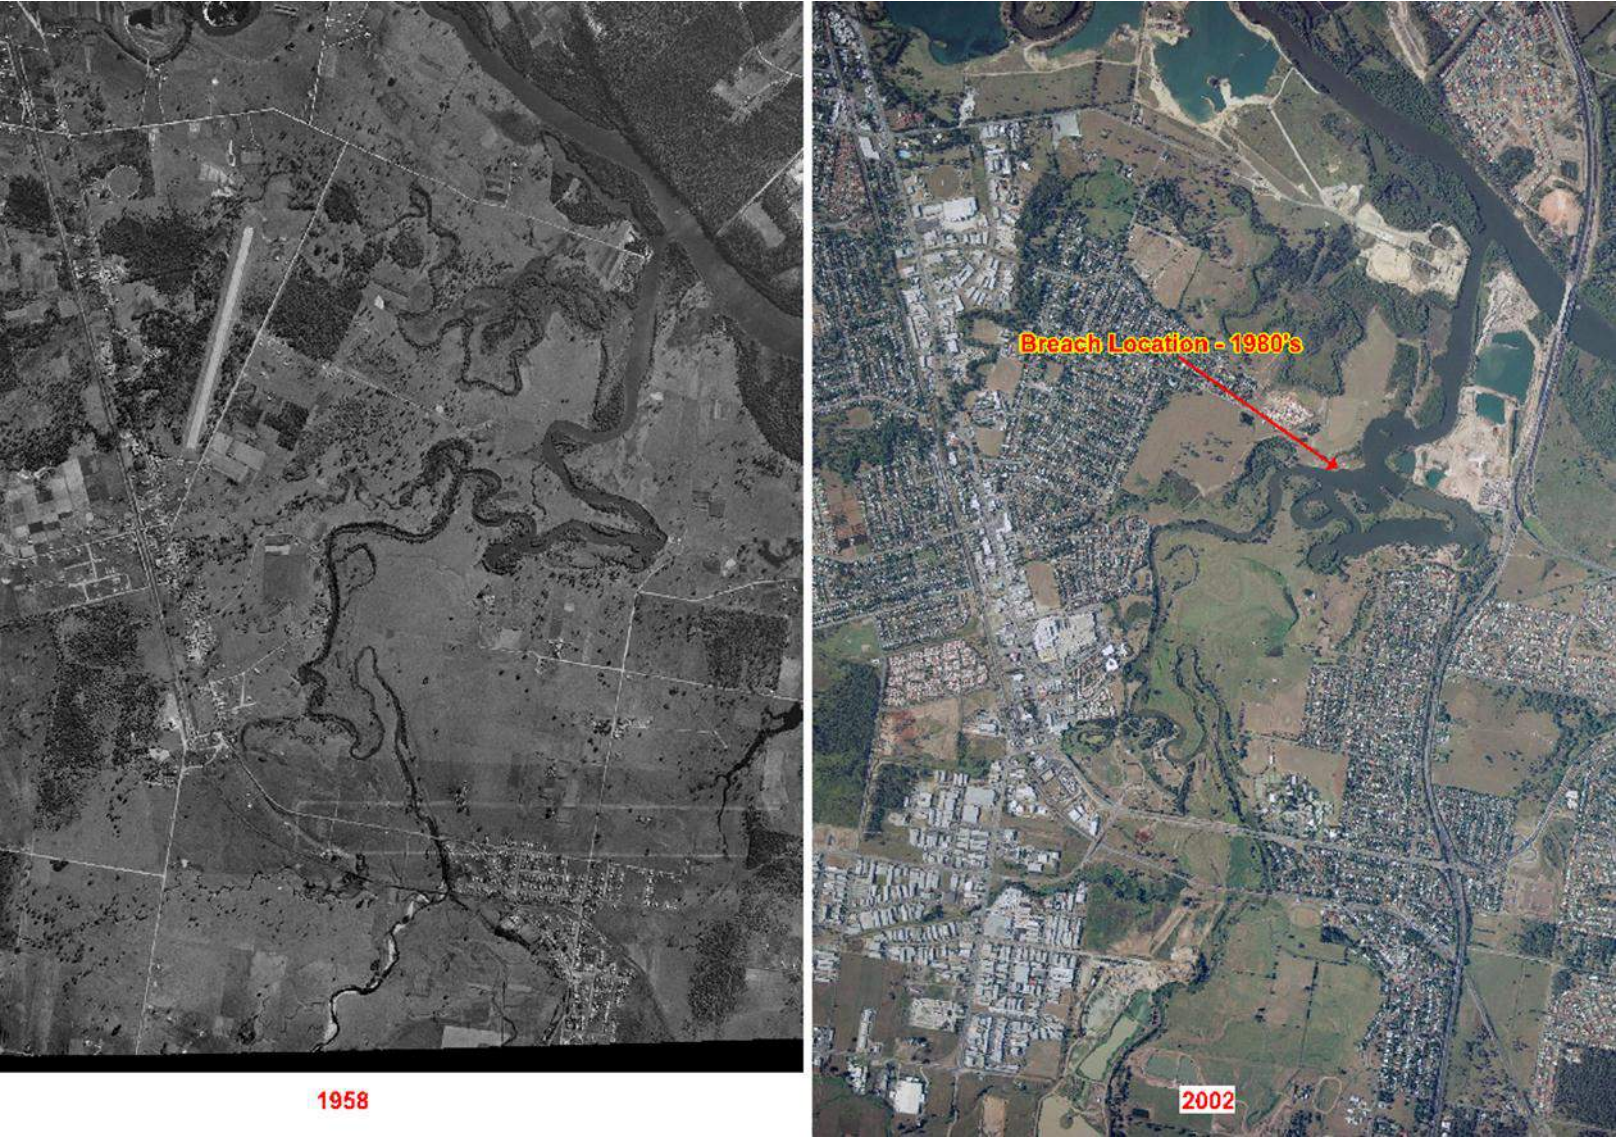
Figure 5-15 South Pine River Catchment Landuse Change

- (a) Gravel extraction pit embankments in the lower South Pine River were breached sometime in the early to mid 1980's⁹. The breach resulted in a new dominant flowpath being formed, shortening the stream length of the South Pine River by approximately 1.5km. The breach location is highlighted in Figure 5-15.
- (4) Significant portions of the South Pine River catchment are urbanised. Changes in catchment urbanisation from 1958 to 2002 are presented in Figure 5-15.
 - (a) Urbanisation increases the proportion of the impervious area within a catchment. This results in increased catchment runoff volumes and decreased runoff response times. The combination of these responses generally increase freshwater environmental and flood flow velocities.

- Sometime between 1983 and 1987 the main channel of the South Pine River was shifted significantly after the embankment to a sand/gravel extraction pit was breached (refer to Figure 5-15). This breach shortened the stream length of the South Pine River by approximately 1.5km. This change in river condition resulted in increased bank migration rates upstream and downstream of the breach location for a period of up to 10 years. The most pronounced impacts are observed within the results for Reach J, K, L M and N. These reaches are all within 1km of the breach location.

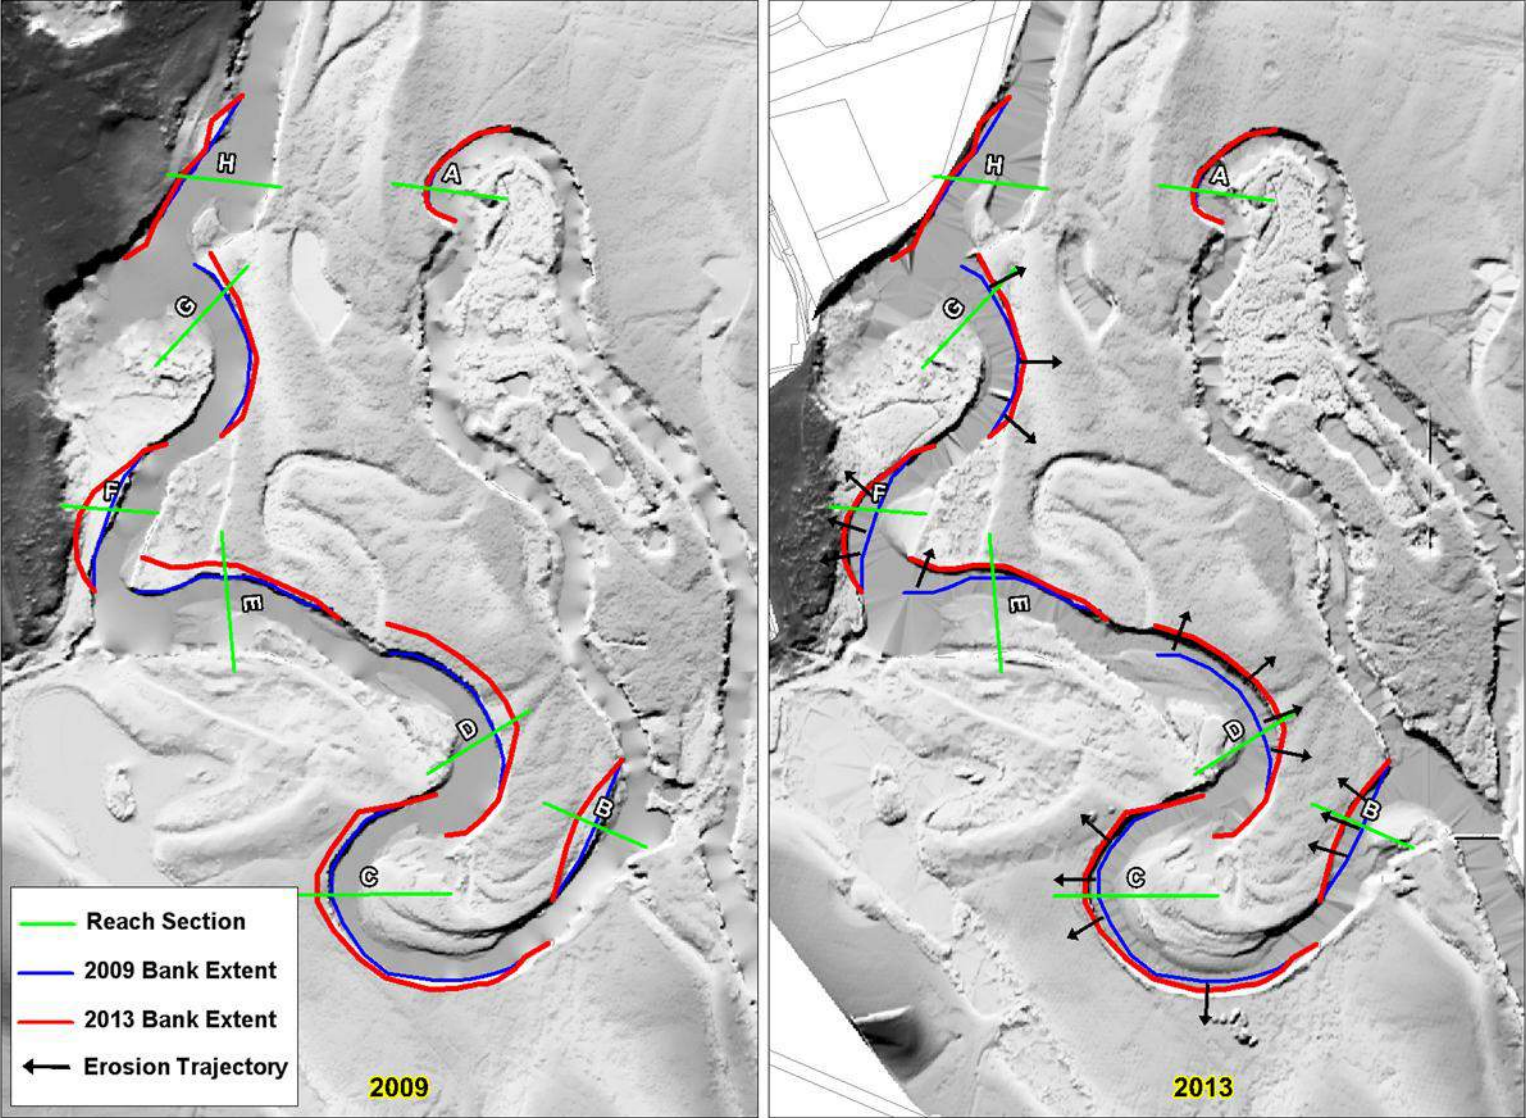
Figure 5-17 LiDAR Comparison for Years 2009 and 2013

Riverbank migration was determined by reference to fixed features (e.g. roads) common to successive dates of photography. An accuracy of about $\pm 2\text{m}$ was possible for each case. Changes in historic riverbank migration rates have been calculated for 14 locations. These locations are highlighted in Figure 5-16. The LiDAR for years 2009 and 2013 are compared in Figure 5-17.

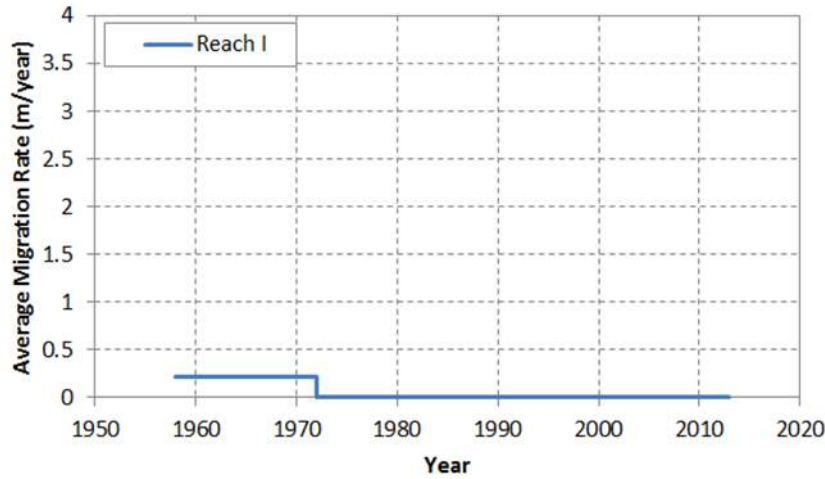
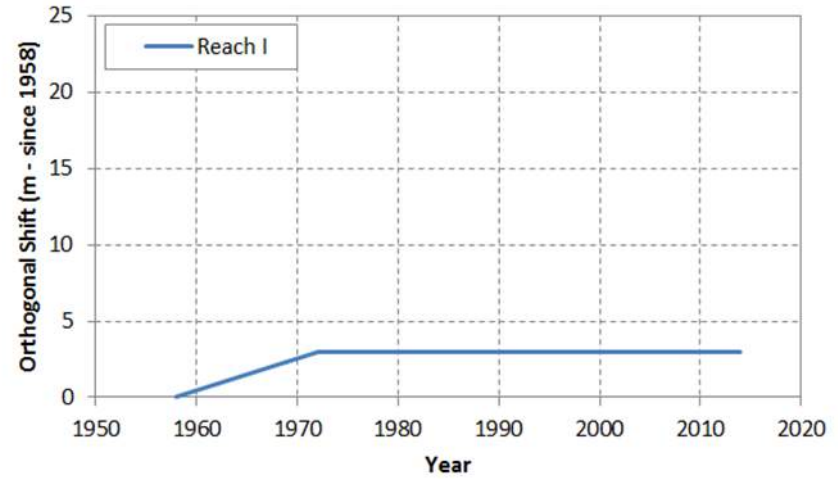
Figure 5-26 Reach I Migration Rate Assessment Results

- Reach I has historically had a stable orientation. This is due to hard engineering erosion protection measures along the western bank of the South Pine River in this location.
- Downstream of Reach I, Reaches J and K are also actively eroding at a rate greater than the long term average. These reaches are meandering, placing increased stresses on the outside bend of the river.
 - The off axis meandering of Reach K has the potential to alter the flow distributions which impact Reach L. This may increase the future channel migration rate at Reach L.
- Reach M and N, closest to the Pine/South Pine River confluence have been relatively stable since the mid 1990's.
