6. Sylvan Beach Boating Infrastructure

Moreton Bay Regional Council
 Shoreline Erosion Management Plan

Sylvan Beach Boating Infrastructure - Locality Plan

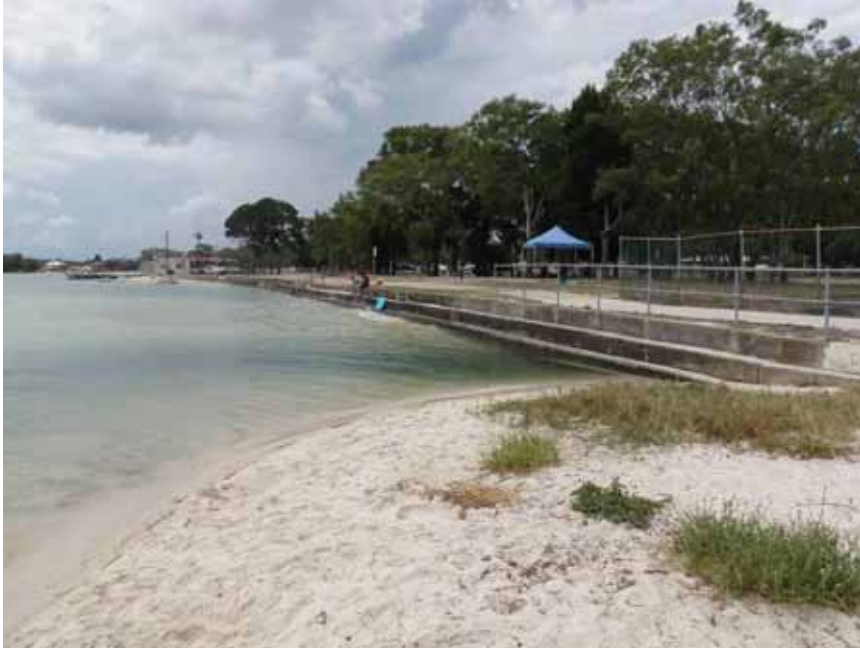
Photo Plate 6-1 Drainage canal culvert outlet south of boat ramp

There is a submerged stormwater pipe and in the southern extent of the study area is a tidal drainage canal with culverts under the road and a footpath along the foreshore (refer to [Photo Plate 6-1](#)).

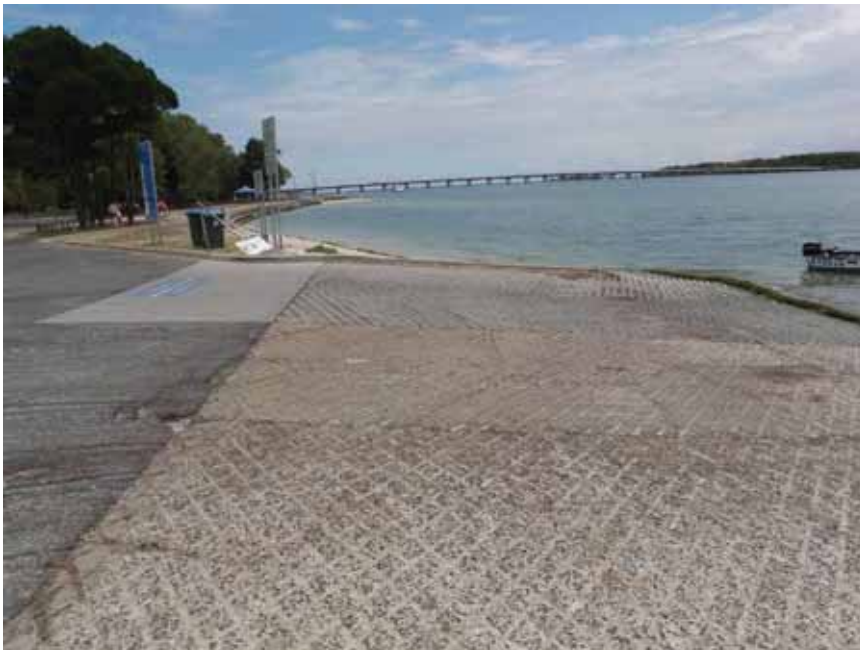
Photo Plate 6-2 Boat ramp

A stepped sea wall and/or rock protection exist along this section of shoreline. Small areas of sand have built up both north of the VMR jetty and south of the boat ramp (refer to [Photo Plate 6-2](#) and [Photo Plate 6-5](#)). A small area of sandy beach also exists south of the jetty facility and buildings (refer to [Photo Plate 6-3](#)). In 2007, Queensland Transport dredged the area in front of the Bellara public boat ramp and the VMR air sea rescue pontoon. Approximately 5,415 m³ of material was removed from the area and was used to nourish the foreshore along Sylvan Beach Esplanade.

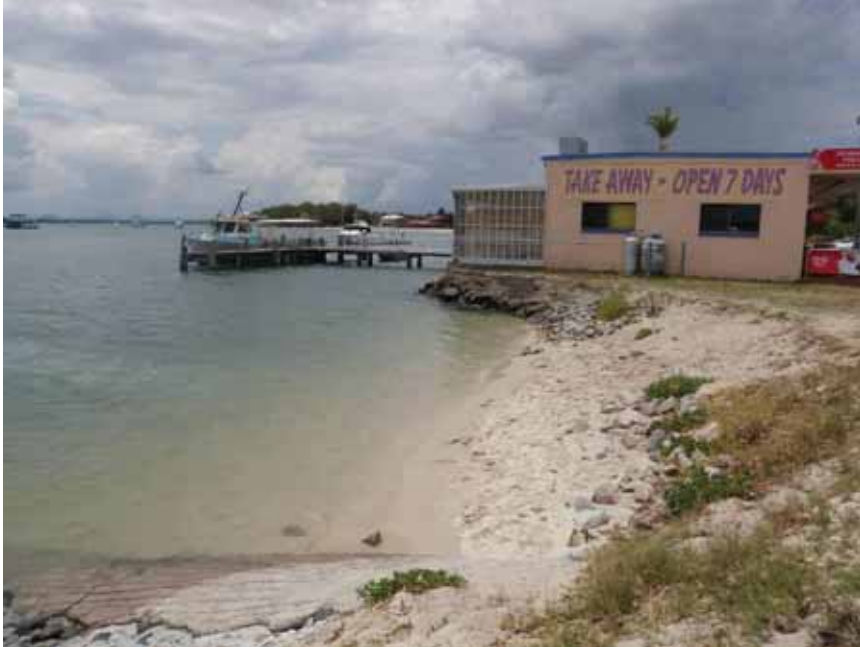
Photo Plate 6-3 Sandy area between boat ramp and jetty facilities

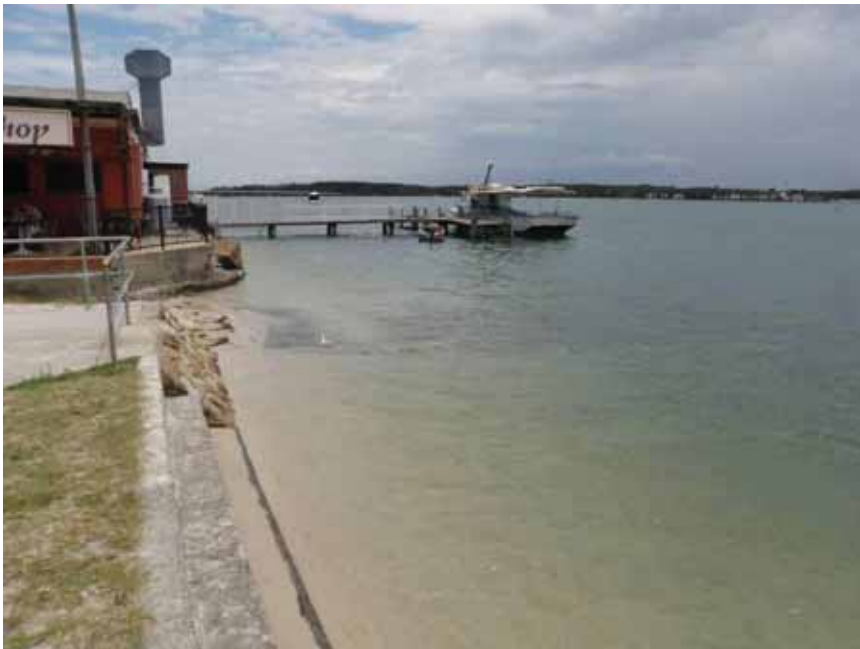
Photo Plate 6-4 Jetty facilities

The Sylvan Beach Boating Infrastructure study area is located at the Bellara public boat ramp and jetty facilities (refer to Photo Plate 6-4) at Sylvan Beach along the western coastline of Bribie Island and is approximately 640 m long from the canal in the south to Warrigal Street in the north (refer to [Figure 31](#)). The land tenure along the foreshore consists mainly of road reserve, with a small area of leasehold tenured land at the commercial properties. The Bellara public boat ramp was the landing point for the original Bribie Island barge service from the mainland that operated up to the time of the opening of the Bribie Island Bridge in 1963.

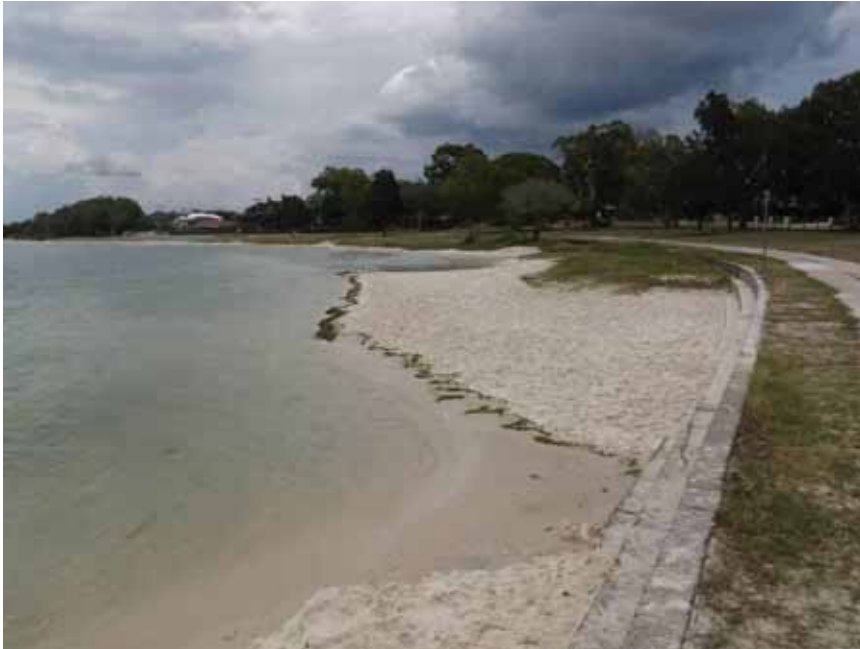
Photo Plate 6-5 Sand build-up north from jetty facilities

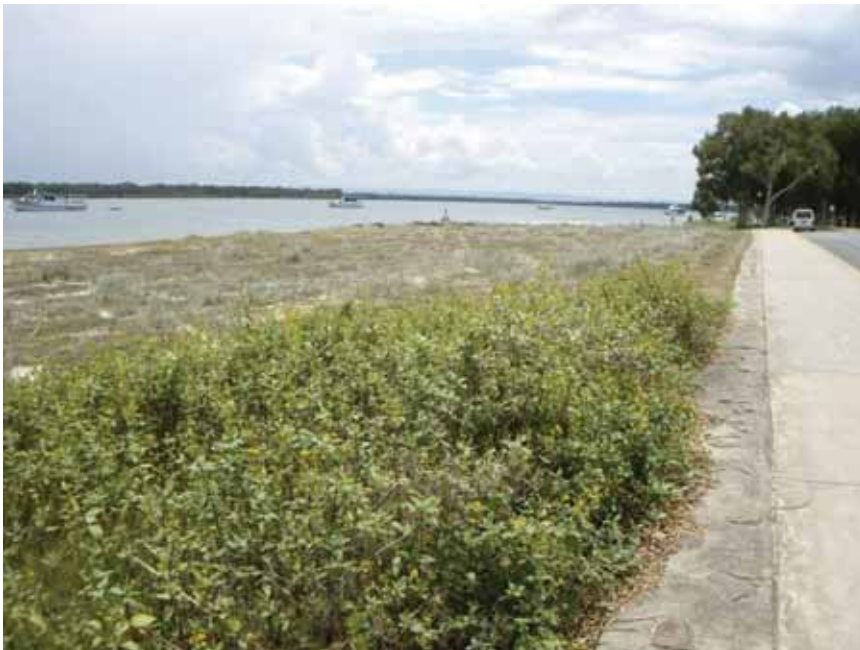
Photo Plate 6-6 Revegetated sand dune north of jetty facilities

A foredune community of grasses has been planted and established at the northern end of this study area (refer to [Photo Plate 6-6](#)). This area is understood to be a dredge spoil deposition area from dredging undertaken by Queensland Transport in the vicinity of the VMR jetty.

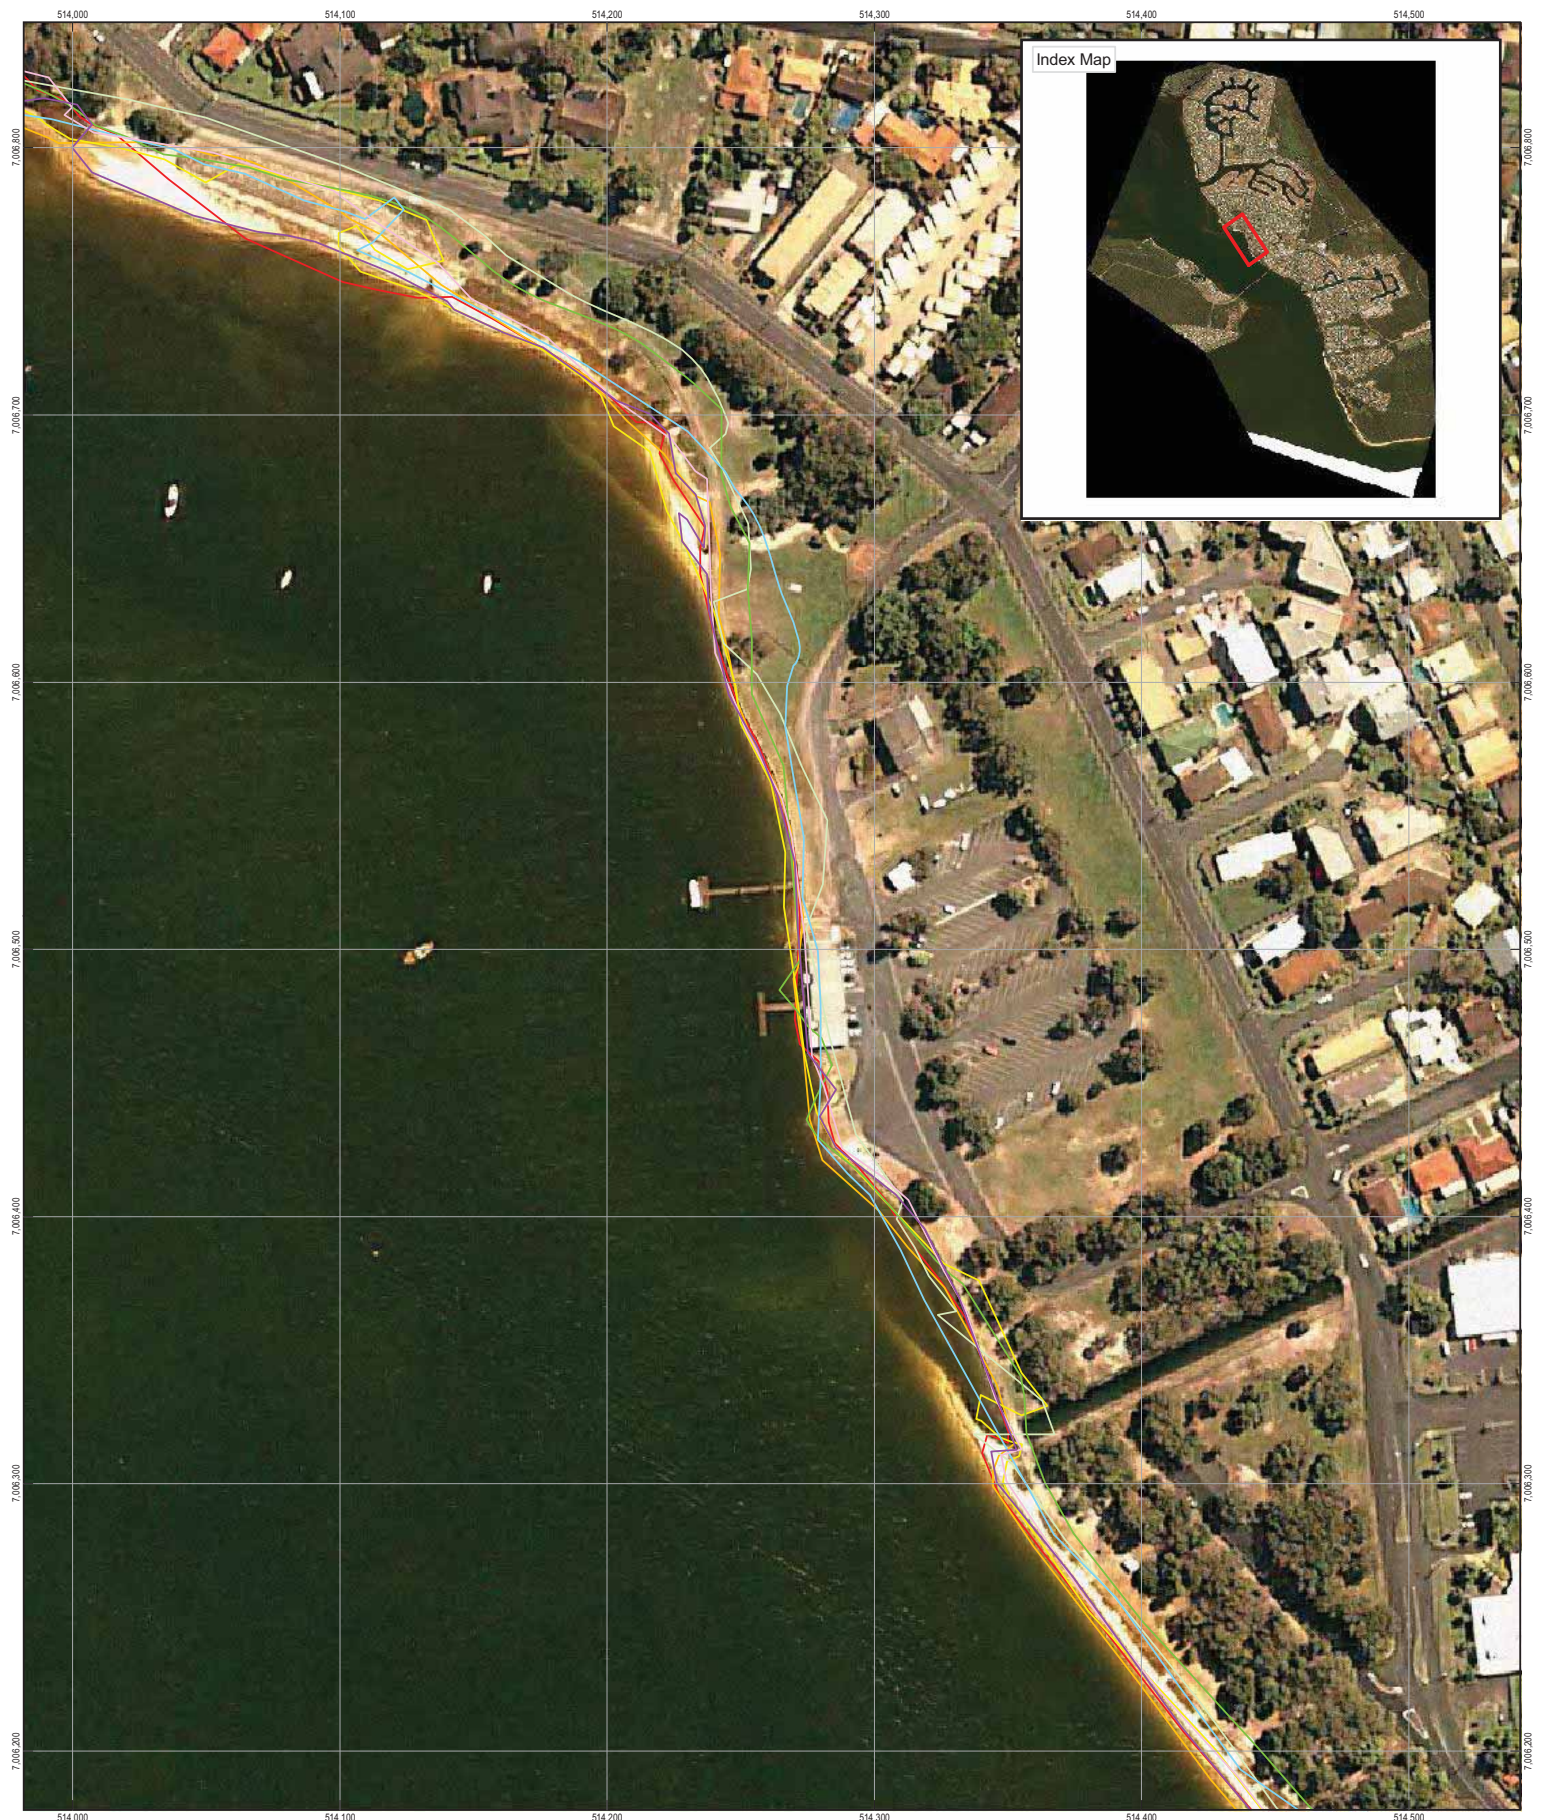
Figure 32

Sylvan Beach Boating Infrastructure - Shorelines

At the southern end of this section, a beach and vegetated low dune area has been maintained seaward of the revetment wall (refer to [Figure 32](#) and [Figure 33](#)).

The photography shows that by 1958 boating facilities were in place in the northern section of this beach compartment, although it is difficult to identify from the aerial photography whether the infrastructure comprised a jetty and a boat ramp, or just a jetty. Information received from a long term resident of this area, Mr R Reynolds indicates that this was the location of the barge landing ramp that was used before the Bribie Island bridge was opened in 1963. Localised accretion on either side of this infrastructure indicates that sediment transport was affected by the structure(s), but that the longshore transport appears to be in equilibrium as sediment movement to the north and the south in equal amounts is apparent.

By 1975, the jetty appears to have been removed and a boat ramp is visible. In addition, a second boat ramp had been constructed approximately 250m to the north. Again, localised shoreline changes around these structures are visible in the photography, but no serious erosion of adjacent shorelines is evident. The 1982 photography indicates that the groyne effect created by these boat ramps had ceased and that sediment transport around the ends of the ramps had been re-established.

A jetty was constructed between the two boat ramps by 1990, and between 1990 and 1999 a second jetty and the revetment wall were constructed. A recreational beach is visible along this part of the shoreline seaward of the revetment, although it is unclear if the sediment in this area has been supplemented by artificial nourishment.

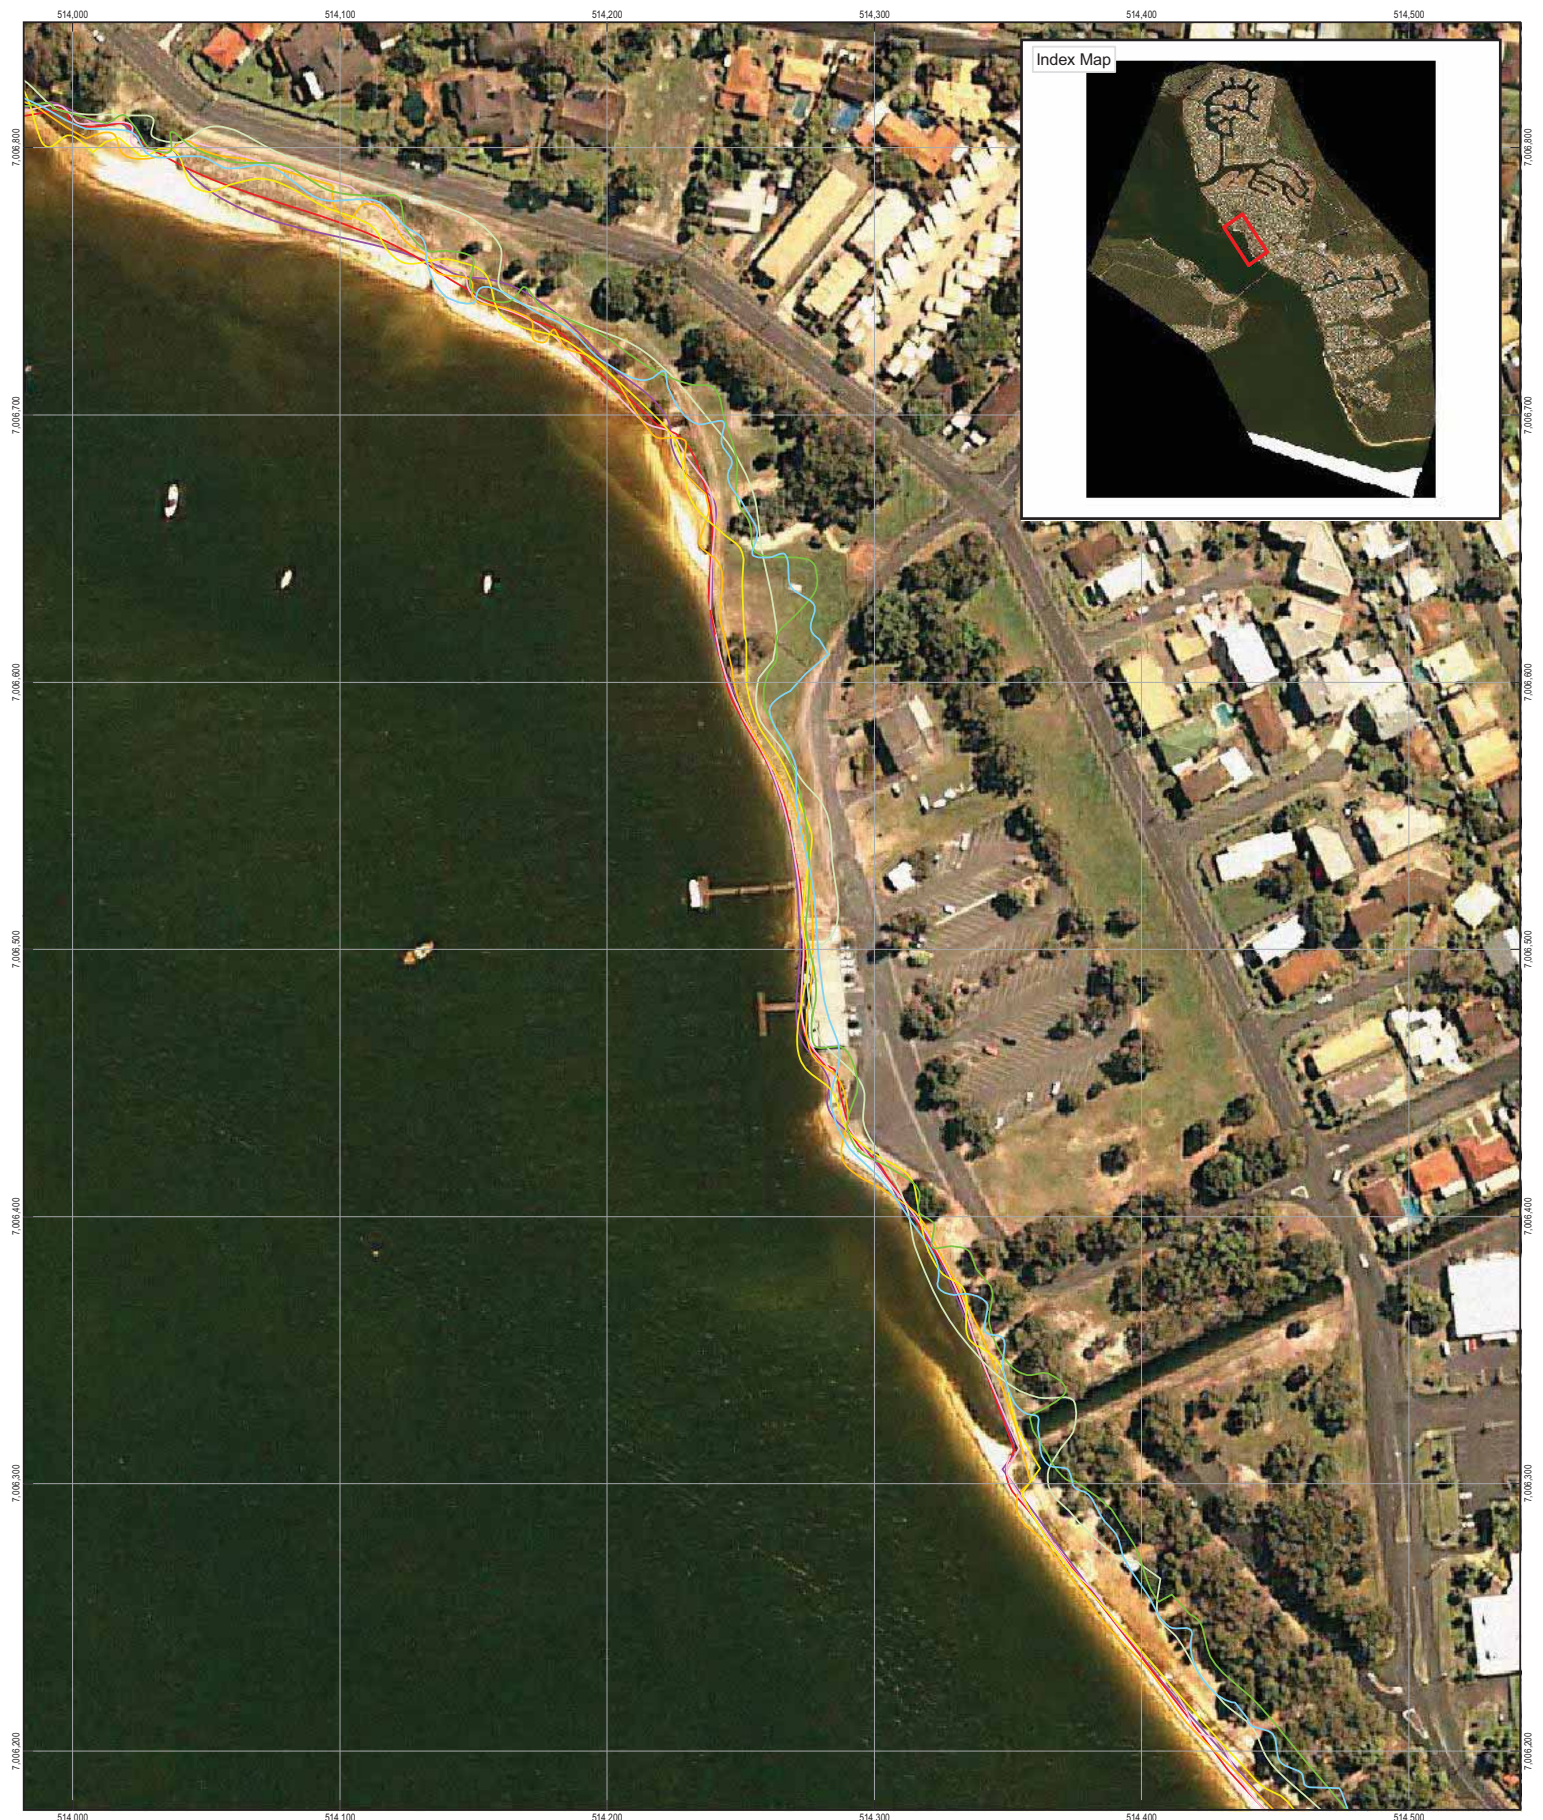
Figure 33

**Sylvan Beach Boating Infrastructure -
Vegetation Lines**

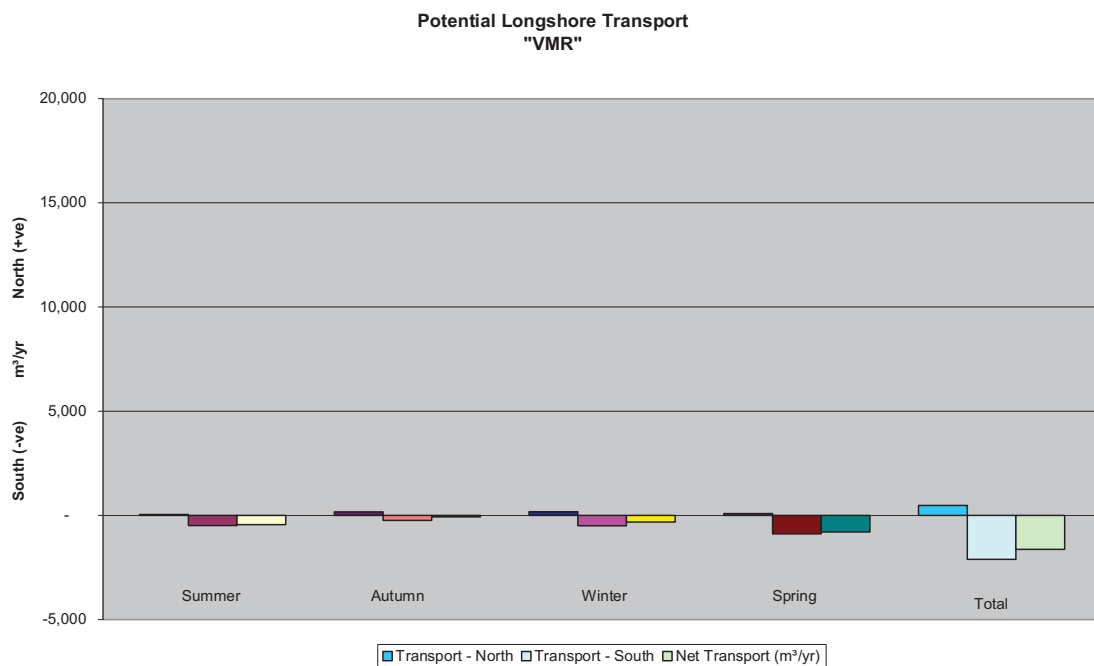
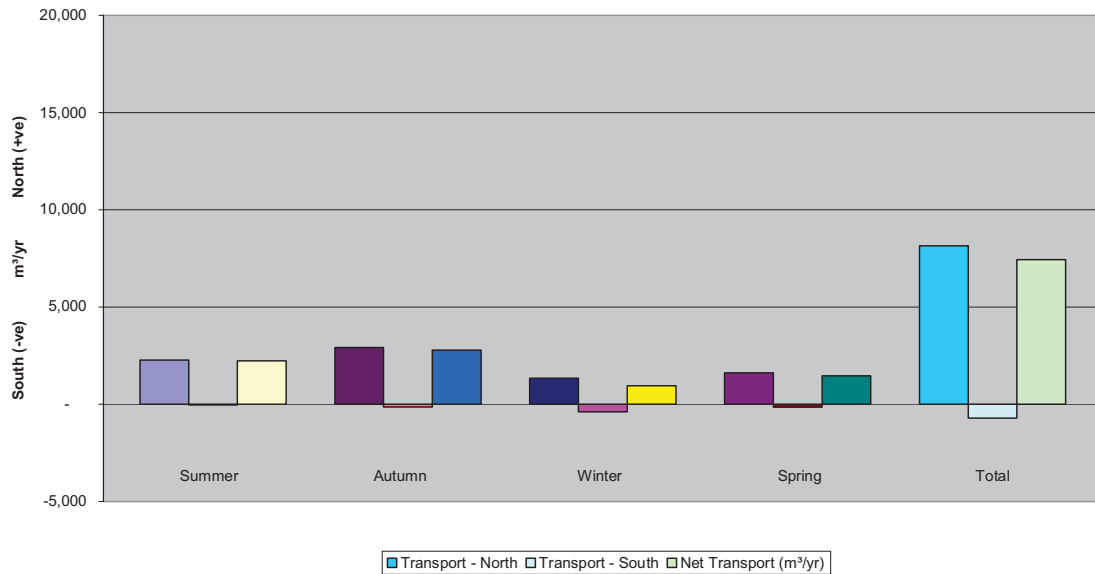
Figure 34 Sylvan Beach Boating Infrastructure – Longshore Transport

Potential Longshore Transport
"VMR North"

For this section of the coast the following observations can be made (refer [Figure 34](#)):

- ▶ The transport at the VMR site is minimal and is to the south as a result of being sheltered from any southerly waves progressing up Pumicestone Passage;
- ▶ The transport at the VMR North site is higher but still small, and is in the opposite direction to VMR, being to the north under the influence of waves progressing up the Passage. In addition this site is more protected from waves from the northerly sector; and
- ▶ The seasonal variation is similar to the annual results with higher potential transport rates occurring during Autumn.
