# Newport Waterways Canal Batter Maintenance Intervention Levels

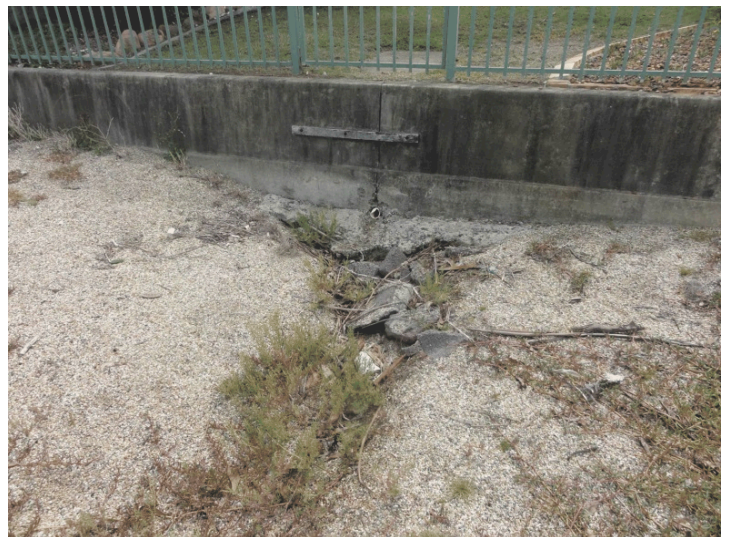
The erosion result is characterised by localised point source scours or rills across the beach generally perpendicular to the revetment wall.

**Example: Erosion - Condition State 4**

**Erosion:** This generally applies to gravel beach areas above low tide level. It is mainly caused by stormwater drainage runoff from the adjacent land through concentration of flows due to landscaping treatments, modification of property levels or boat ramps. Other forms of erosion may result from direct or nearby placement of roof-water drainage outlets or swimming pool or spa filter backwash pipes near the canal revetment wall.

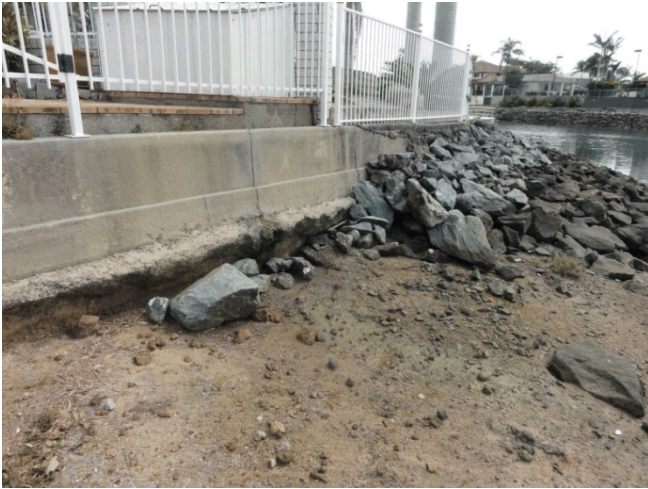
**Beach Depletion:** Beach depletion results in a progressive widespread lowering of the beach.

**Example: Beach Depletion - Condition State 4**

Depletion of a beach generally results from erosion due to stormwater runoff from the adjacent land occurring along a revetment wall.

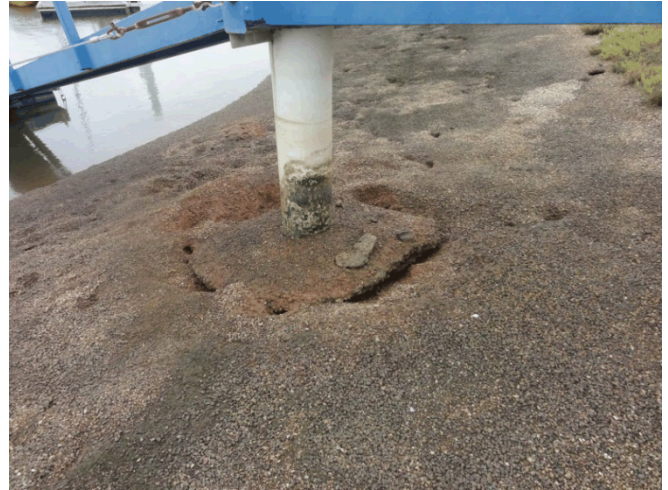
**Example: Pile erosion - owner responsibility**

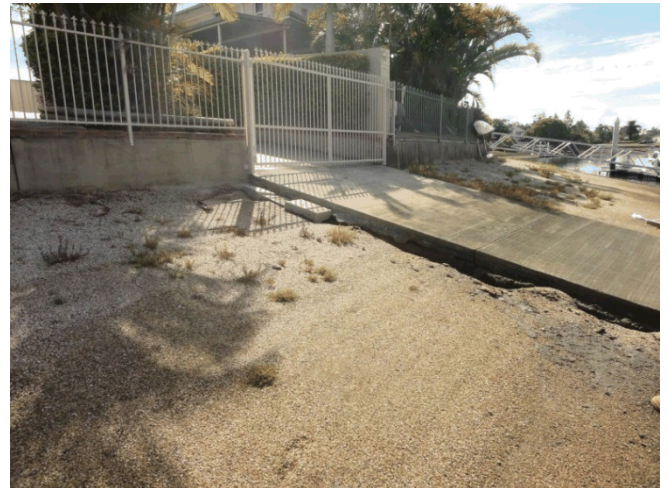
**Example: Ramp erosion - owner responsibility**
