ITEM 2.1 - FLOOD MANAGEMENT DEVICES PORTFOLIO ASSET MANAGEMENT PLAN - 61712125 (Cont.) #1 Flood Management Portfolio Asset Management Plan - March 2021

### Flood Management Devices Portfolio Asset Management Plan

Document Reference									
Document title	Flood Management Devices Asset Management Plan								
ECM Reference	A20264514								
Date prepared	November 2020								
Adopted Date	17 March 2021								
Prepared by	Asset Management

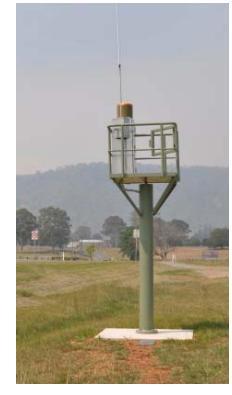
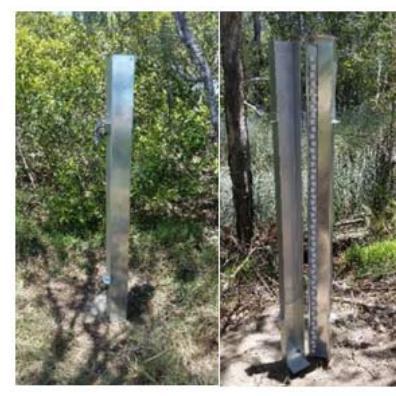
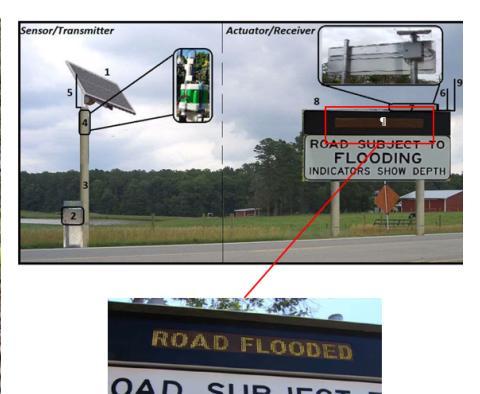
Figure 1 - Flood Monitoring Stations

Figures 1-3 are examples of the three primary device types within the FMD portfolio.

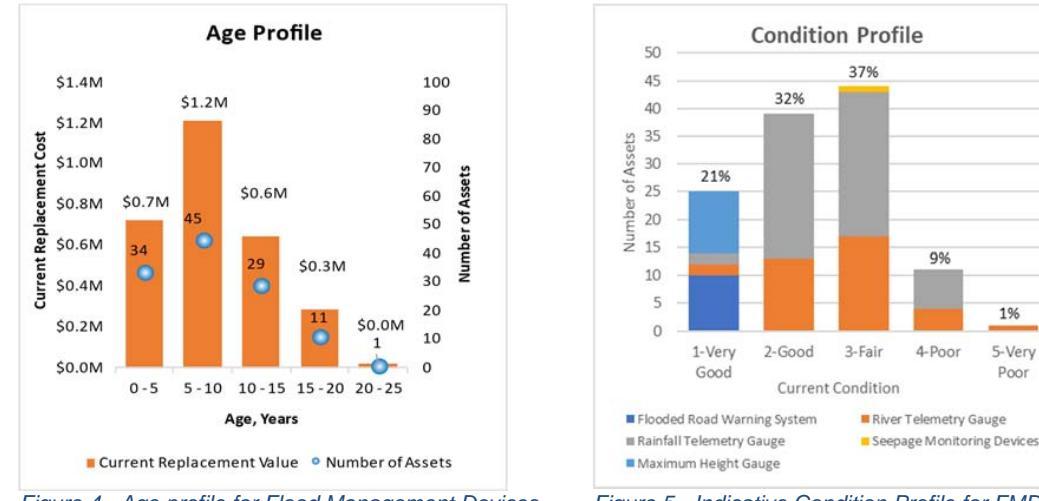
Figure 4 - Age profile for Flood Management Devices

Figure 4 shows the age profile for MBRC's FMD assets, which indicates the number of assets and their total current replacement cost within each age band. As age reflects the year in which the assets were built, the profile also indicates the pattern in which they were acquired over time. There is a high proportion of assets at or beyond the 10 to 15 year age band. This is of interest due to the useful lives for most FMD assets being within the range of 15 to 20 years.

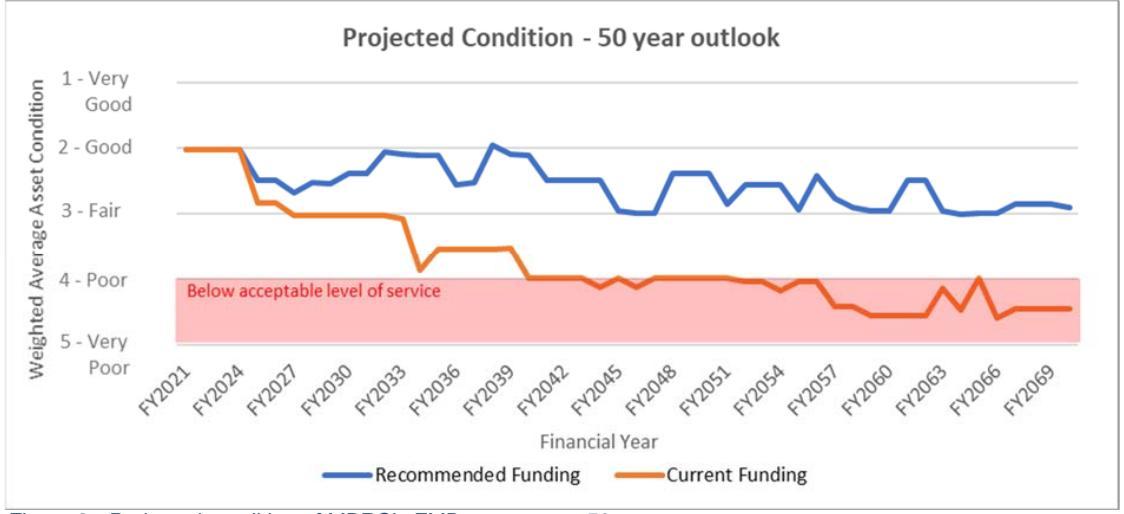
Figure 8 - Projected condition of MBRC's FMD assets over 50 years

Figure 8 illustrates that with the currently adopted funding schedule the condition of the assets will decline to a point in time at around the year 2040 when the portfolio as a whole will fail to meet the required standard.

With the recommended funding the overall portfolio is expected to continue to meet service levels and strategic objectives well into the future.

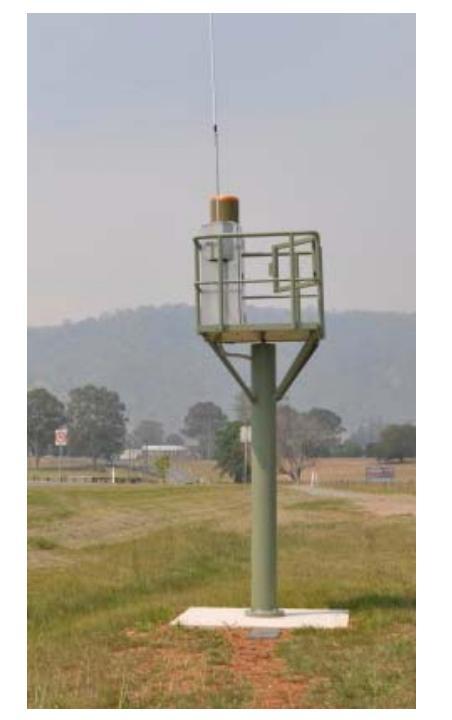
*Figure 13* - Telemetry Gauge (Rainfall and River)

The following figures illustrate typical automatic telemetry gauges owned by MBRC.

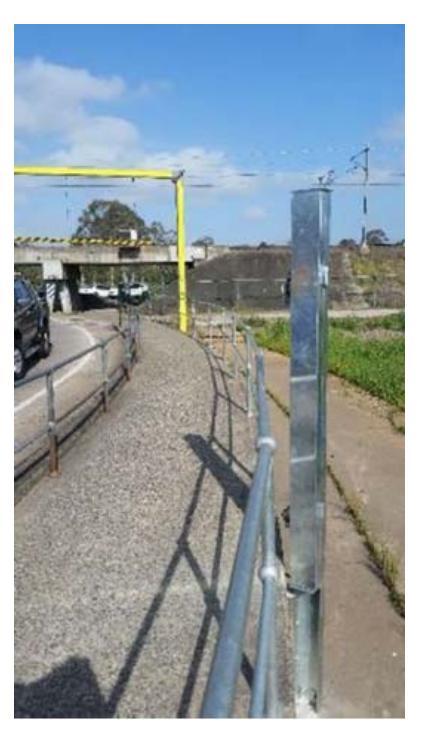
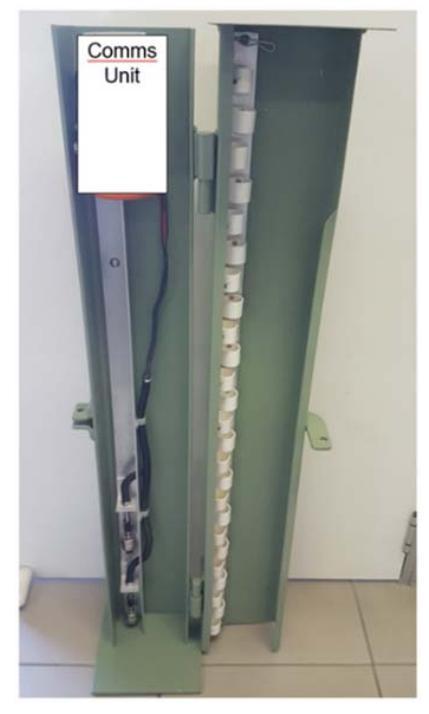
Figure 15 - Flooded Road Sensor

Figure 16 - Flooded Road Sensor

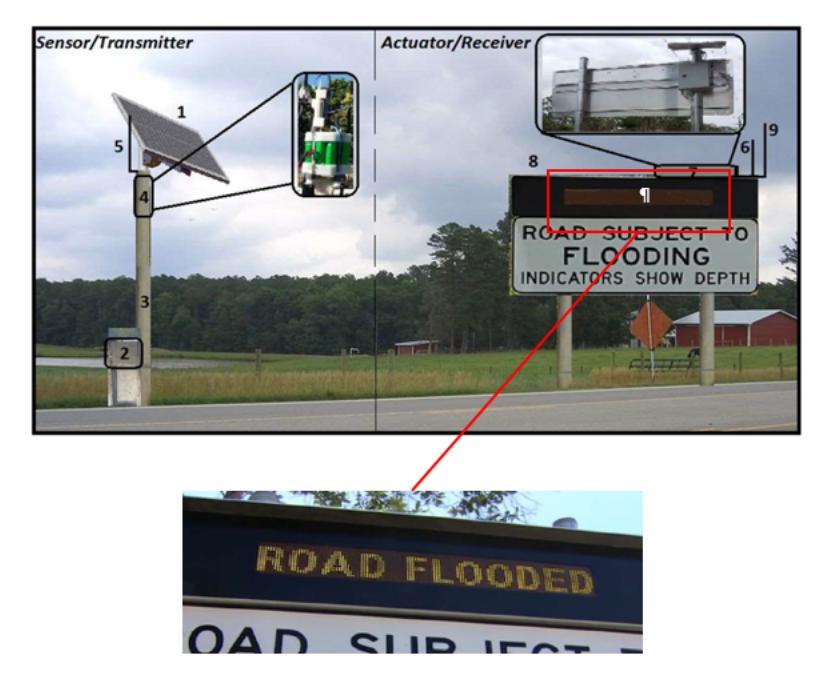
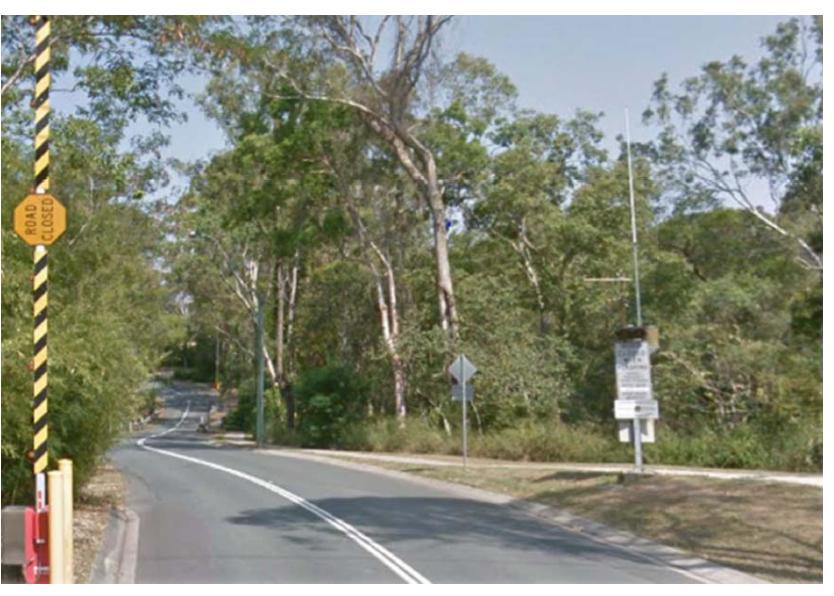
Figure 17 - Flooded Road Warning System (Automated Bright Flashing LED Signs)

These are automatically activated devices including automated bright flashing LED signs, automated boom gates and flashing lights. These systems may be triggered by a telemetry gauge or flooded road sensor. Figure 17 and Figure 18 shows examples of flooded road warning systems.

Figure 18 - Flooded Road Warning System (Automated Bright Flashing LED Signs)

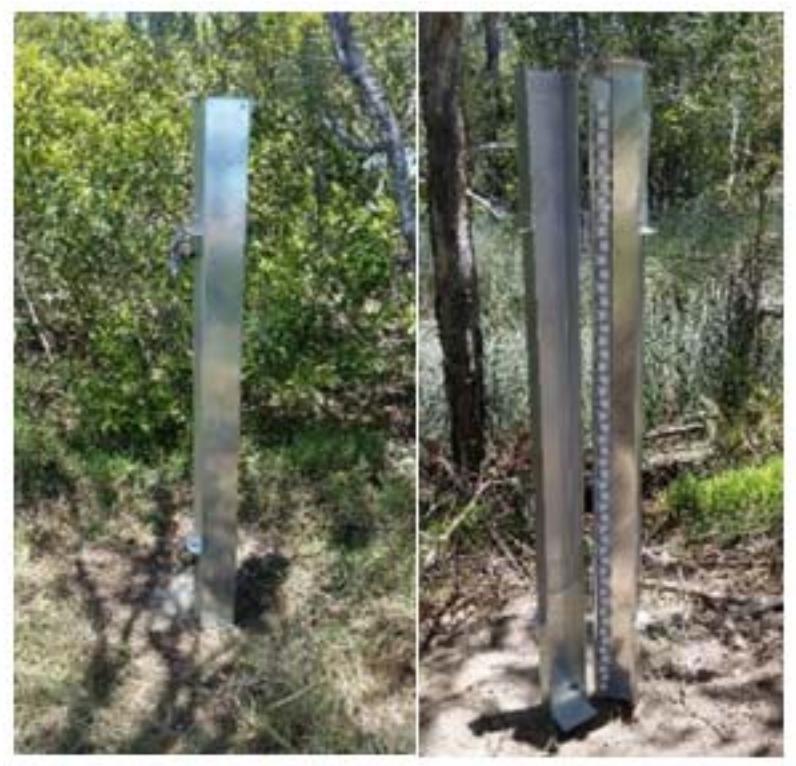
Figure 19 - Maximum Height Gauge

Maximum height gauges are used to measure the highest flood level at the location of the gauge. These gauges are manually checked and emptied post event and are used to confirm recorded levels to assist in post flood investigations, gauge calibration and improving gauge relationships. Figure 19 shows an example of a maximum height gauge. The gauge is read by measuring the height of the highest full cup.

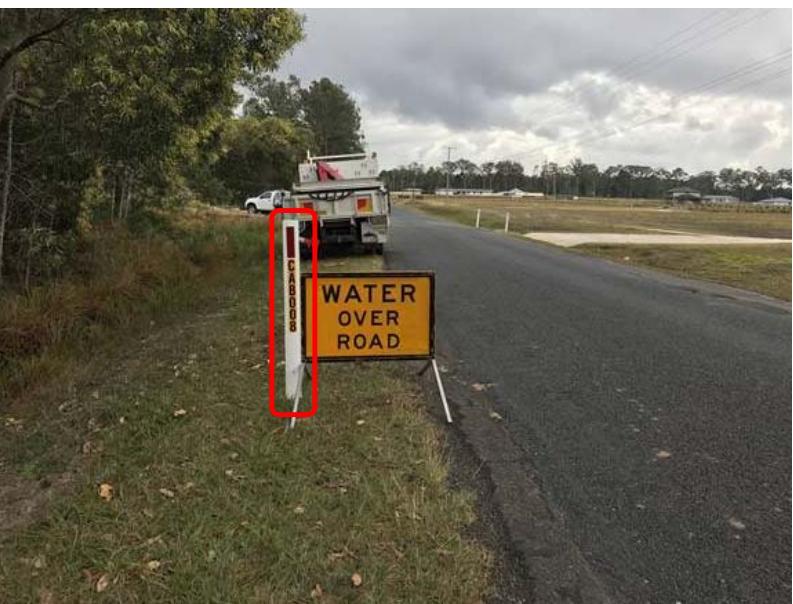
Figure 20 - Road Closure ID Indicator

Road Closure Identification indicators are posts showing Council's Road Closure ID for the location. These are installed to clarify the location of usual flooded road closure locations. The ID correlates to the GIS information for recording and public display of road condition information on Council's community website.

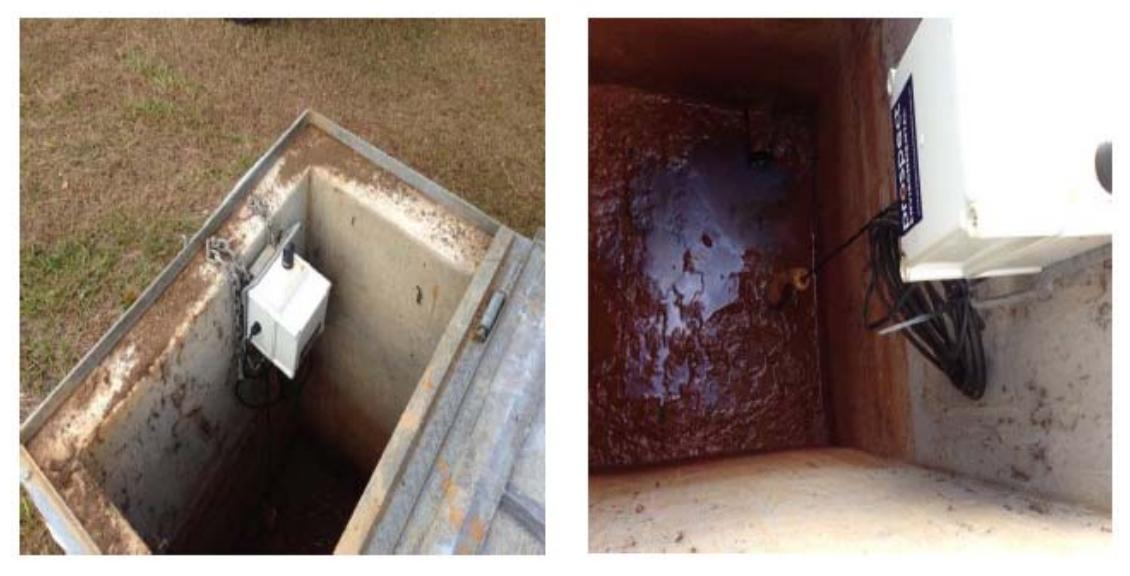
Figure 21 - Halpine Lake Seepage Pit and Monitoring Unit

There is currently one seepage monitoring device. The seepage monitor is located in a pit at the base of the Halpine Lake embankment. The seepage monitor will broadcast an alarm using SMS when it detects significant water in the base of the pit, which is a possible indicator of excess seepage through the embankment. Figure 21 shows photos of the seepage pit.

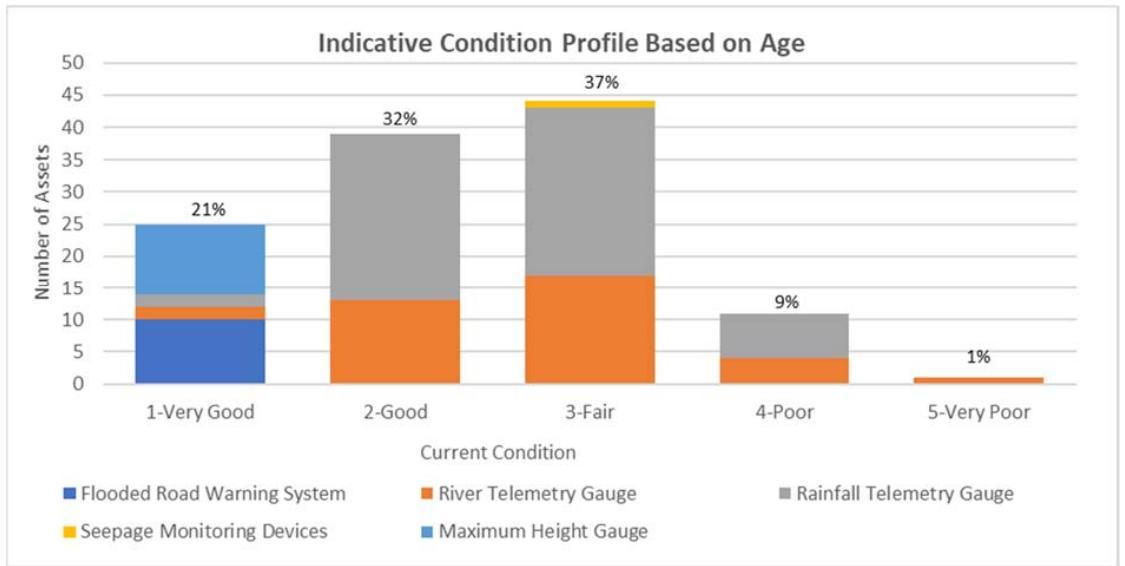
Figure 23 - FMD indicative condition profile (estimated based on age)

The condition profile from using the above approach is illustrated in Figure 23 below. It is indicated that 90% of FMD assets are in fair to very good condition. 10% of the assets, all telemetry gauges, are likely to be in poorer condition than the rest of the portfolio due to their age and are likely to required detailed assessment for replacement in the near future.

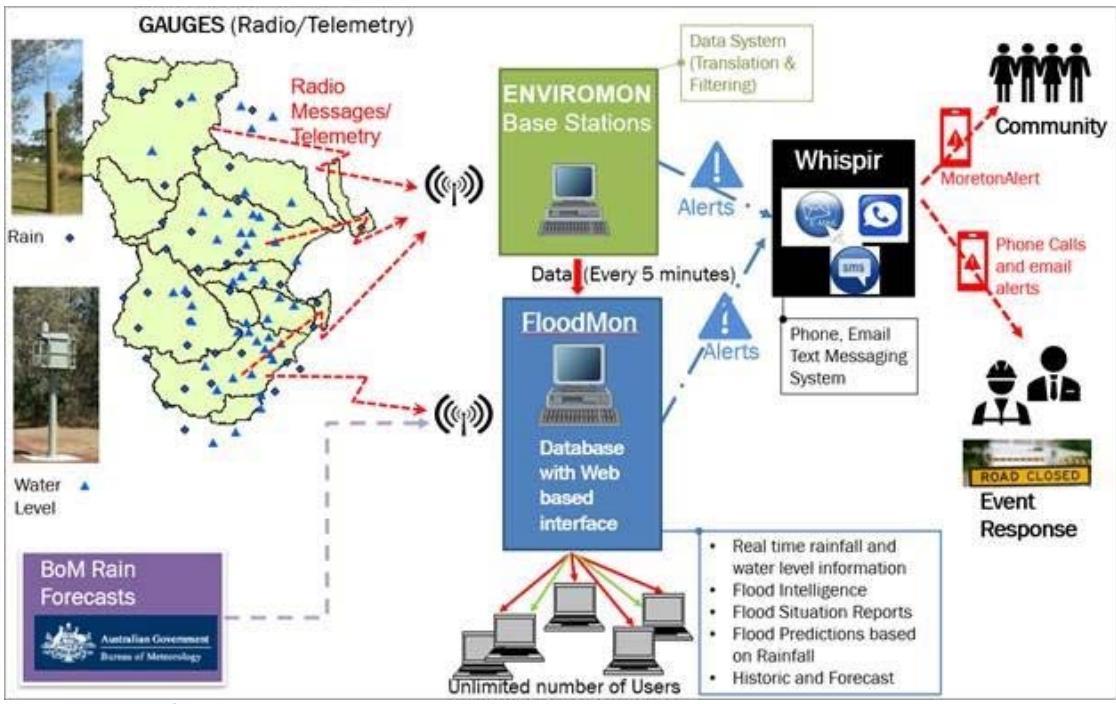
Figure 29 - MBRC Telemetry Network

Within the MBRC network, the data captured via the Enviromon Base stations is transferred to Council's flood gauge data management system (TARDIS/FLOODMON). Figure 29 summarises telemetry data capture. TARDIS is Council's original flood gauge data management system. FLOODMON is effectively the next generation of TARDIS with additional features and functionality and is currently run in parallel with TARDIS until event testing and final adoption.
