FIGURE 3-4: Rectification Concept Plan for Humpybong Creek RED_03 Lake

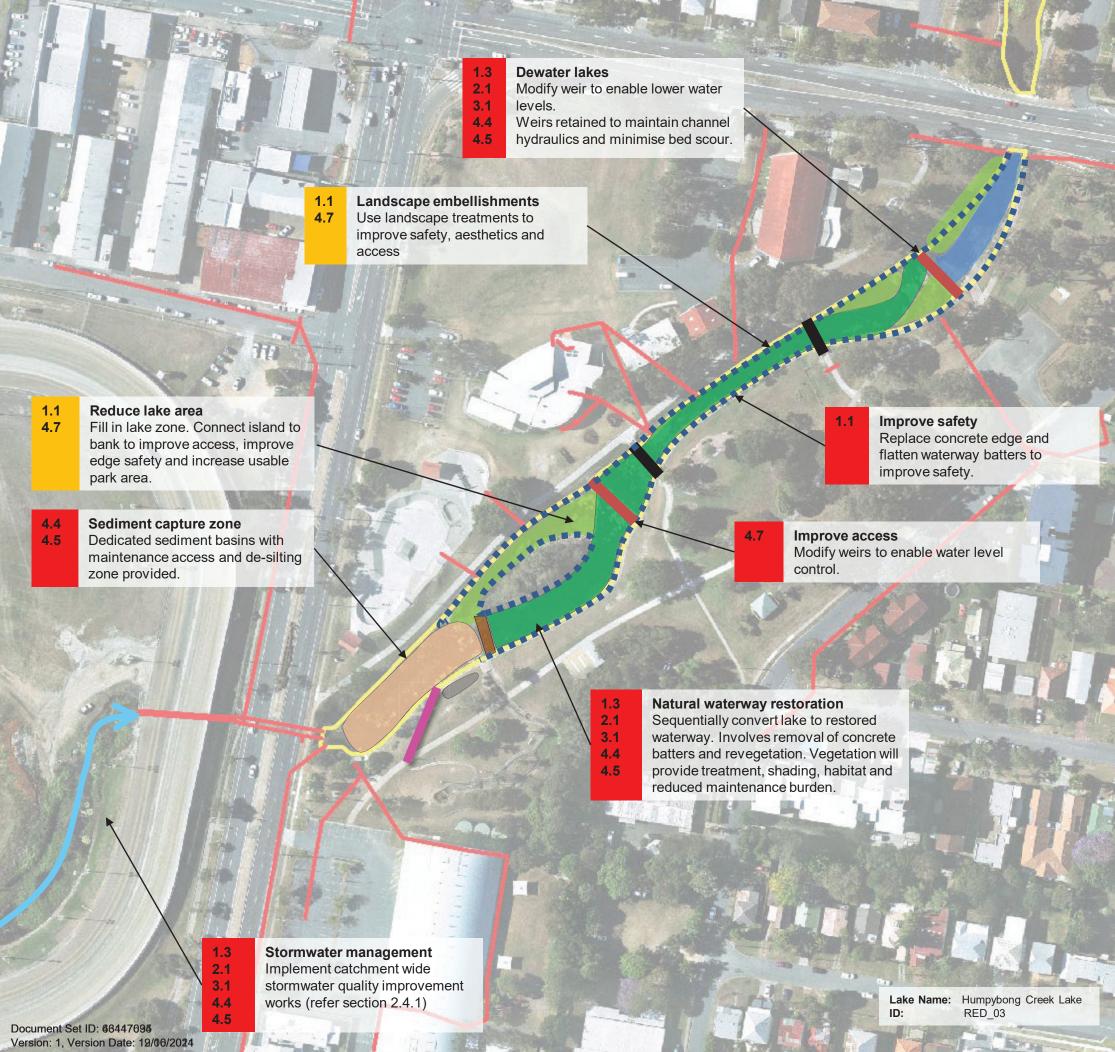
Proposed desilt zone

Concrete edge to be removed

Dedicated Maintenance Access
