Infrastructure Data Assessment Report Caboolture River Catchment Regional Council's Regional Floodplain Database Stage 2

Infrastructure Data Assessment Report Caboolture River Catchment Regional Floodplain Database Stage 2

RE: Hydrography Review Report for the Hays Inlet, Redcliffe and Caboolture River Catchments Regional Floodplain Database Stage 2, Packages 2 and 4

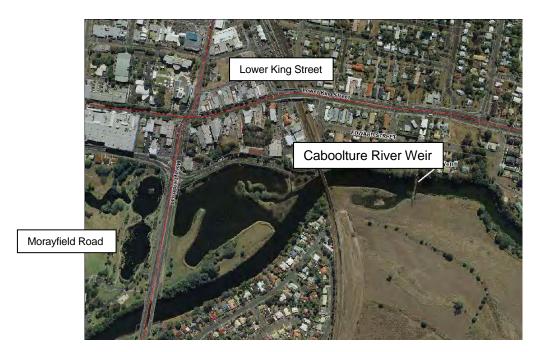
Figure 3-1 Location of Caboolture River Weir

The Caboolture River weir is currently not included in the DEM. Details of the weir, such as survey of the weir crest is required for inclusion in the model. This information may be sourced from SEQwater. The weir is located to the east of Morayfield Road and to the south of Lower King Street.

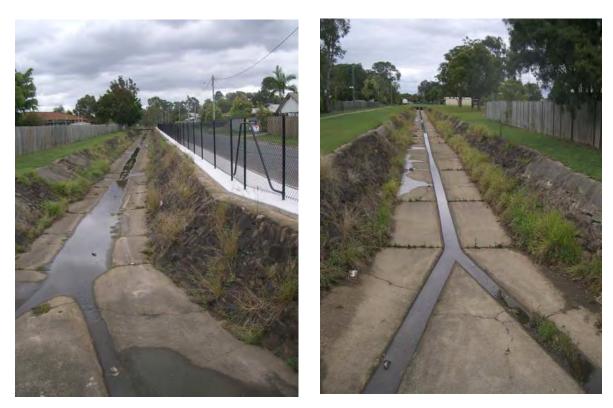
Figure B-1 Channel along Rarity Street Upstream and Downstream of McKean Street

During the site visit, a channel along Rarity Street was identified with an approximate width of 5m and an approximate depth of 1m. It was confirmed that this channel was included in the DEM provided.

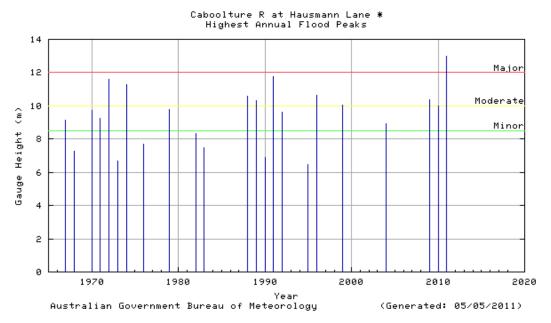
Figure 2-1 Historic Peak Flood Levels Caboolture River at Hausmann Lane

Based on the recorded flood levels illustrated in Figure 2-1 significant flood events occurred in 1972, 1974, 1988, 1989, 1991, 1996, 1999, 2009 and most recent in January 2011. The three largest events on record are the 1974, 1991 and 2011 floods. It is understood that Figure 2-1 does not include information for the 2011 event; hydrographs for this event for the three river gauges are provided in Appendix A.

The highest flood level on record is from the January 2011 flood event.

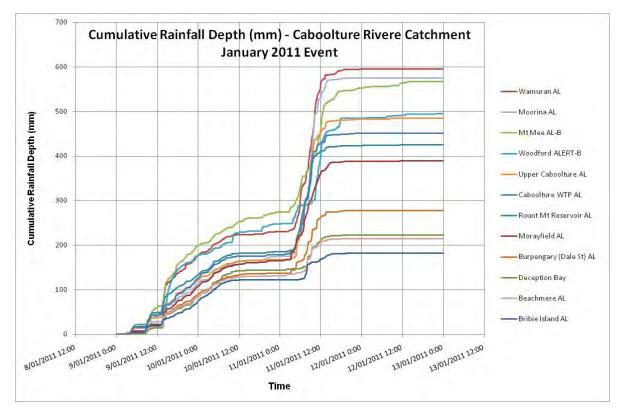
Figure 2-1 Cumulative Rainfall Depths (mm) – Caboolture River Catchment January 2011 Event

To represent the rainfall during the event, records from 12 gauges were utilised in the hydrologic model established for the January 2011 event. The recorded cumulative rainfall depths in millimetre (mm) for these rainfall gauges are illustrated in Figure 2-1. Spatially these gauges are positioned well within and around the catchment, thus resulting in reasonably good coverage of the study area. Figure 2-2 presents the location of the rainfall gauge locations utilised for the model calibration.

Analysis of the recorded rainfall data between the 9th and 12th of January 2011 suggest a similar trend in the timing of the rainfall bursts over the 4 day period. However, it is noted that the cumulative rainfall depth over 4 days results in significantly varied magnitudes across the Caboolture River catchment. Cumulative rainfall depths range from approximately 500 to 600mm within the west of the catchment, where as cumulative rainfall depths range from 200 to 300mm towards the east.

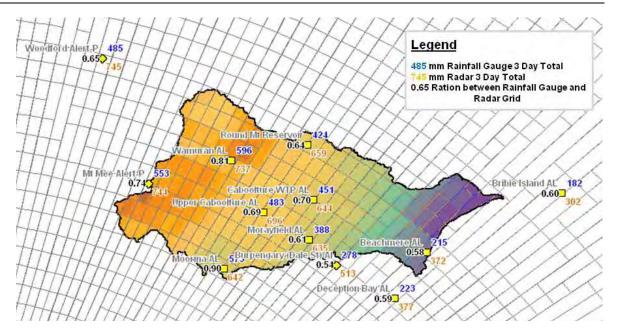
Figure 2-4 Comparison of Radar and Rainfall Gauge Totals, January 2011 Event

- The total rainfall from the radar is consistently higher for all gauge locations. The radar data would therefore need to be scaled if being utilised to calibrate the model;
- The radar/gauge rainfall depth ratio varies ranging from about 0.6 in the east of the catchment to 0.9 towards the west of the catchment, indicating that the scaling factor is slightly different across the catchment; and
- The radar grid clearly shows areas of very heavy rainfall in particular in the western part of the catchment, which was not represented by the location and records of the gauge data. It shows that the spatial distribution of rainfall intensities is better represented by the radar data.

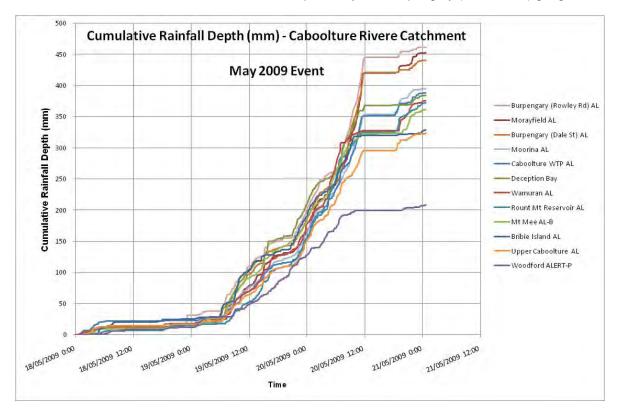
Figure 3-1 Cumulative Rainfall Depths (mm) – Caboolture River Catchment May 2009 Event

Records from 12 gauges were utilised in the hydrologic model established for the May 2009 event to represent the rainfall. The recorded cumulative rainfall depth in millimetre (mm) for these rainfall gauges is illustrated in Figure 3-1. Spatially these gauges are positioned well within and around the catchment, thus resulting in reasonably good coverage of the study area. The utilised records from the gauge locations are the same as for the January 2011 event, except for Beachmere, which did not record rainfall in 2009. The gauge locations are illustrated in Figure 2-2.

The majority of the cumulative rainfall depth at these gauges range between 320mm and 400mm, indicating that the rainfall was equally distributed across the catchment during the May 2009 event. The lowest record of 209mm was recorded at the Woodford gauge and the two highest rainfall depths of 457mm and 444mm were recorded at the Deception Bay and Burpengary (Dale Street) gauges.

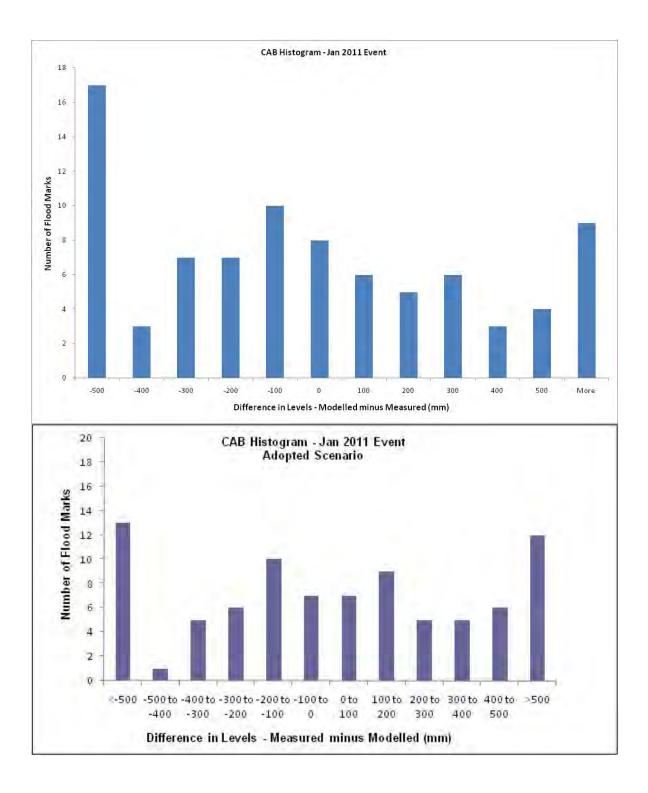
APPENDIX B: FLOOD MARK HISTOGRAM – JANUARY 2011 EVENT

The histogram shows that the majority of the flood marks show difference in flood levels between +/-200 mm, which suggests a reasonable calibration. It was noted that the flood model predicted, in general, significantly lower levels along Caboolture River (south-eastern part of the catchment).

Some flood marks differ significantly between the surveyed and the modelled level (between +/- 2m); however it was also noted that some of the surveyed flood marks located very close together show very different levels, which suggests that some of the flood mark levels may be inaccurate. Also, a discrepancy was found when comparing some of the surveyed flood mark levels with the ground levels used in the model (derived from the LiDAR). For the 89 flood marks in total, 15 flood marks have surveyed flood levels lower than the ground level in the model. Council and BMT WBM have investigated this discrepancy and surmised that the anomalies are likely due to:
