## **Appendix A BCC Natural Channel Design Guidelines Extracts**

## **Appendix B Reviewed Flood Studies**

## **Appendix C   Photos from Catchment Inspection**

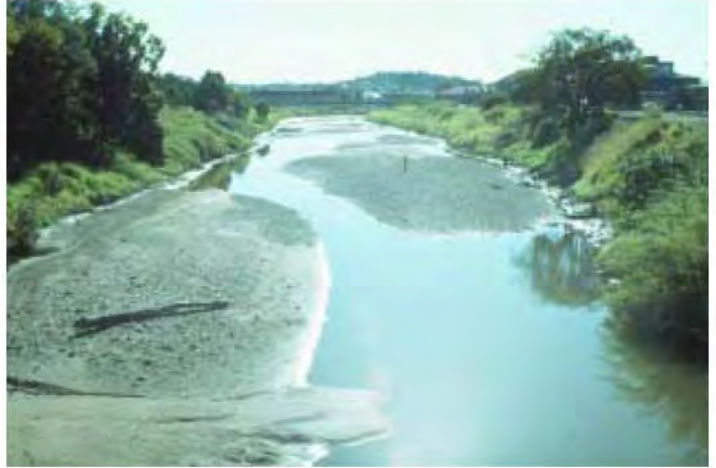
Photo C2

*Slight meandering, regular cross section,  
well maintained grass channel.*

*Bankfull:  $n = 0.028$*

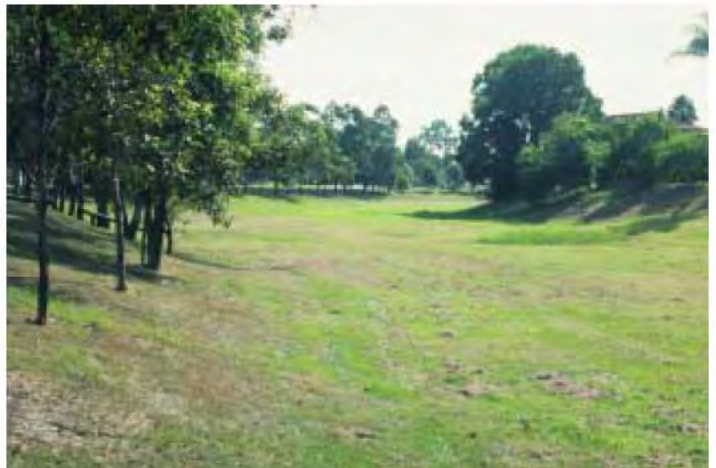
Photo C3

*Mown grass channel, regular cross  
section, slight meander.*

*Bankfull:  $n = 0.028$  (clean)*

*$n = 0.030$  (some shrubs)*

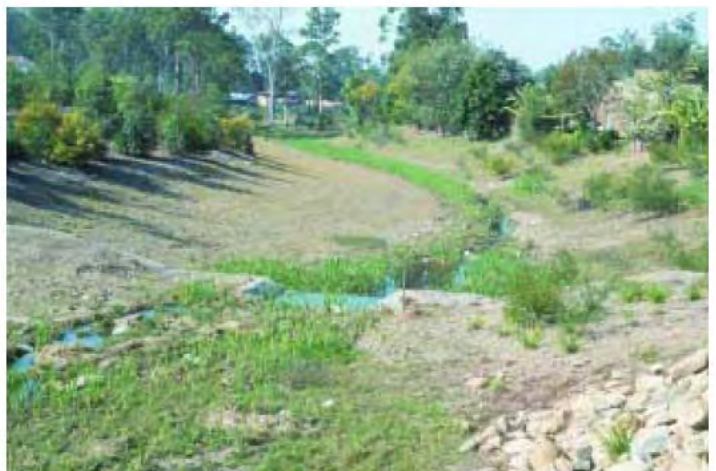
Photo C4

*Regular cross section, slight meandering, mown overbanks.*

*Bankfull:  $n = 0.04$*

*Overbank grass:  $n = 0.03$  (shallow flow depth assumed)*

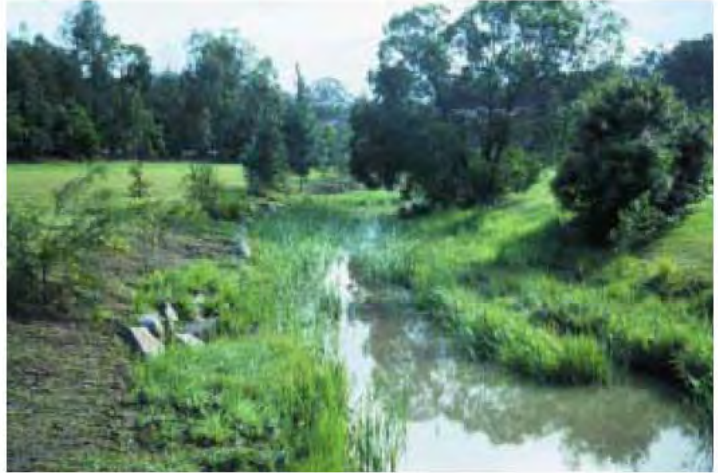
Photo C5

*Mown grass banks, unmaintained wetland plants on bed, regular cross section, very slight meander.*

*Bed: Manning's  $n$  is variable depending on flow depth.*

*Bankfull components:*

*bed  $n = 0.035$*

*bank  $n = 0.030$*

*resulting in a bankfull  $n = 0.035$*

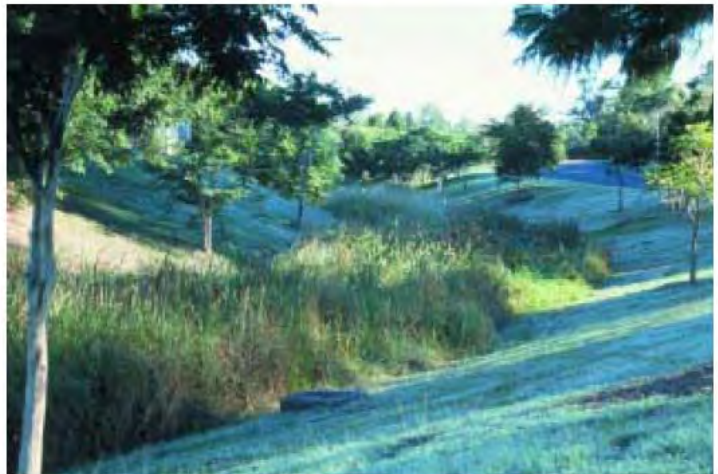
Photo C6

*Canopy trees in early stages of growth, straight, regular channel.*

*Bankfull:  $n = 0.04$*

*Overbank:  $n = 0.15$*

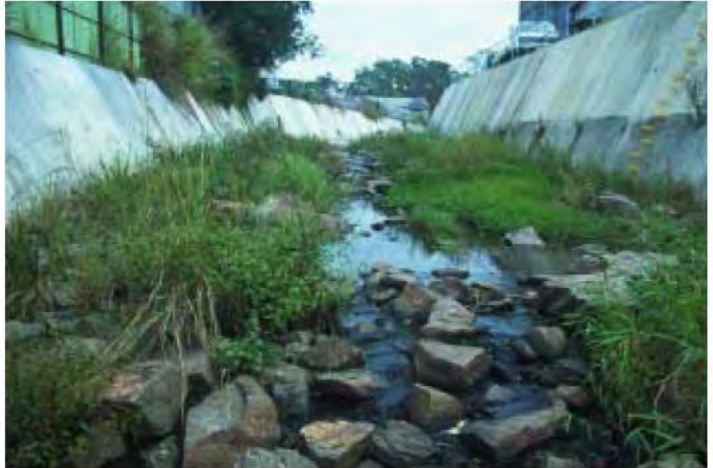
Photo C8

Deep channel, irregular cross section,  
meandering channel.

Bankfull:  $n = 0.045$

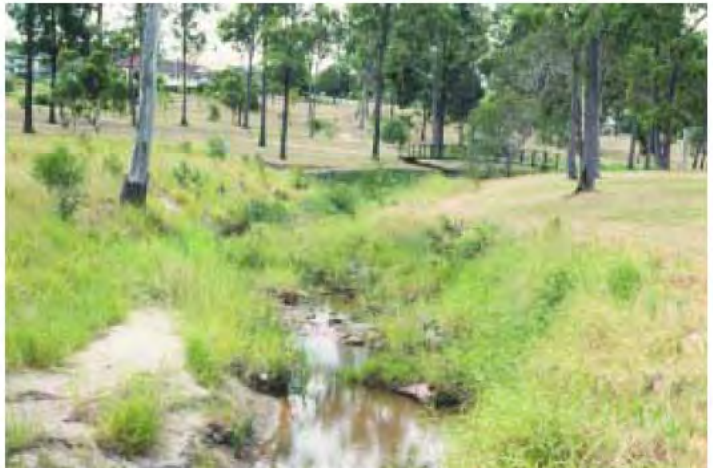
Photo C9

Near straight channel, full canopy cover  
with few weeds, pool-riffle system,  
shallow pools with boulders.

Bed:  $n = 0.045$

Bank:  $n = 0.09$

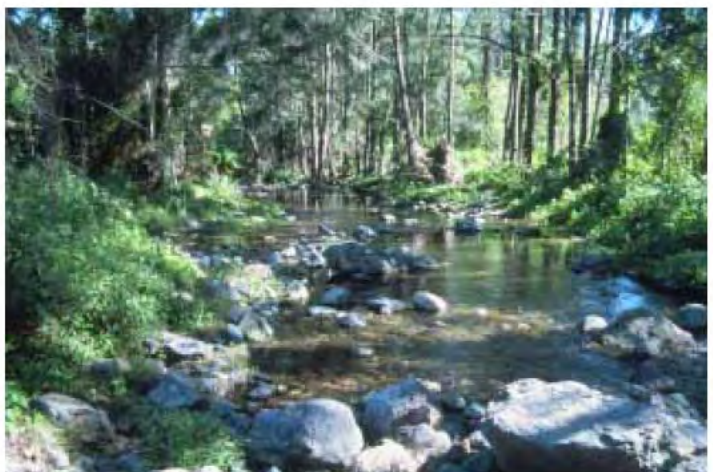
Photo C10

*Pool-riffle bed system, meandering channel, thick shrub growth on banks, deep pools.*

*Bed:  $n = 0.04$*

*Left bank:  $n = 0.06$*

*Right bank:  $n = 0.20$*

*Bankfull:  $n = 0.06$*

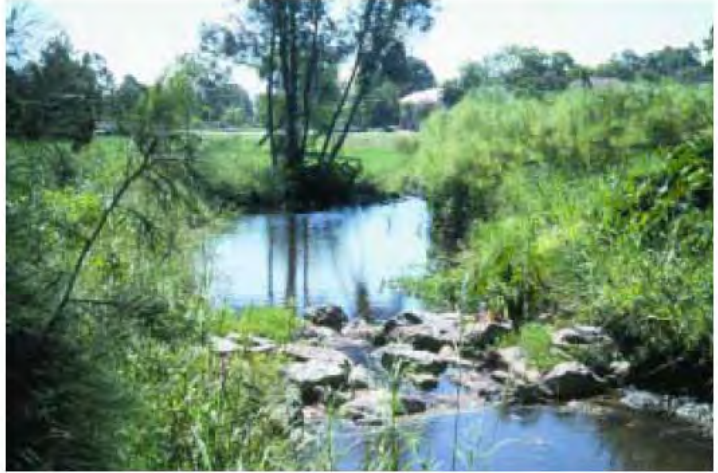
Photo C11

*Channel vegetation in early growth stage, gradual bends, regular cross section, deep water, pool-riffle system.*

*Bankfull (existing):  $n = 0.04$*

*Long-term (full vegetation) bed:  $n = 0.05$*

*banks:  $n = 0.15$*

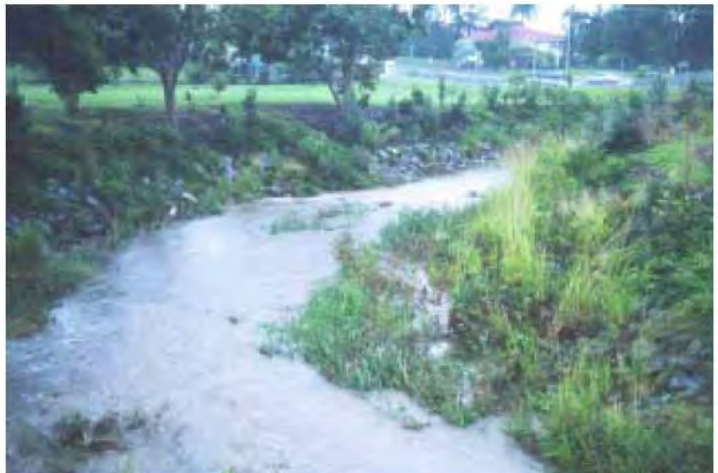
Photo C12

*Irregular, meandering, constructed channel with boulders.*

*Bankfull:  $n = 0.05$*

*Bank vegetation:  $n = 0.15$*

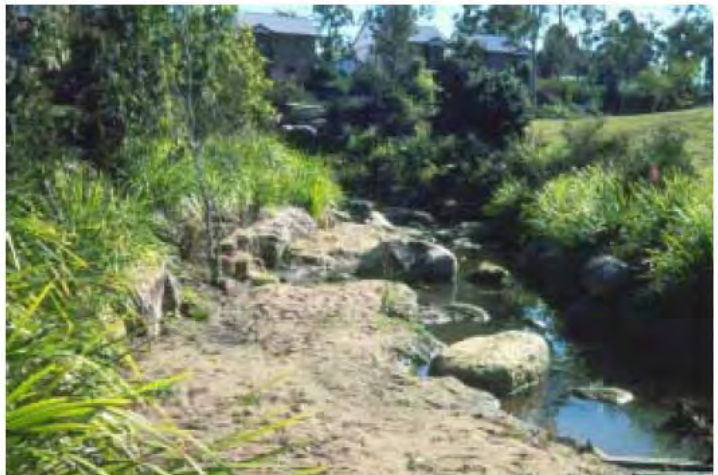
Photo C13

*Irregular channel with meanders and woody debris (logs).*

*Bankfull:  $n = 0.05$*

*Overbank:  $n = 0.10$*

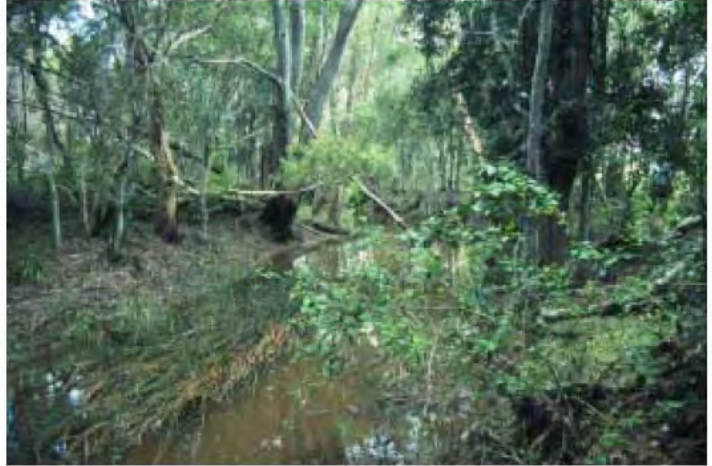
Photo C14

*Bed is a combination of thick, flexible vegetation and open rock pools and riffles. banks have sparse trees and woody shrubs. Irregular channel shape with slight meandering.*

*Bed:  $n = 0.06$*

*Bank:  $n = 0.12$*

*Bankfull:  $n = 0.07$*

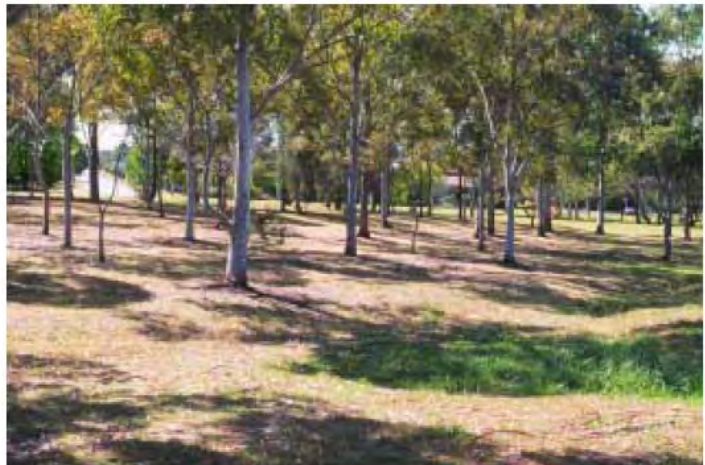
Photo C18

*Overbank vegetation consists of tall truck trees, no low branches or shrubs. Tree spacing of approx. 8 metres.*

*Overbank:  $n = 0.05$*

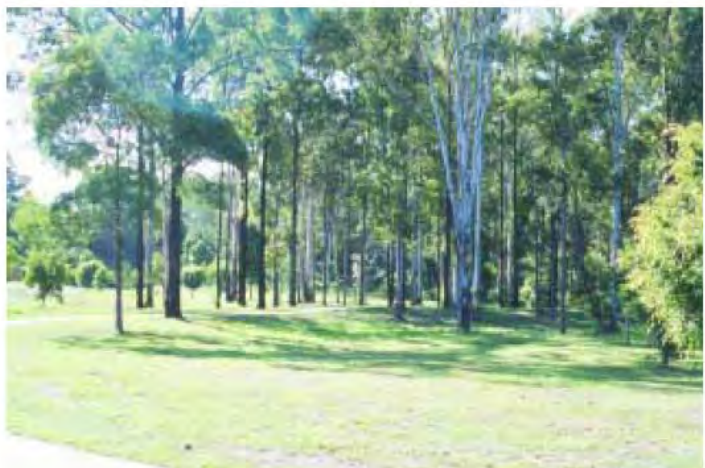
Photo C19

*Irregular channel with meanders.*

*Channel:  $n = 0.04$  to  $0.05$  depending on channel irregularity and debris content.*

*Overbank area consists of single truck trees with no low branches or shrubs.*

*LHS (5 m spacing):  $n = 0.055$*

*RHS (6-7 m spacing):  $n = 0.05$*

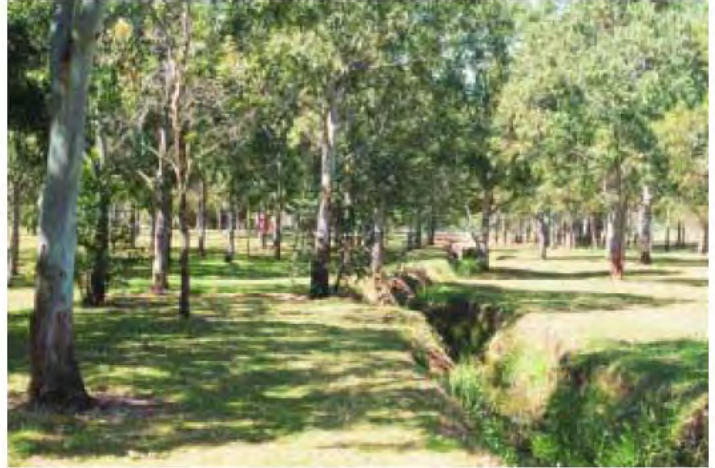
Photo C20

*Trees at approx. 5 metre spacing, no low branches.*

*Overbank:  $n = 0.055$*
