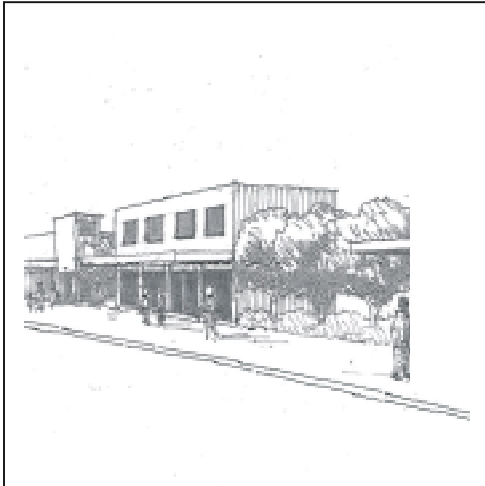
Image 6 – Acceptable
Continuous built form and
streetscape treatment along
North Lakes Drive

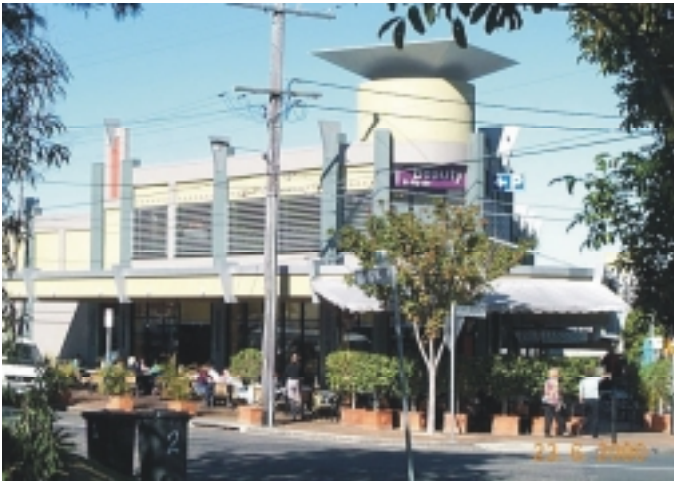
Image 7 – Acceptable
Landmark corner building to
have distinctive architecture and
relationship with the street.

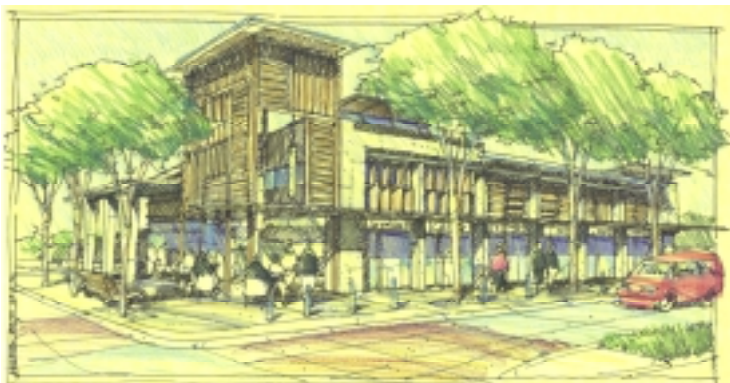
Image 8 – Acceptable
Building to address corner and
provide a landmark.

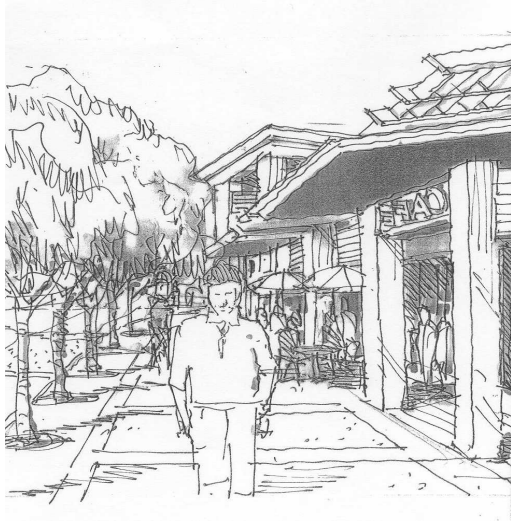
Image 9 – Acceptable
Landscape planting will soften
the appearance and give scale to
buildings.

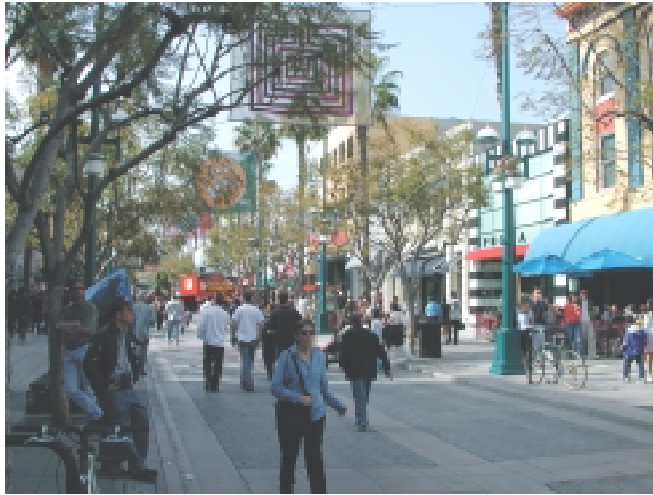
Image 10 – Acceptable
Street Environment

- pedestrian friendly
- 2 storey scale
- street furniture
- integration of footpath and street paving
- street trees
